NASA/TM—2005-214021

# Analysis of Carbon/Carbon Fragments From the Columbia Tragedy

David R. Tallant and Regina L. Simpson  
Sandia National Laboratories, Albuquerque, New Mexico

Nathan S. Jacobson  
Glenn Research Center, Cleveland, Ohio

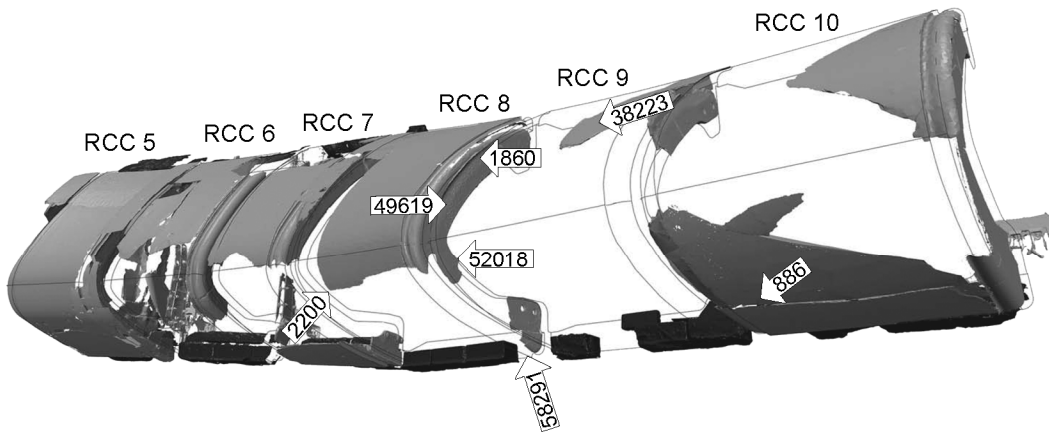
A three-dimensional reconstruction of the port wing RCC panels 5 to 10 is shown in Figure 7. The seven arrows point out the locations where samples were taken, roughly following the probable entry pattern of the plasma. The numbers were assigned as the Columbia wreckage was collected and catalogued.

Figure 7.—Schematic showing recovered portions of port wing leading edge panels from Columbia. Samples taken for this study are marked.

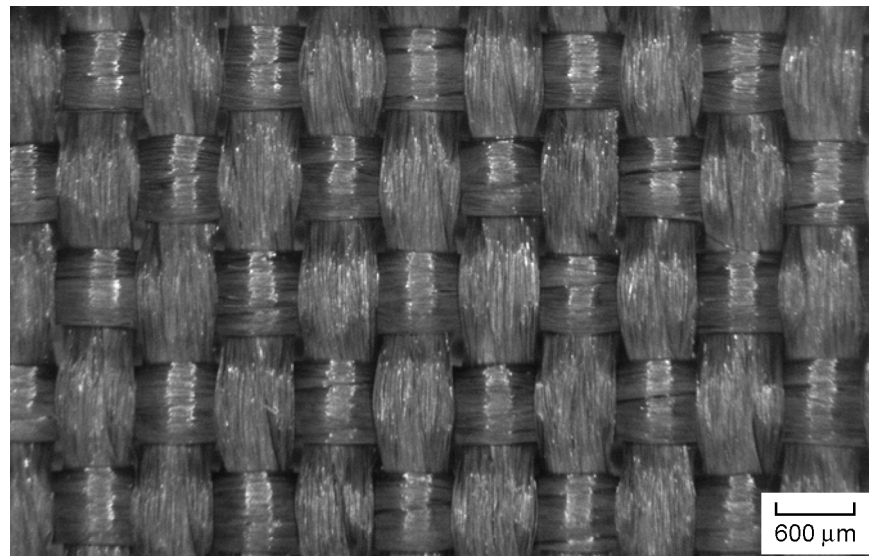
Figure 9 is an optical micrograph of the as-fabricated carbon/carbon cloth. This is made of rayon-derived carbon fibers by Avtex (Formerly of Front Royal, VA). Raman spectra for this cloth are given in Figures 10(a) and (b) with illumination along the edge of the fiber and at the end of the fiber, respectively. Note that when illumination is at the fiber ends (versus along the length of the fibers), the 1350 cm<sup>-1</sup> band is enhanced in intensity because the ends of graphene planes are sampled, where symmetry results in a larger Raman cross-section for the vibrational mode resulting in the 1350 cm<sup>-1</sup> band. Therefore, care is necessary in interpreting Raman spectra from highly oriented assemblages of carbon, as in high-temperature-processed fibers.

Figure 9.—Photograph of the as-fabricated RCC (Avtex) cloth used in RCC.

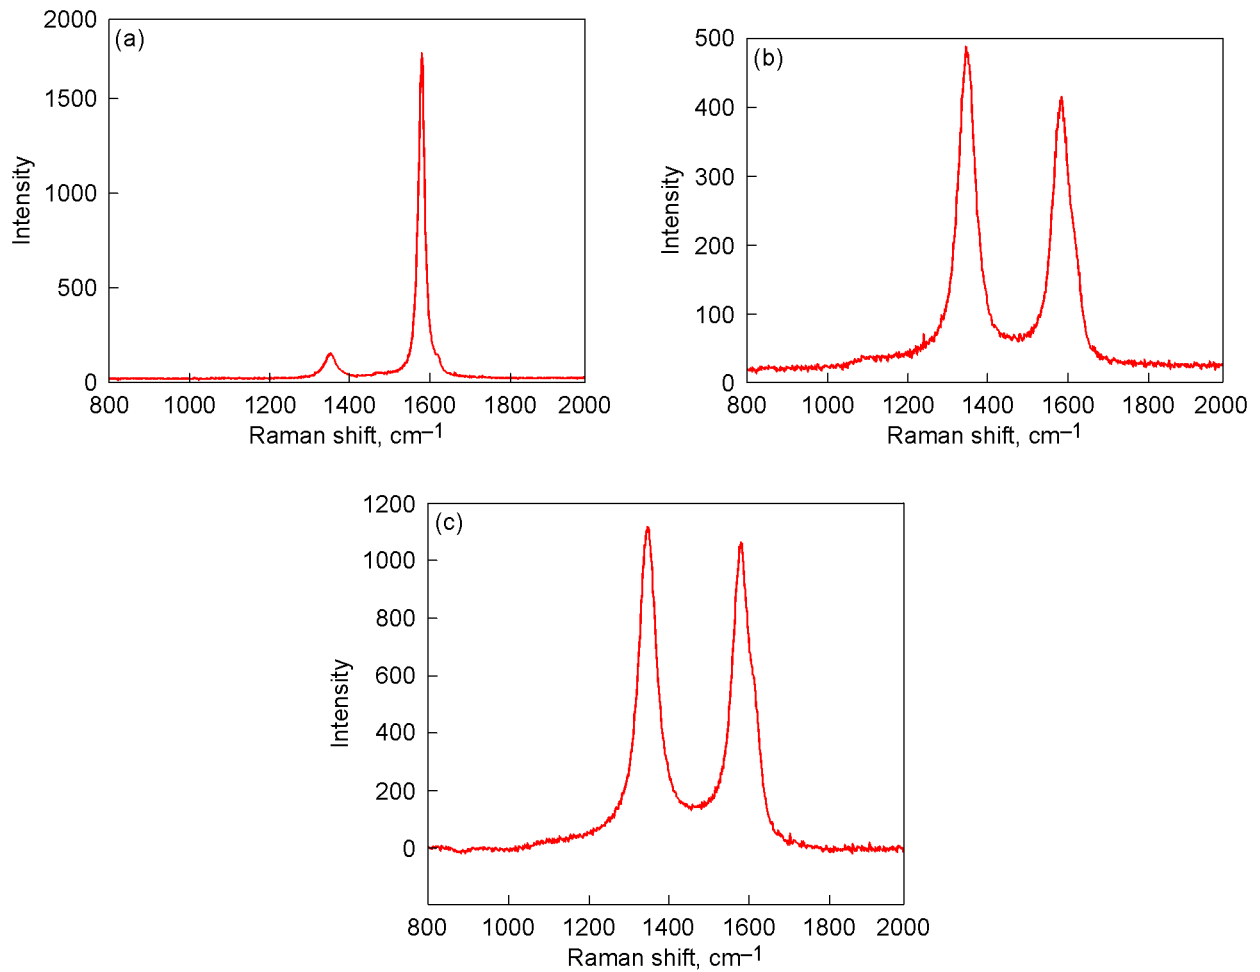
In this analysis, it is particularly important to compare the Raman bands from the recovered RCC from Columbia to the Raman bands in Figure 10(c). Particularly important is the relative height of the 1350  $\text{cm}^{-1}$  band. If the Raman bands from the recovered RCC show a substantially smaller 1350  $\text{cm}^{-1}$  band than the as-fabricated material, it is very likely that the RCC was exposed to a higher temperature during the accident.

Figure 10.—Raman spectra of the as-fabricated materials. (a) Cloth illuminated along the edge of the fiber. (b) Cloth illuminated at fiber end. (c) As-fabricated RCC core (includes cloth lay-up, graphitized phenolic resin, and graphitized liquid carbon precursor).
