NASA/TM—2005-214092

Shuttle Rudder/Speed Brake Power Drive Unit (PDU) Gear Scuffing Tests With Flight Gears

Margaret P. Proctor and Fred B. Oswald
Glenn Research Center, Cleveland, Ohio

December 2005

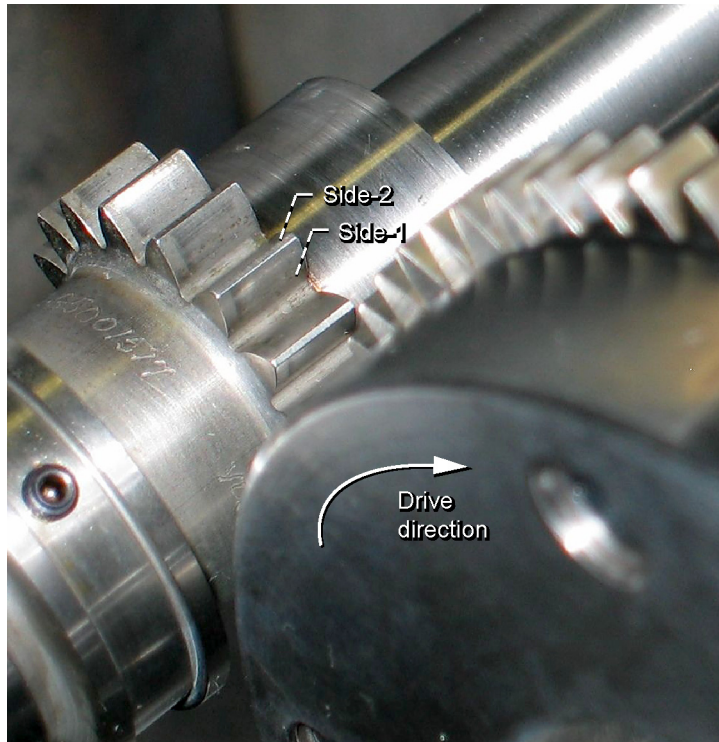
Figure 9.—Pre-test photo of pinion teeth.

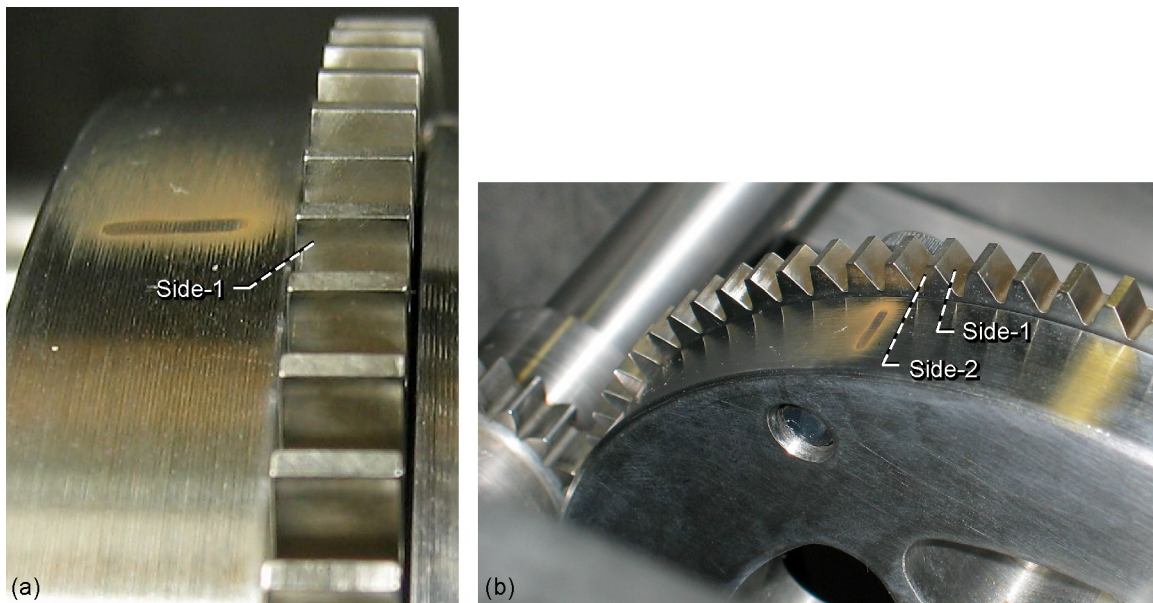
Figure 10.—(a) Pre-test photo of ring gear teeth showing side-1. (b) Pre-test photo showing another view of ring gear teeth, side-1 and side-2.

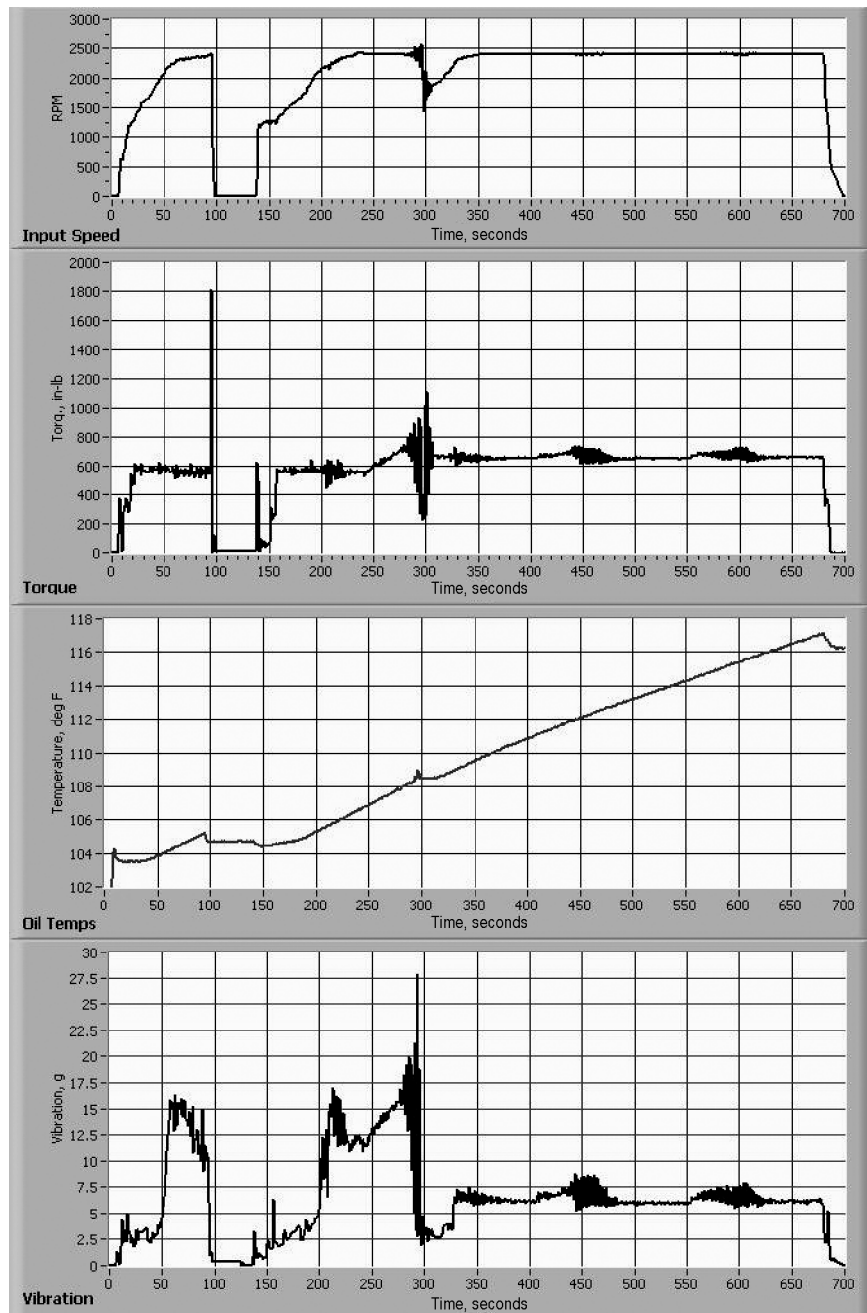
The only tests that generated any damage beyond normal polishing wear of the gear teeth were Back-3c, Score-1, and Score-2. The Back-3c test was conducted at an input speed, torque, and power of 2402 rpm, 664 in.-lb, and 25.3 hp. A plot of the time history of the speed, input torque, oil fling temperatures, and the pinion vibration levels for Back-3c is shown in figure 11.

Figure 11.—Time history of test Back-3c with side-1, build-1 showing input ring gear speed and torque, oil fling temperature and vibration data from the accelerometer near the pinion shaft.

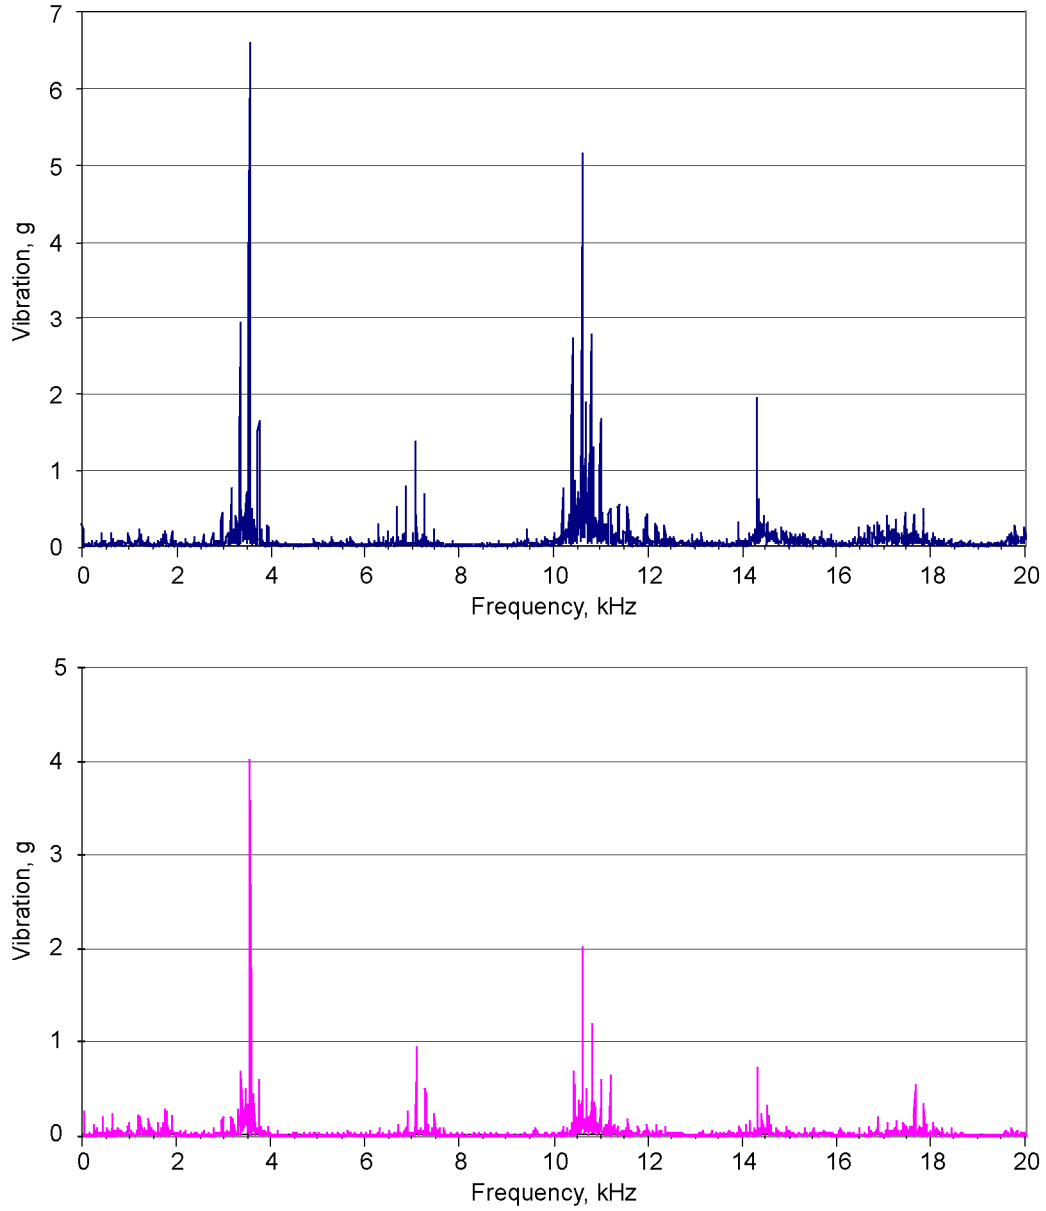
Frequency spectra of the accelerometer located near the pinion shaft taken at 250 and 550 sec are shown in figure 14 (a) and (b), respectively. The spectra show the vibration frequencies for the first four harmonics of gear mesh frequency. If we speculate that the tooth damage observed after this test occurred at 300 sec, when the oil temperature increased, we might expect to see a difference in these vibration traces because of this damage. However, the traces do not show any indirect evidence of a change to the tooth surfaces.

Figure 14.—Frequency spectra from test Back-3c at 250 sec (top) and 550 sec (bottom). The first harmonic of gear mesh frequency occurs at 3523 Hz (2402 rpm x 88 teeth/60 sec/min).

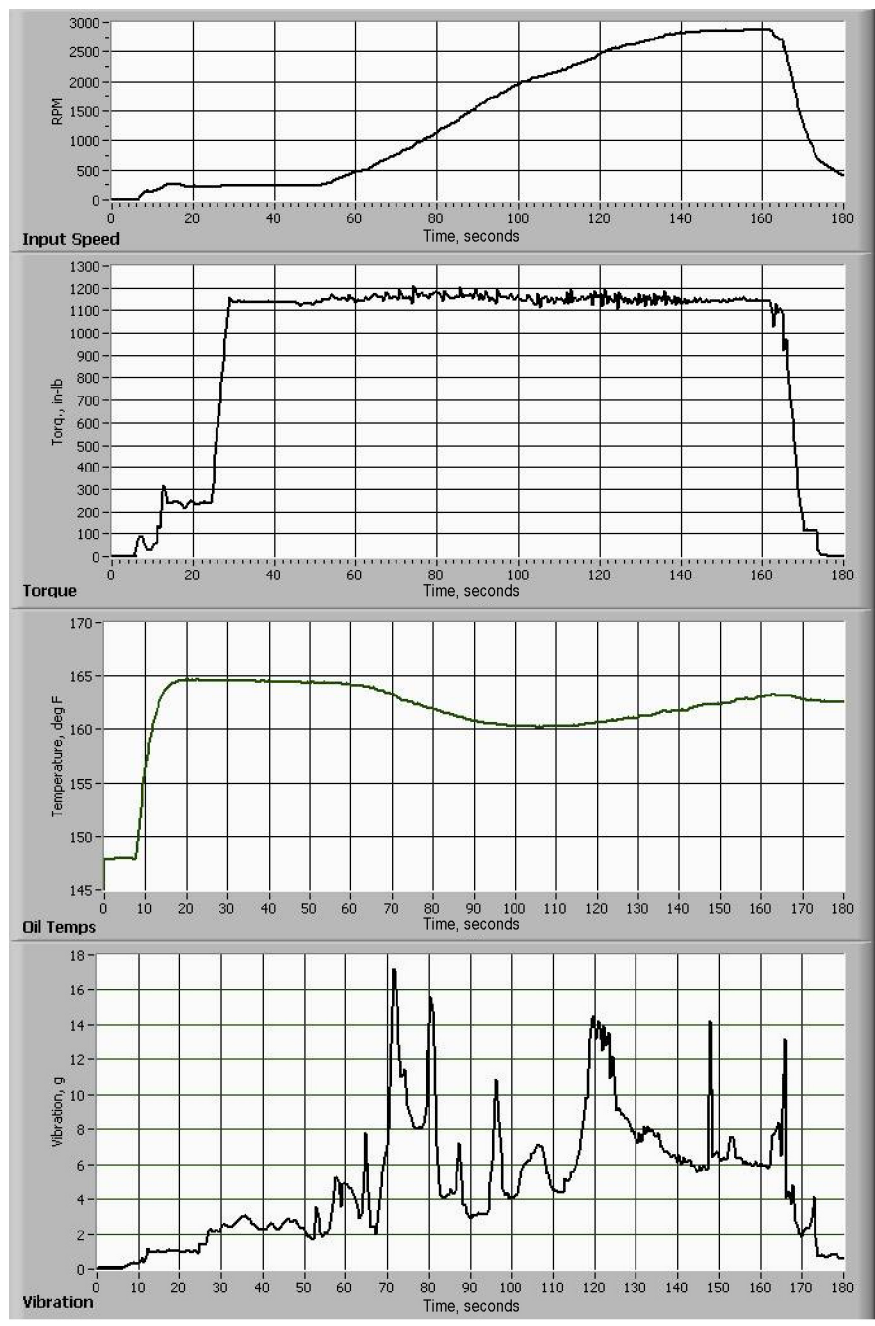
Small wear marks near the tips of the driven side of the pinion teeth (fig. 15), were generated during the Score-1 test on side-2, build-1 conducted at input speed, torque, and power of 2865 rpm, 1167 in.-lb, and 53 hp. No corresponding wear was observed on the ring gear teeth as shown in figure 16. The time histories of input speed, input torque, oil fling temperature, and pinion vibration are shown in figure 17. There is no distinct corroboration of vibration rise and fling temperature rise as in the Back-3c test. There are some high vibration levels in the test however. The drop in oil fling temperature is likely due to turning off the heat gun and heat lamp prior to rotation and some initial cooling due to flinging the oil to cooler surfaces above the oil bath.

Figure 17.—Time histories of input ring gear speed and torque, oil fling temperature and pinion rms vibration level for Score-1 test on side-2, build-1.
