**SPACE SHUTTLE BODY FLAP ACTUATOR BEARING TESTING FOR NASA RETURN TO
FLIGHT**

ABSTRACT

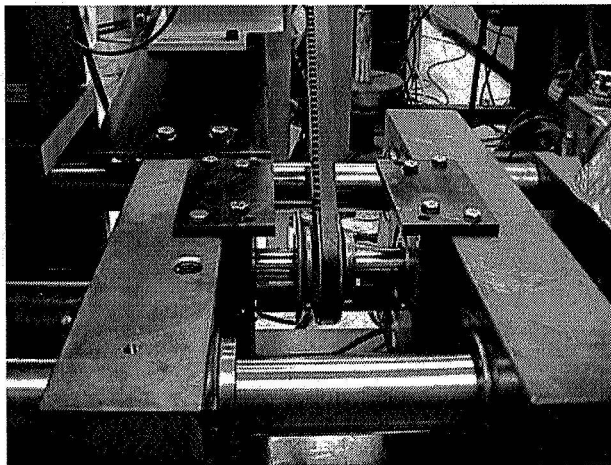
Figure 2 MSFC Bearing Testing Rig

A preexisting test rig (Figure 1) was adapted to conduct life tests on the body flap output shaft bearings (Size 106). The bearing tester supports an angular contact bearing on each end of the drive shaft. Axial load was applied to the bearing pair and shaft by the bearing tester. A drive pulley was attached to the middle of the drive shaft and was driven by a variable speed ac motor. The bearing housing temperature was controlled to 140F by circulating ethylene glycol through coolant passages in the bearing test housings. During testing, the bearing axial load, shaft rotational speed, motor amps, and temperature of bearing outer races were monitored and recorded.
