# ISS Internal Active Thermal Control System (IATCS) Coolant Remediation Project - 2006 Update

**Russell H. Morrison**  
The Boeing Company

**Mike Holt**  
NASA Marshall Space Flight Center

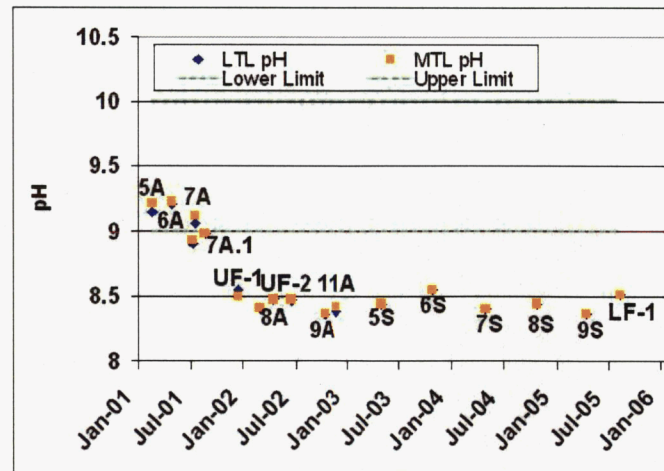
The Teflon flexhoses are permeable to CO<sub>2</sub>. The elevated CO<sub>2</sub> levels in the on-orbit atmosphere have caused increases in total inorganic carbon (TIC) to levels on the order of 200 ppm in the coolant. The CO<sub>2</sub> has also caused a reduction in coolant pH, Figure 1. The pH has been fairly stable in the range of 8.4 to 8.5 since flight 8A in 2002.

**Figure 1. Coolant pH as measured in coolant samples returned from ISS for ground analysis**

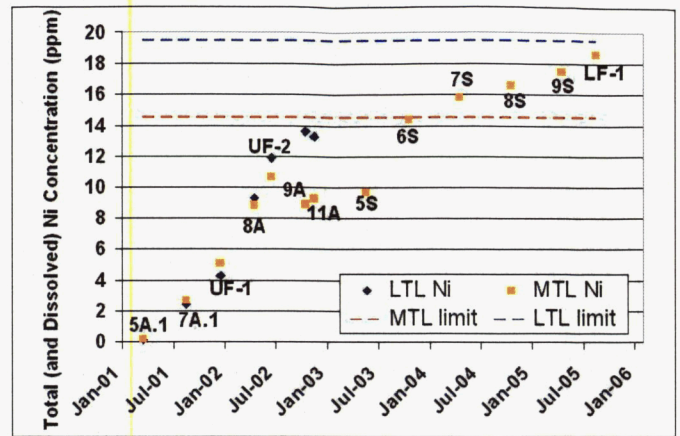
The decrease in pH has been accompanied by an increase in dissolved nickel ions within the coolant as illustrated in Figure 2. Nickel concentration in the coolant has increased at a rate of roughly 2.3 ppm per year since late 2003.

**Figure 2. Total (approximately equal to dissolved) nickel concentration as measured in ISS coolant samples returned to ground for analysis**

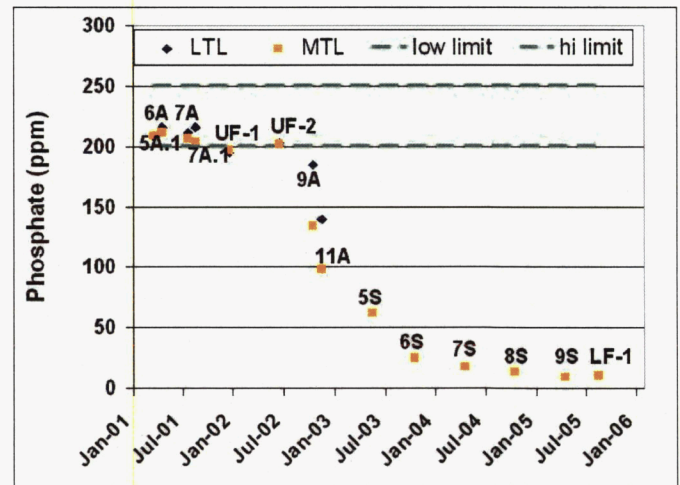
As the pH decreased and the nickel ion concentration increased, the point was finally reached when the phosphate in the coolant began to combine with the nickel to precipitate as nickel phosphate. The falling phosphate concentration is illustrated in Figure 3. It has been fairly stable since bottoming out at about 10 ppm in early 2005.

**Figure 3. Phosphate concentration as measured in ISS coolant samples returned to ground for analysis**

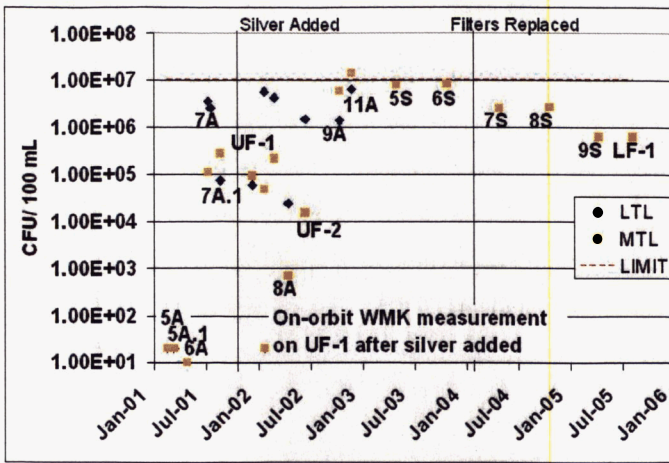
The planktonic microbial population, as measured in coolant samples returned from orbit, has been elevated since flight 7A in July 2001, Figure 4. Counts as high as 1.4E+07 colony forming units (CFU) per 100 milliliters (ml) were measured on flight 11A. There has been a steady slow decline in the counts measured in coolant samples since flight 5S to the current level of 6.3E+05 CFU/ml.

**Figure 4. Planktonic microbial heterotrophic plate counts on R2A Agar as measured in ISS coolant samples returned to ground for analysis**

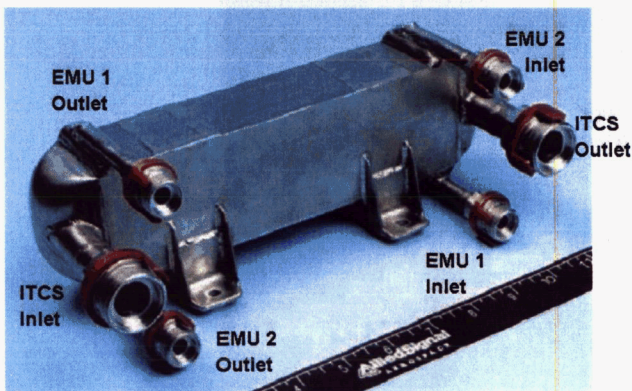
Figure 16. SPCU HX

There are many components in the IATCS that contain nickel braze, but only a few represent potential catastrophic hazards. One is the SPCU HX that is installed in the USOS Airlock, Figure 16. This provides cooling for the Extravehicular Maneuvering Unit (EMU) when the crew is in the airlock. On the IATCS side of that HX, the pressure is normally 40 to 60 psia but can be as high as 115 psia. The maximum allowable pressure on the EMU side is about 30 psia. The EMU side is not protected by a relief function at this time and, should it over-pressurize, the likely failure point is in the liquid cooled undergarment worn by the crewmember underneath the Extravehicular Activity (EVA) suit. There are times in the normal procedures when the crewmember is attached to the EMU side of the SPCU HX while suited up and at vacuum. A rupture of the undergarment at that time could result in up to one gallon of IATCS coolant spilling into the suit. The risk then is that the crewmember will inhale the coolant and drown. The corrosion study team predicted that the nickel braze layer in a normal SPCU HX can be penetrated in about 4 years at pH 8.3 [5]. For that reason, the Airlock SPCU HX was replaced on March 15, 2005 with a spare unit that had undergone a second braze cycle and was expected to have a life in excess of 50 years.

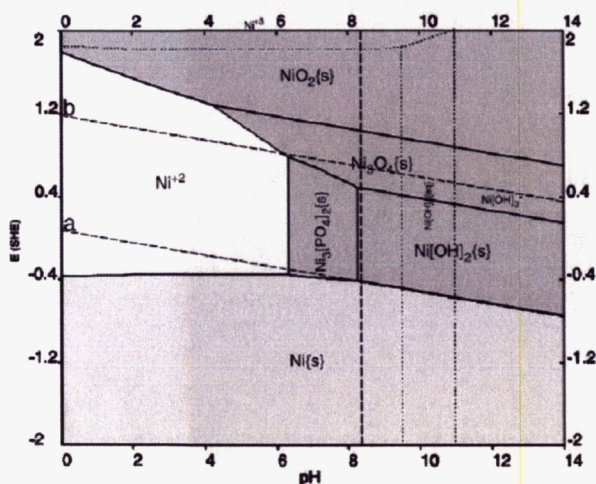
The IATCS coolant working group has enlisted the aid of specialists in the modeling of corrosion and water chemistry effects. Products of that effort, like the stability diagram in Figure 20, have proven invaluable in understanding observations from on-orbit coolant samples as well as those from tests performed on the ground at beaker, bench and full system levels. The models are refined with data and then used to predict the outcome of future tests and remediation efforts.

**Figure 20. Nickel Pourbaix diagram for IATCS coolant showing that on-orbit equilibrium pH lies at boundary between nickel hydroxide and nickel phosphate formation**

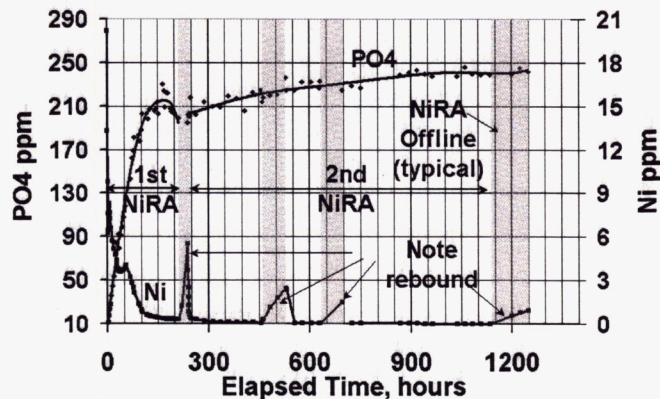
**Figure 21. Recirculating bench test results of NiRA showing nickel removal (green) and phosphate re-dissolution (orange)**

The IATCS coolant working group has performed extensive experimentation and perfected the application of a chelating resin produced by DOW Chemical for the removal of nickel ions from the IATCS coolant. A recirculating bench test of the NiRA performed in 2003/4 demonstrated its effectiveness at reducing nickel concentration, Figure 21. As the nickel concentration drops, nickel phosphate crystals distributed throughout the test bed were observed to re-dissolve and phosphate concentrations returned to their pre-precipitated levels. Subsequent bench testing proved the effectiveness of additional resin treatments for maintaining a constant pH during NiRA implementation. Ground NiRA units have been produced for experimentation and to support nickel

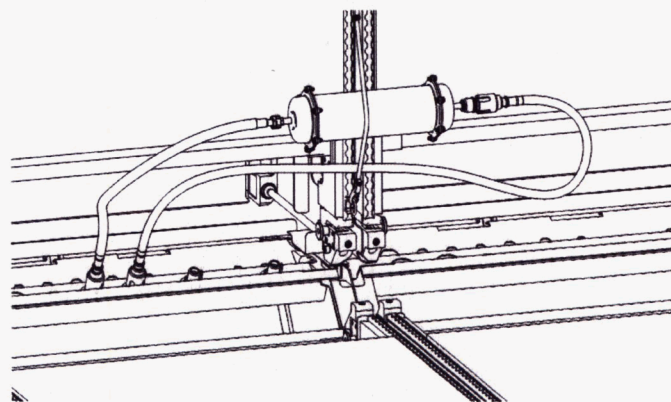
**Figure 22. NiRA canister installed in US Lab**

ion removal from the Node 2 cooling systems while it is processed at the NASA Kennedy Space Center (KSC). Flight units have been delivered to NASA KSC and are scheduled to be carried to orbit on flight 12A.1, Figure 22.

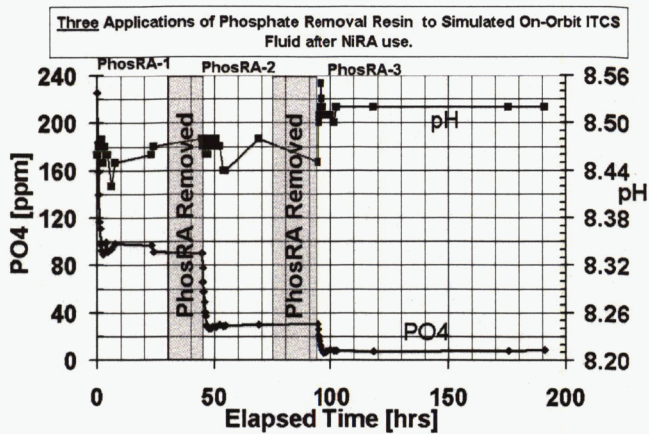
**Figure 23. Bench scale testing of PhosRA resin showing phosphate removal effectiveness and ability to maintain a relatively constant pH**

Phosphate was added to the coolant primarily as a corrosion inhibitor for the stainless steels in the system. Corrosion testing has shown that this is unnecessary at the pH levels the coolant is experiencing. Its propensity for forming nickel phosphate at the equilibrium pH of the on-orbit coolant has provided motivation to eliminate it. Future elements of the IATCS will be launched with coolant that has no phosphate. In order that payload racks may be freely moved between the US Lab and other on-orbit elements, and to preclude future nickel phosphate formation, it will be necessary to remove the phosphate from the US Lab coolant. To that end, the program has completed an extensive development program to adapt a DOWEX ion exchange resin to this application. Figure 23 illustrates its effectiveness at the bench level for phosphate removal without perturbing pH. Two flight units of the PhosRA, based on the NiRA

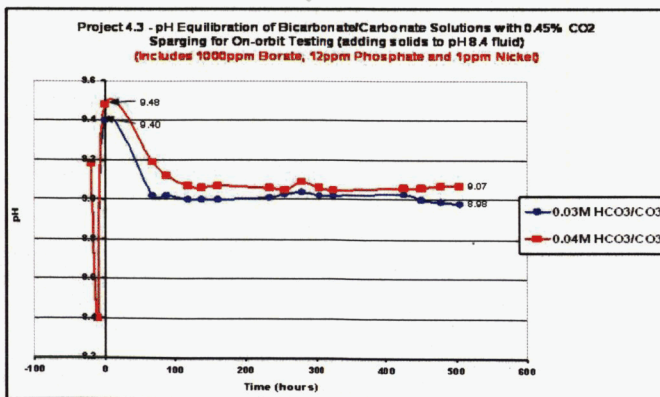
Laboratory testing has shown that addition of 0.04 equimolar carbonate / bicarbonate buffer to the 1000 ppm borate buffer already in the on-orbit US Lab coolant after pre-treatment with NiRA and PhosRA will raise the pH to about 9.5. Equilibration of the coolant with the CO<sub>2</sub> in the US Lab atmosphere will lower the pH to between 9 and 9.1, Figure 24.

**Figure 24. 0.04 molar carbonate / bicarbonate (red) pH vs time while being sparged with air/CO<sub>2</sub> at US Lab concentrations**

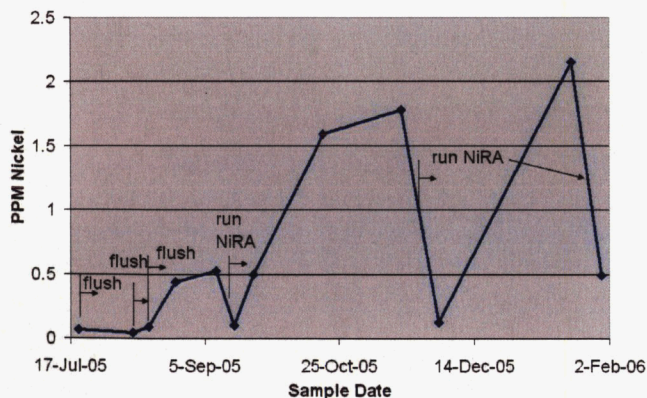
Figure 27. Node 2 LTL Nickel

It was decided to fill Node 2 with SSP 30573 Rev. B fluid modified to delete the silver and phosphate and lower pH to 8.4 by sparging with CO<sub>2</sub> in April 2005. Glutaraldehyde at 200 ppm was added for microbial control. This coolant is circulated through the Node 2 loops 5 days per week, 8 hours per day using ground support equipment pumps as ground operations allow. Ground NiRA units are installed to remove nickel. The intent is to remove as much intermetallic nickel from Node 2 on the ground as possible, so as to minimize the necessity to use NiRAs in Node 2 on orbit. All hardware life predictions for Node 2 are based on this chemistry and are not an issue. Figures 27 and 28 show the nickel concentrations in the Node 2 loops since this coolant has been added. These demonstrate the effectiveness of the NiRA for controlling nickel in actual flight hardware loops at the on-orbit pH conditions.
