NASA/TM-2008-215100
NESC-RP-06-115/06-028-E

International Space Station (ISS) S-Band Corona Discharge Anomaly Consultation

International Space Station (ISS) S-Band Corona Discharge Anomaly

December 14, 2006

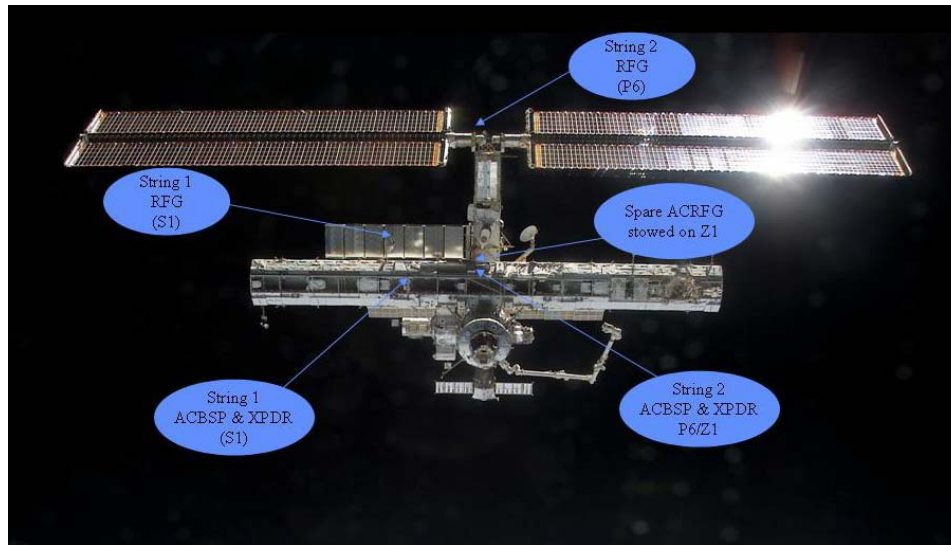
Figure 6.1-2. ISS S-Band Installation Sites

On April 13, 2006, there was a reflected RF power anomaly observed after four minutes nominal operation within the ACRFG (refer to Figure 6.1-1). This was in the “String 1 RFG” unit on S1 (S/N 002) as shown on the ISS in Figure 6.1-2. The “String 2 RFG” unit (S/N 003) on P6 is the primary unit. The spare unit (S/N 001) is stowed on Z1. Corona was examined as a possible root cause of the anomaly. Section 3.5 of the MDA ACRFG Reflected RF Power Anomaly Report (ref. 1) determined the necessary voltages to produce corona, at various pressures, in the narrowest electrode gaps in the coaxial cavity 5-pole diplexer and 3-pole bandpass filter (see Figure 6.1-3) assemblies. The results of the MDA analysis suggest the conditions present in the Bandpass Filter and Diplexer at 1 psia may have been favorable for the corona.
