STEREOMICROSCOPE INSPECTION OF POLISHED ALUMINUM COLLECTOR 50684.0. M. C. Rodriguez¹, M. J. Calaway², J. H. Allton³; ¹ Geocontrol Systems- ESCG at NASA/Johnson Space Center, Houston, TX 77058; melissa.rodriguez-1@nasa.gov, ² Jacobs- ESCG at NASA/Johnson Space Center, Houston, TX 77058, ³ NASA/Johnson Space Center, Houston, TX 77058.

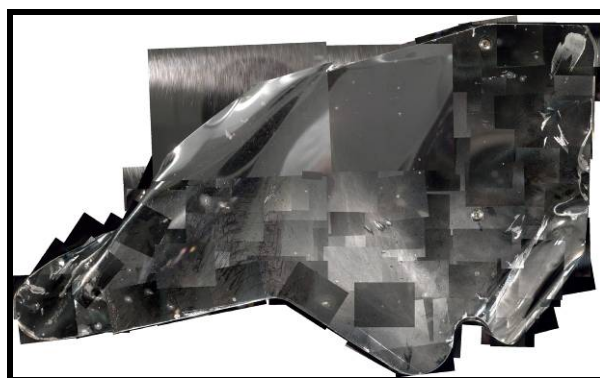
Fig. 2. Overview image of remaining polished aluminum kidney, 50684.0.

Stereomicroscope Observations: Post-flight characterization shows that the collector area has remained intact and did not fracture during impact. However, the Al collector was distorted and bent from the original dimensions. Mud and salt evaporite contamination from the Utah lakebed landing site is observed on the outer edges of the collector (Fig. 3) in smears and dried droplet formations. An extremely fine layer of particulate contamination is also present on the interior, flatter portions of the collector, recording evidence of physical movements of fragments during the hard landing (Fig. 4). Examples of hypervelocity impact craters, found on the right-hand portion of the image, are shown at higher magnifications in Fig. 5. All of the crater shapes appear to be uniformly round diameters at the collector surface and have unevenly splayed protruding edges. The interior “pit” bases also appear to be consistently rounded. Various gouges and scrapes from the hard landing have also been imaged; these are markedly different from impact cratering features and also appear near collector edges (Fig. 6).
