# Building a GPS Receiver for Space Lessons Learned

Steve Sirotzky, *Perot Systems*

## ABSTRACT

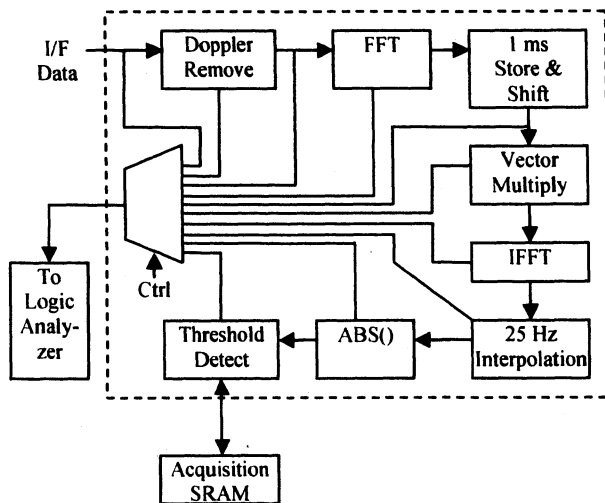
**Figure 3: Acquisition Blocks and Debugging Mux**

Several errors were discovered by observing the signals between and inside the functional blocks. These include biases in the ADCs, logical errors, rounding asymmetries, state machine errors, unexpected counter overflows, and I/O errors. A logic analyzer was used for immediate debugging and also to store data to a file for processing.
