NASA/TM-2008-215525
NESC-RP-06-61/05-036-E

Failure Analysis Study and Long-Term Reliability of Optical Assemblies with End-Face Damage

**Failure Analysis Study and Long-Term Reliability of Optical
Assemblies with End-Face Damage
Technical Assessment Report**

*Phase I: International Space Station (ISS) Termini Root Cause
Analysis Report*

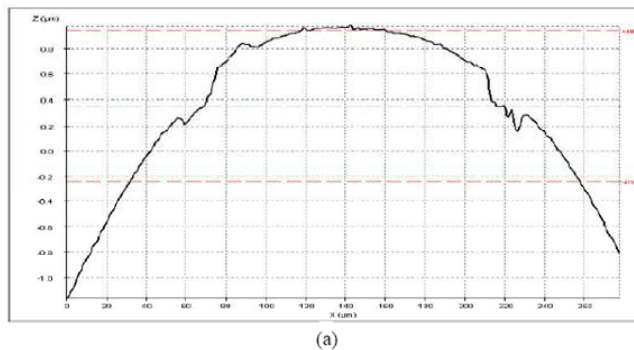
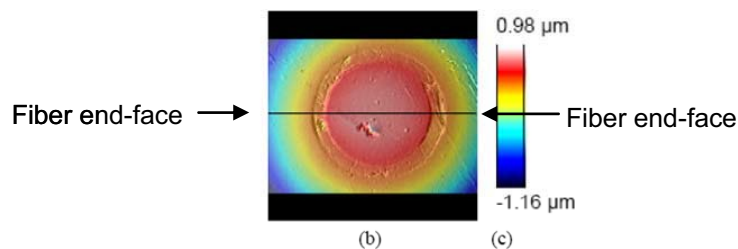
Figure 4.0-2. Confocal Profile

In many applications, a physical contact connection is implemented to mate fiber optic connectors such that the insertion losses are reduced. In the case of this connector, the high vibration levels originally used to “qualify” the connectors for military standard applications showed data indicating that the terminus/connector system should not be of a physical contact type. Therefore, the same processes were specified in this application. For a “concave” polish, it is imperative that the glass end-faces do not come in contact with one another in order to comply with the military standard method and reasoning for non-contact. As stated in OHB’s “Fibre Optic Manufacturing Procedure” Section 4.6: “Inspect the profile of the terminus end-face under 40X magnification. The surface should be slightly concave with the face of the ceramic tip.” This is not an effective method for determining the fiber’s profile. Figure 4.0-1 shows what the profile looks like at 40X magnification. The end-face appears to be flat, and not protruding. This method is non-conclusive for true determination of the end-face profilometry. The profile should be determined using an interferometer or confocal microscopy as illustrated in Figure 4.0-2. The confocal data clearly shows the end-face of the fiber to be convex, which should have failed inspection.

The horizontal line appearing in the top chart of Figure 4.0-2 corresponds to the profile plot shown in the colored image figure below the chart.

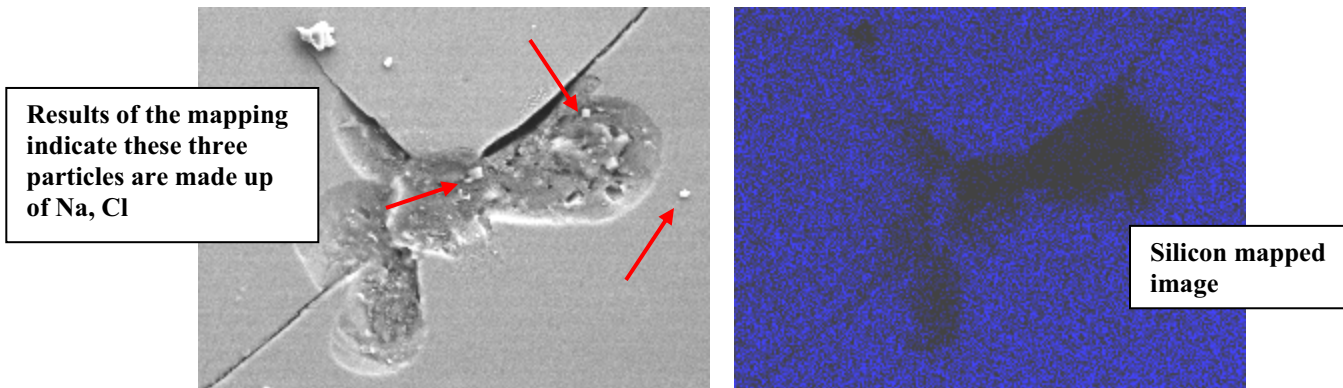
Figure 7.1-6. Elemental Mapping of Si, Na and Cl

The discovery of salt crystals in the glass was puzzling. To identify where the salt crystals are located on the end-face, elemental mapping was performed. Elemental mapping was not effective at 500X magnification to locate small traces of certain elements, so to locate Na and Cl, a higher magnification was used. Figure 7.1-6 shows the results when this sample was mapped for Si, Na, and Cl.

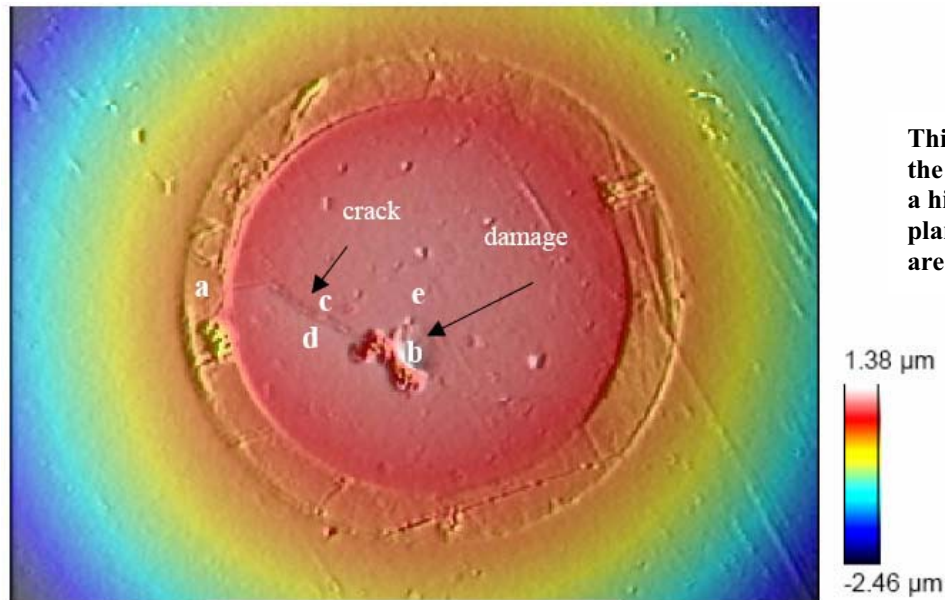
Figure 7.1-7. Confocal Topographical Image

Optical microscopy and SEM do not have the ability to generate a profile of the end-face so confocal microscopy is performed. Confocal microscopy (Figure 7.1-7 and Table 7.1-1) will generate a topographical map and a profile in the X-Y axis. It was discovered that the fiber has a convex end-face rather than concave.

These termini are supposed to be manufactured with a slight concave end-face as observed in Figure 7.3-5. This is per the manufacturing procedure [ref. 4]. Since this particular sample has a convex end-face, the fiber more than likely contacted what it was mated to and was damaged.

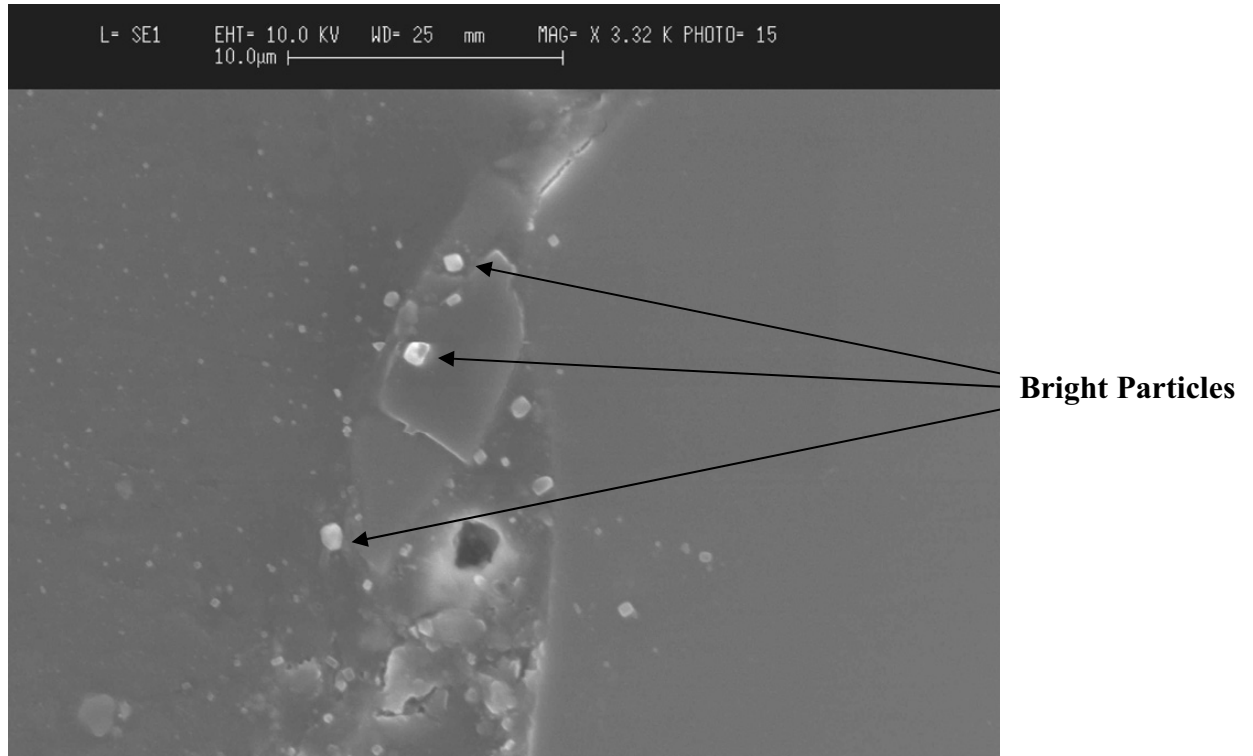
Figure 7.2-5. Magnification of 3,320X SEM Image

An EDS data analysis was performed on one of the “bright” particles and traces of oxygen, Na, magnesium, aluminum, Si, Cl, potassium, and calcium were found.

Elemental mapping of the debris on this sample was performed very similar to the previous sample. At higher magnifications, traces of Na and Cl can clearly be identified. The bright areas of the images in Figure 7.2-5 are the elements that have been mapped. Refer to Figure 7.2-7.

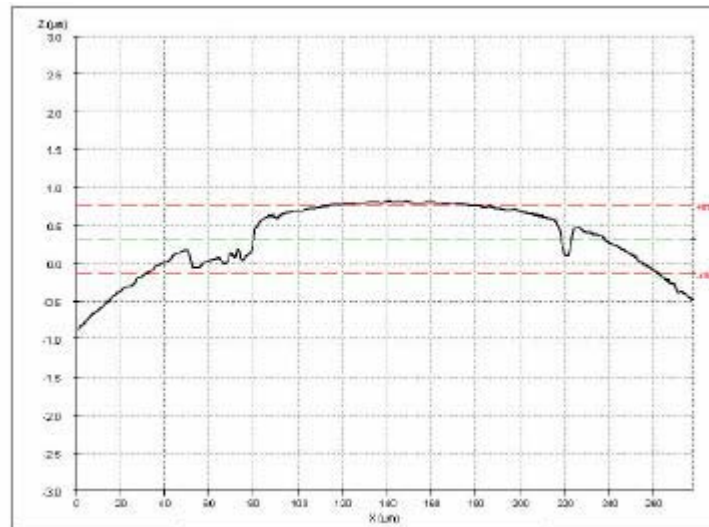
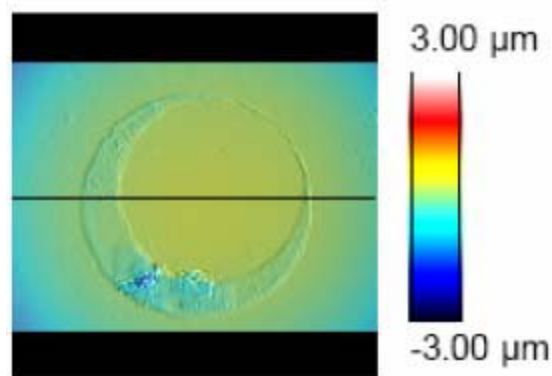
Figure 7.2-8. Confocal Data

The horizontal line appearing in the top chart of Figure 7.2-8 corresponds to the profile plot shown in colored image figure below the chart.

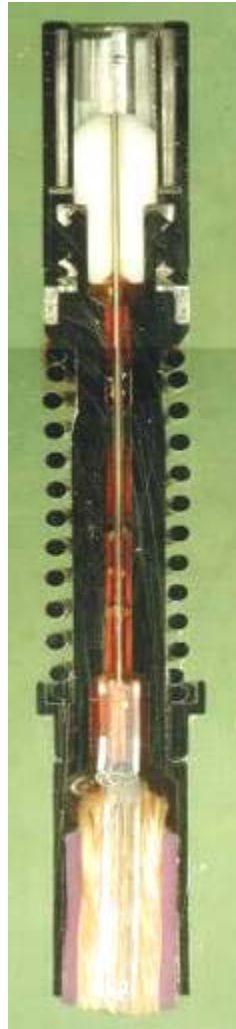
Figure 7.3-2. Cross-Section View of the Optical Fiber Termini

This sample was cross-sectioned to get a profile view of the fiber end, and identify features that have not yet been observed in other termini. There was some large metallic debris observed in Figure 7.3-2 that may have initiated the flaw.

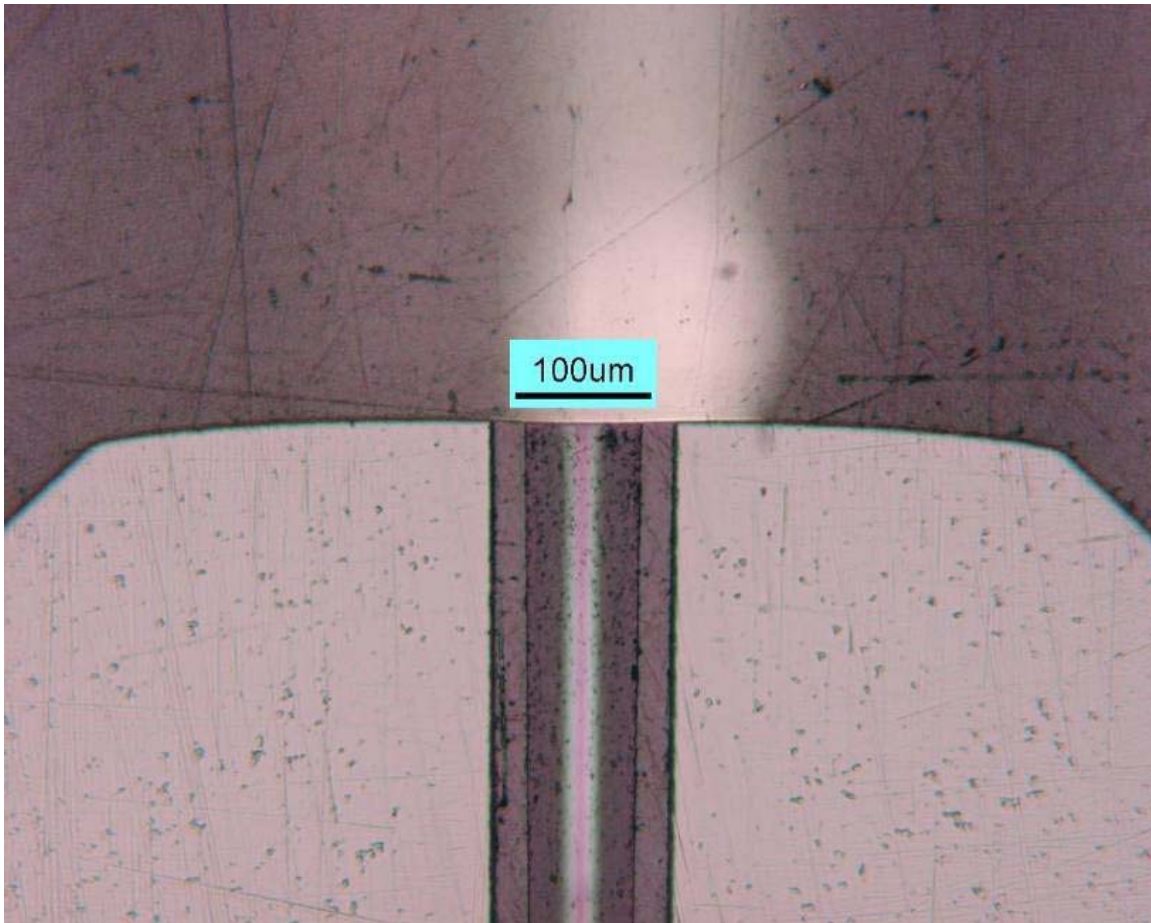
Figure 7.3-4. Magnification of Cross-Section @ 100X

The magnified images in Figures 7.3-4 and 7.3-5 indicate (without a doubt) that the end-face is concave. This is by design so the glass does not make physical contact to another terminus end-face when mated into the connector. Note that the crack has not propagated all the way to the edge of the fiber, leaving the fiber intact.

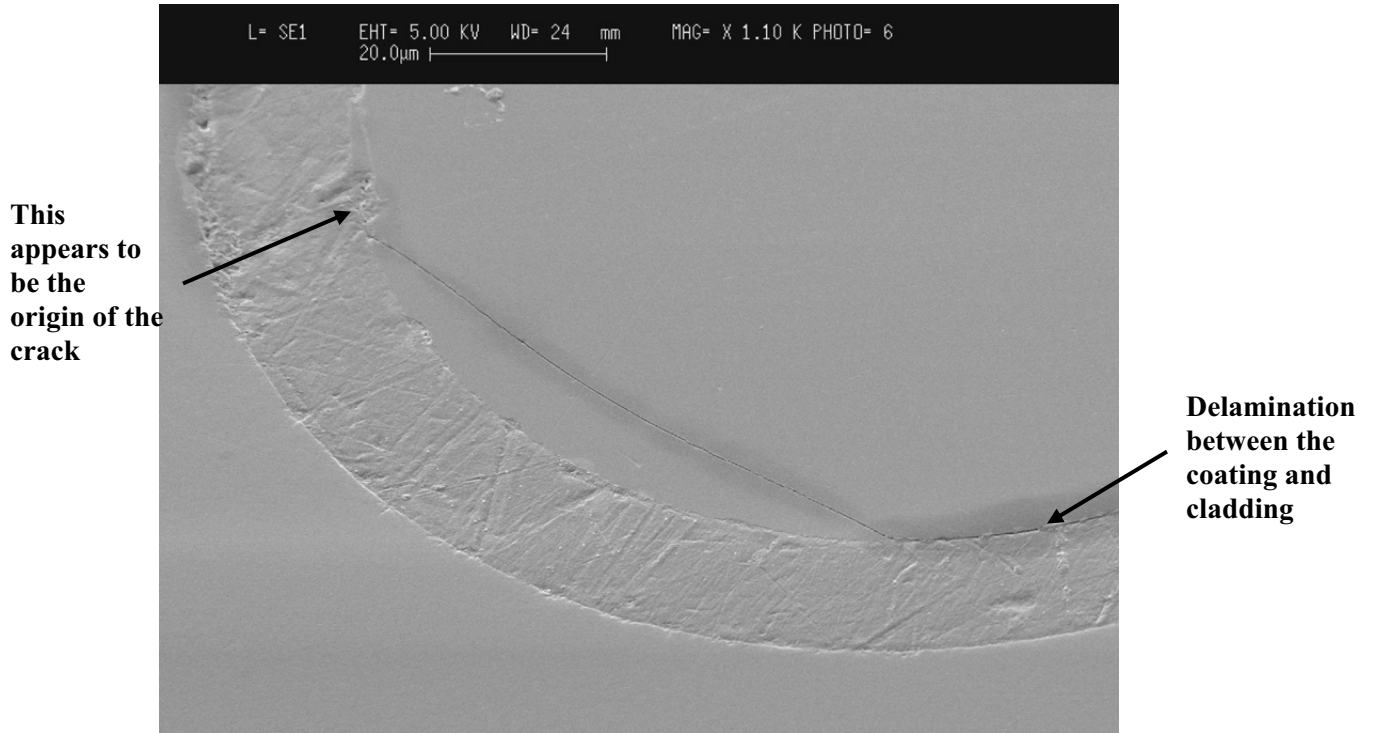
Figure 7.4-3. Magnification of 1,100X SEM Image

The SEM image taken at 1.1×10^3 magnification (Figure 7.4-3) shows an area suspected of being the break origin, a crack propagating through the cladding, and delamination between the coating and glass where the crack ends. If this is in fact the origin, the crack could have propagated with the help of shrinkage of the epoxy.

1. The location of the suspected origin suggests the flaw started from the edge of the fiber. This likely was caused by an abrasive particle used to wipe the fiber.
2. The scratches observed in Figure 7.4-1 are fairly deep, and this terminus should have been polished with a finer grit lapping film to remove them.
3. Debris on the end-face suggests the cleanliness was not maintained.

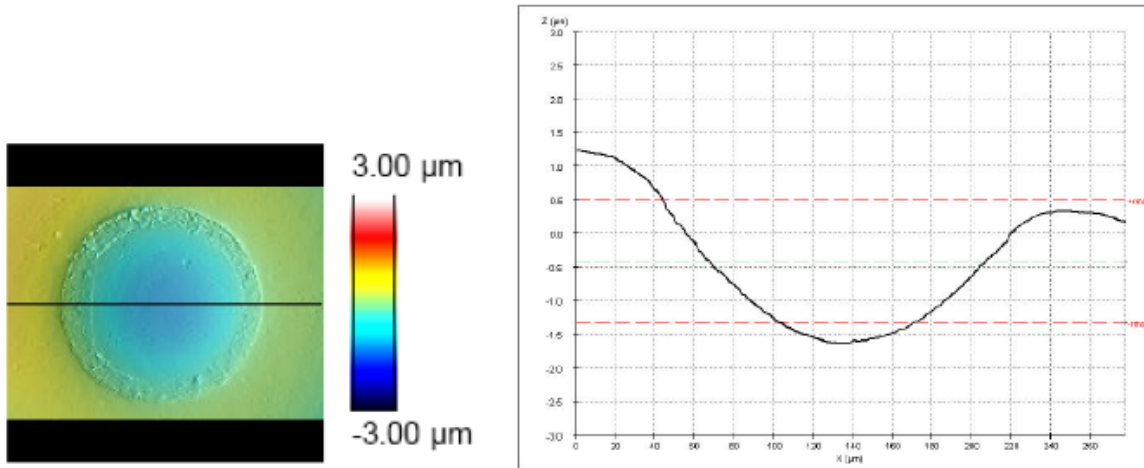
Figure 7.4-6. Confocal Data

The confocal microscopy data (Figure 7.4-6) indicates the end-face has a concave profile. This conforms to the manufacturing procedure [ref. 3]. The radius of curvature measures 2.0 mm.

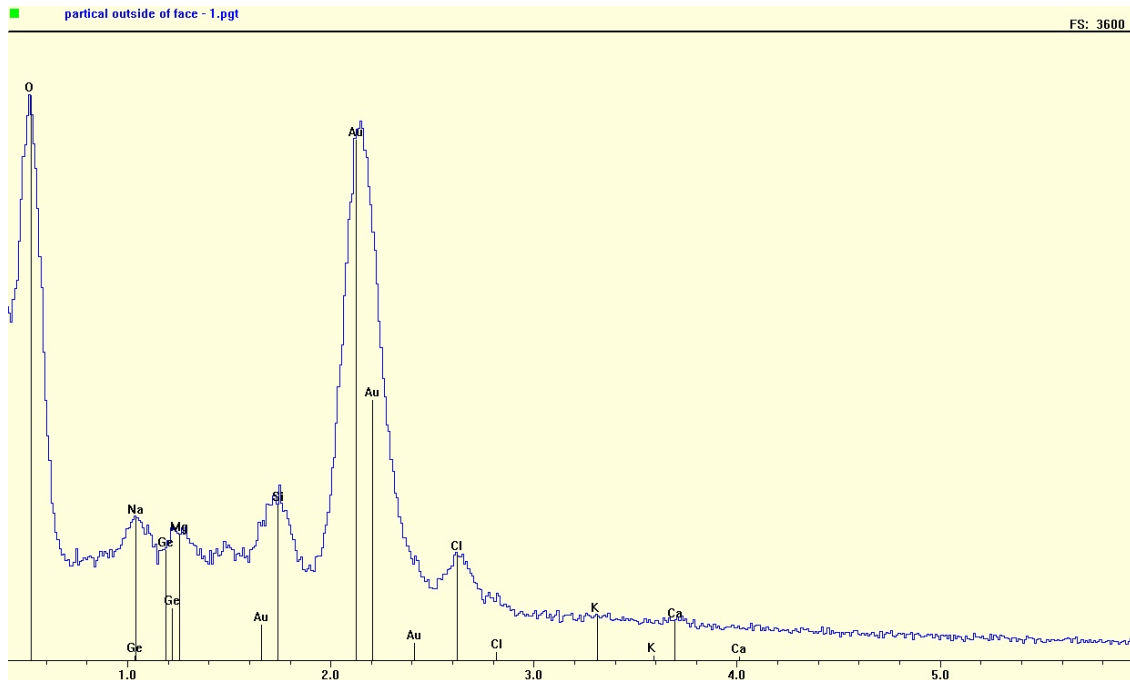
Figure 7.6-5. EDS Data of Particle on Ferrule - 1

An EDS data analysis (Figure 7.6-5 and Figure 7.6-6) was performed on some debris on the ferrule end-face.

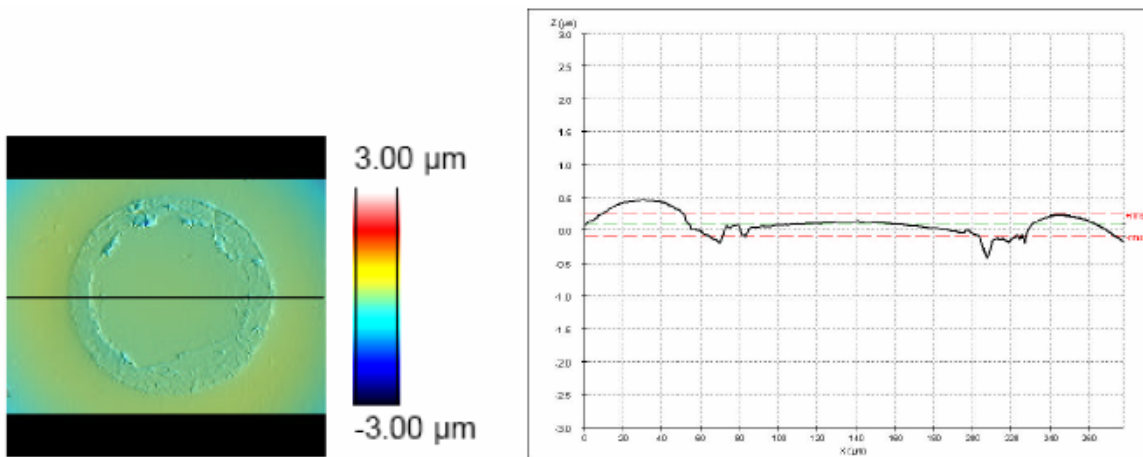
Figure 7.6-7. Confocal Data

Confocal microscopy was performed and indicated the fiber end-face is convex (Figure 7.6-7). The radius of curvature is 13.5 mm.

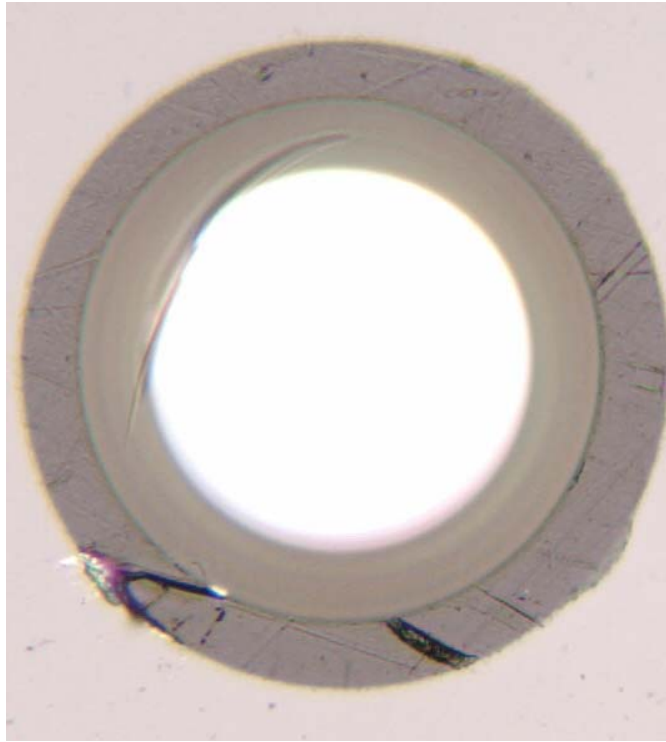
Figure 7.7-2. Bright Field Image @ Magnification of 200X

These termini are inserted into a sleeve when mated. The signature of the scratch might indicate the end-face was not clean when the connection was made.

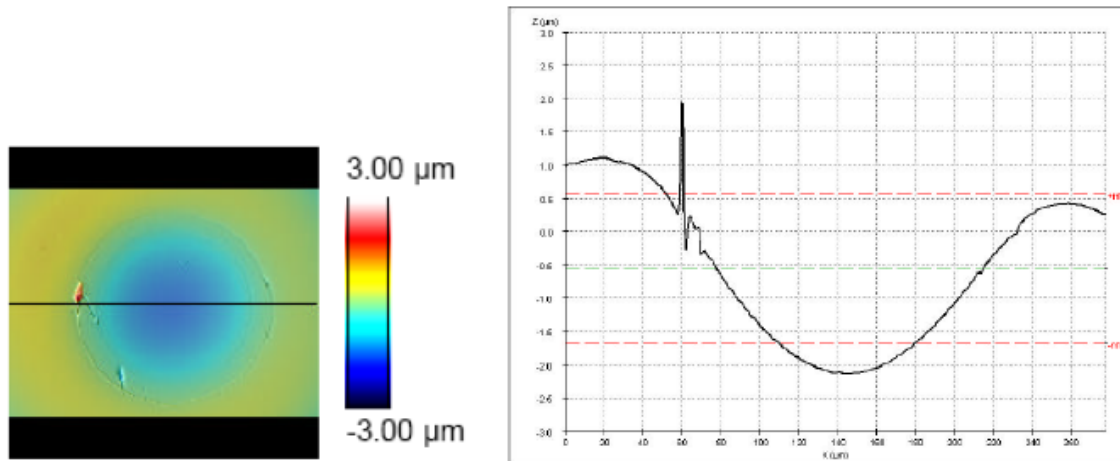
Figure 7.7-6. Confocal Data

Confocal microscopy (Figure 7.7-6) indicates the end-face is concave per requirements of the manufacturing procedure [ref. 3]. The radius of curvature is 1.4 mm.

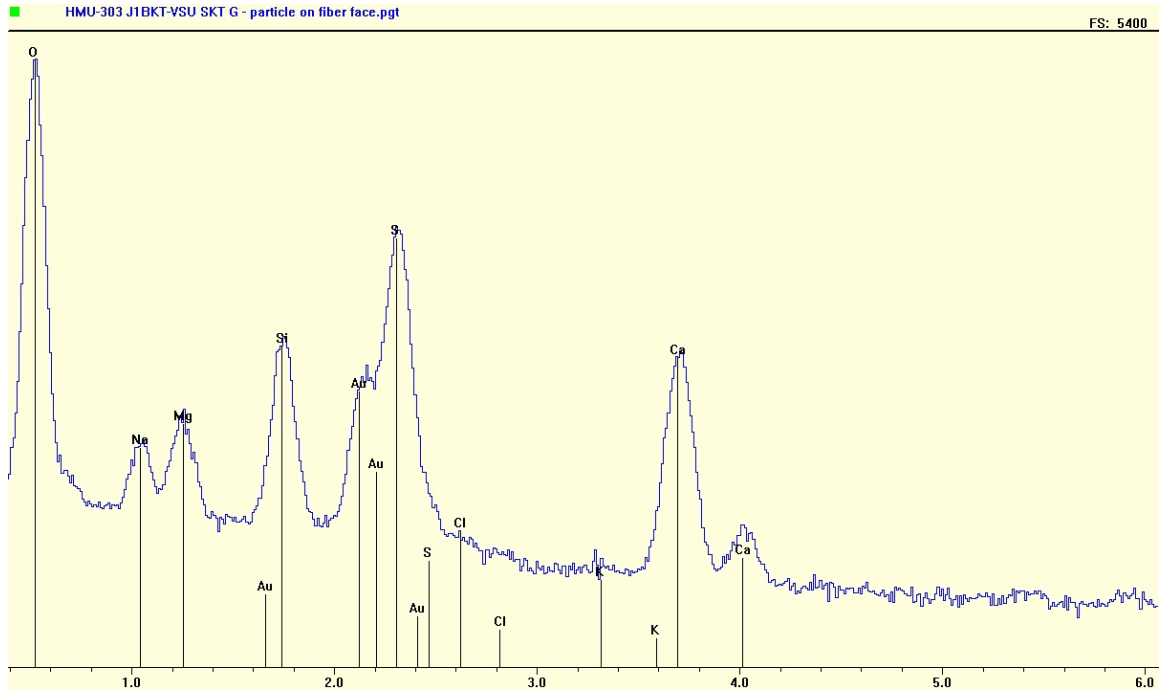
Figure 7.9-5. EDS Data of End-Face

No areas of visible corrosion were discovered, but EDS does indicate the presence of Na and Cl (Figure 7.9-5). Figure 7.9-6 shows a comparison of this EDS data to an area free of debris.

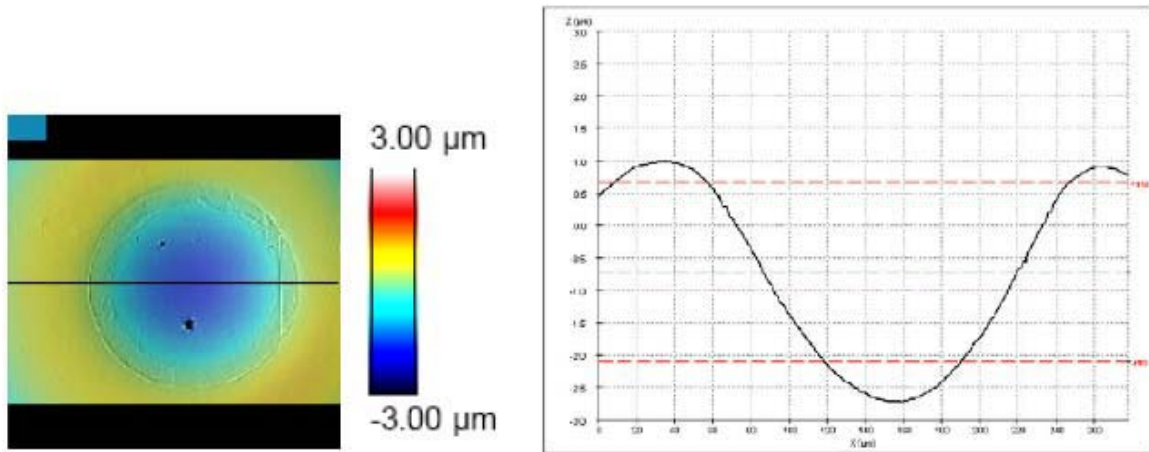
Figure 7.9-7. Confocal Data

Confocal data (Figure 7.9-7) indicates the end-face has a concave profile, with a radius of 1.1 mm.

1. The origin of the crack does not appear to be on either end, so it may have originated in the middle.
2. The formation of the scratches in the glass and coating may suggest it was mated with debris present.
3. The cleanliness of the termination was not maintained.

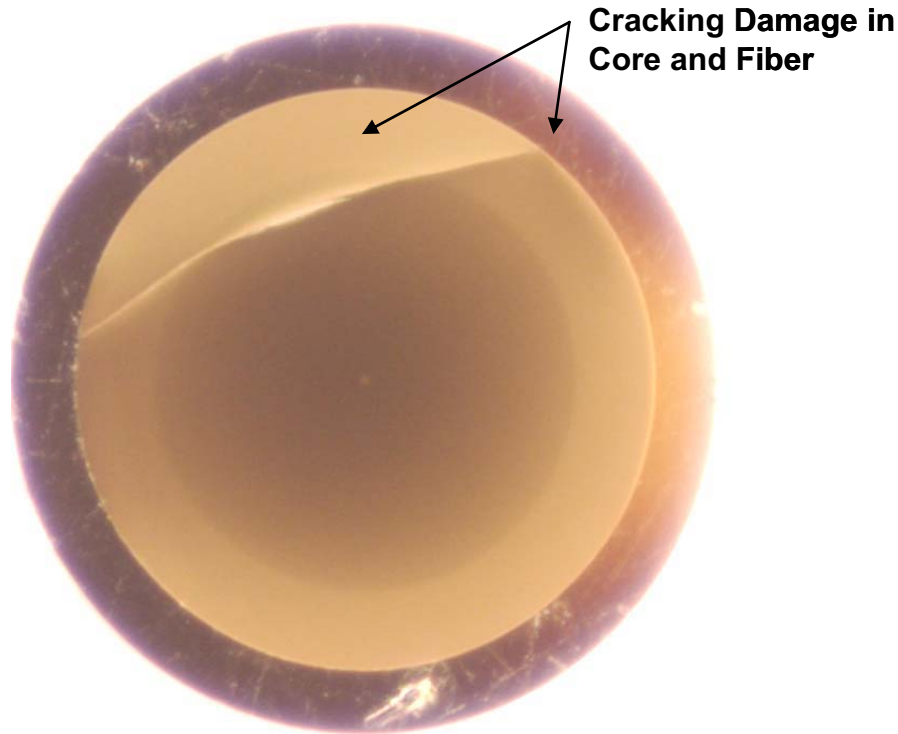
Figure 7.10-2. Dark Field Image

This termination is cracked partially through the core and deep into the fiber (Figure 7.10-1). There is some debris present on the ferrule end, and some damage/debris on the bottom of the coating.

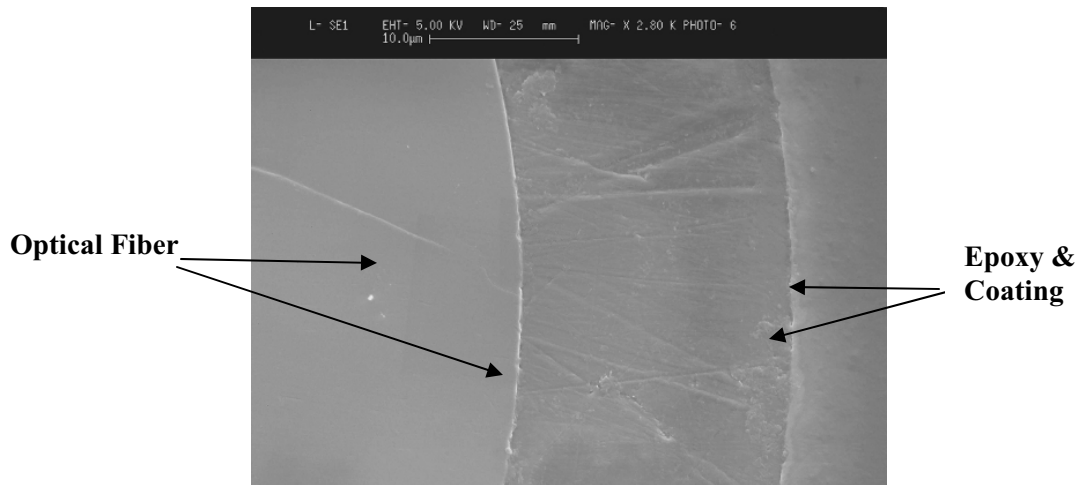
Figure 7.11-4. Magnification of 2.8 KX

The ends of the crack can be clearly analyzed under 3.2×10^3 and 2.8×10^3 X magnifications (Figure 7.11-3), but no definitive origin was identified.

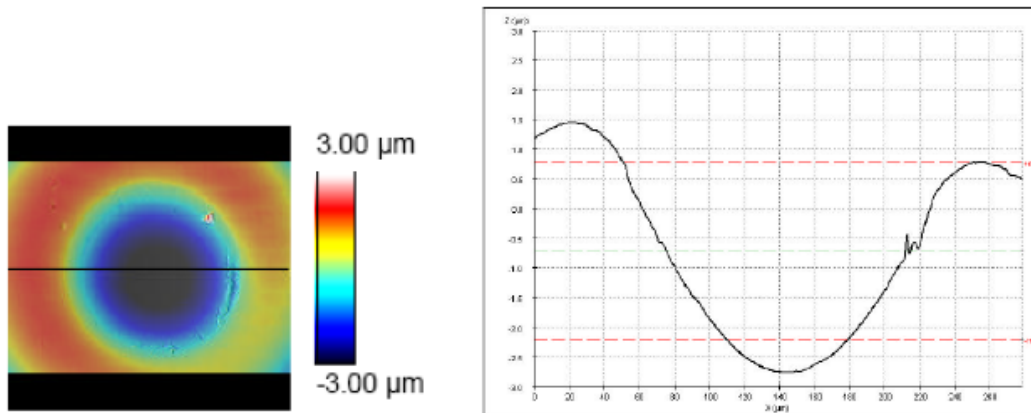
Figure 7.11-5. Profile of End-Face

Confocal data (Figure 7.11-5) indicates the end-face has a concave profile, with a radius of 1.2 mm.

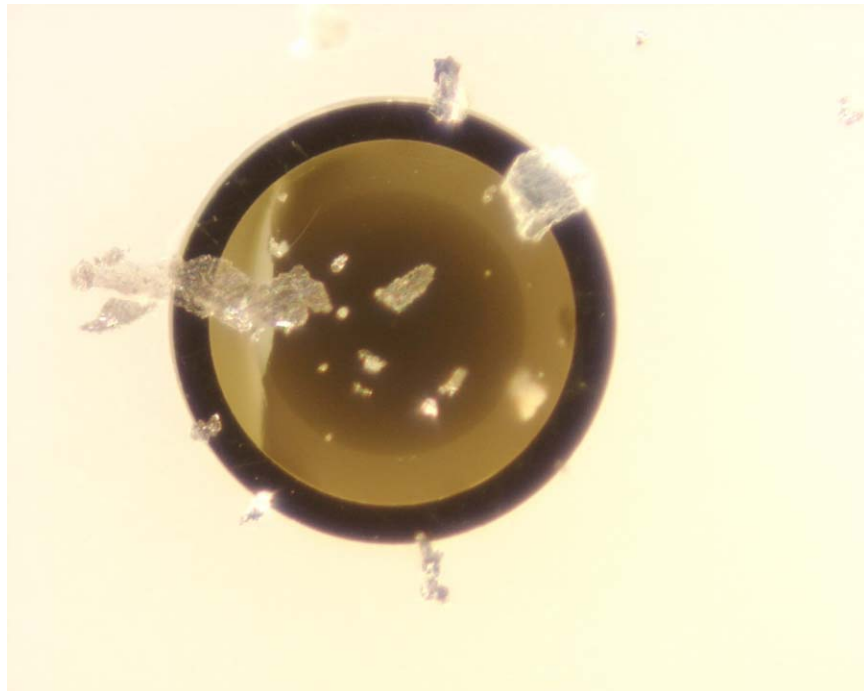
Figure 7.12-2. Magnification of 200X Bright Field Illumination

The crack can easily be observed at a 200X magnification (Figure 7.12-2) and with dark field illumination.

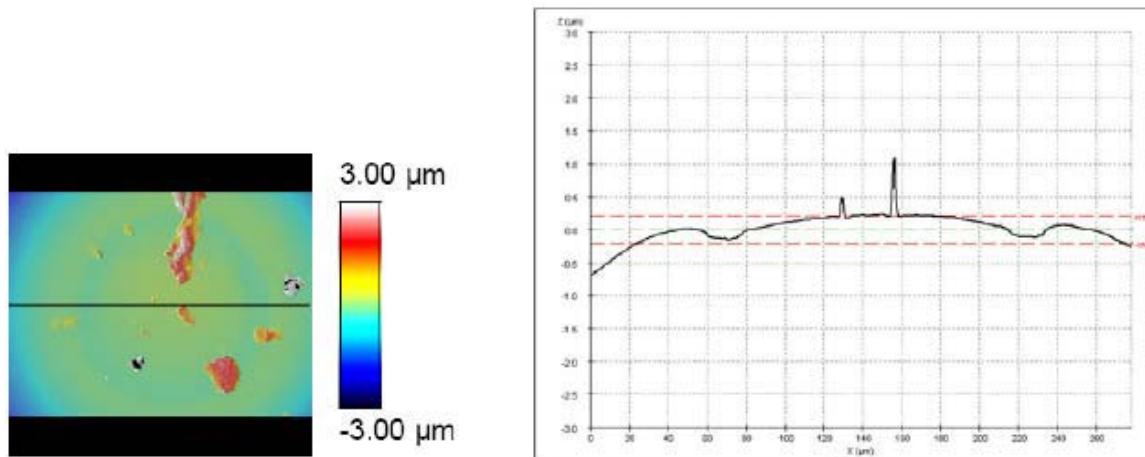
Figure 7.12-4. End-Face Profile

Confocal data (Figure 7.12-4) suggests the end-face has a slight convex profile. However slight it may be, the fiber still extends beyond the ferrule. The radius of curvature measured 8.7 mm. It is important to note the height of the contamination showed in Figure 7.12-4. The large spike in the center of the graph shows the particles height at that location as being well above the surface of the optical fiber terminus. When this terminus is mated to another terminus in close proximity that particle will undoubtedly make contact with both surfaces as it is compressed between the two interfaces. This impact can cause damage to both optical fibers being mated together.

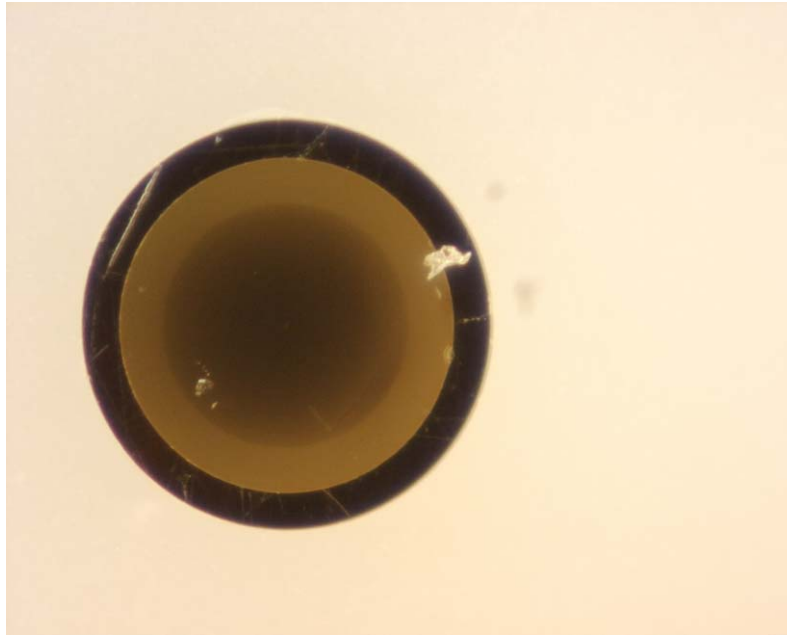
Figure 7.13-2. No Visible Cracks
