NASA/TM-2009-215575

Terahertz NDE of Stressed Composite Overwrapped Pressure Vessels – Initial Testing

February 2009

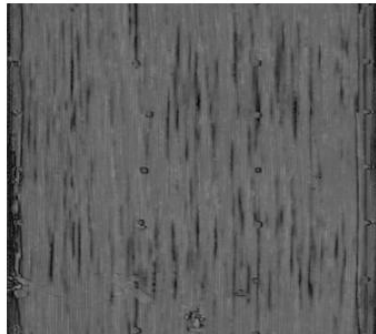
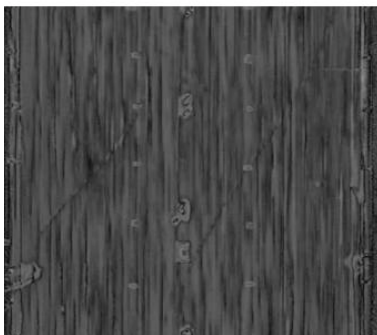
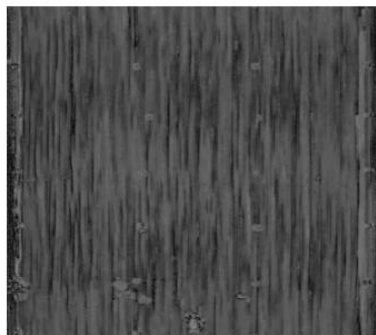
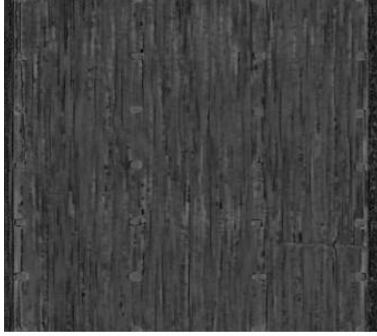
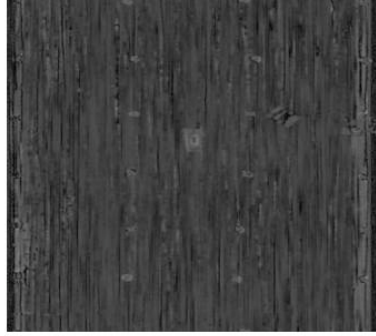
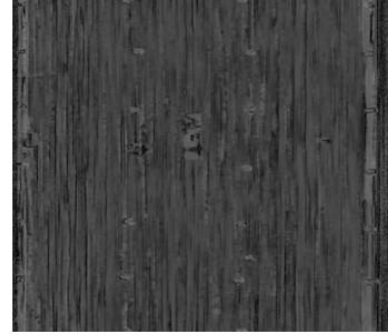
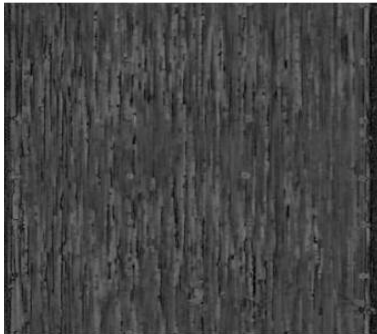
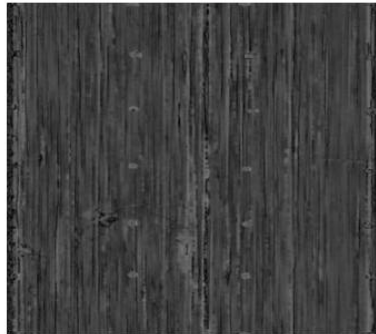
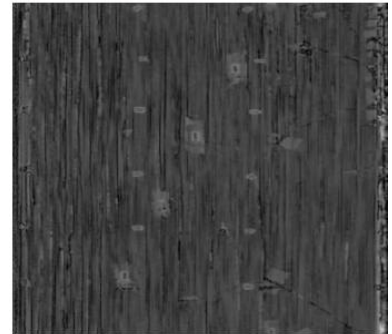
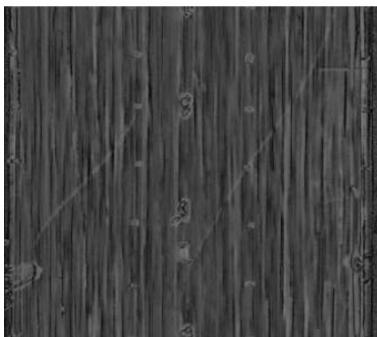
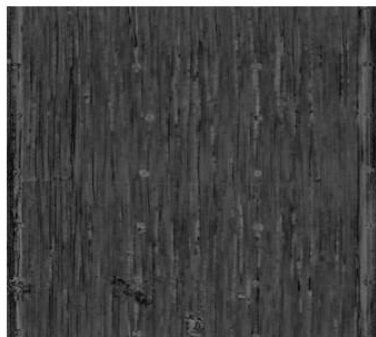
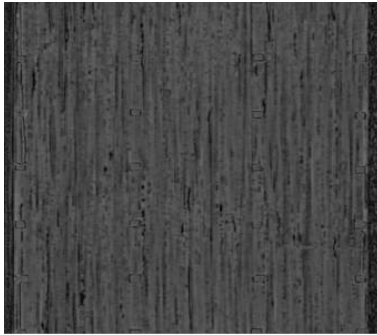
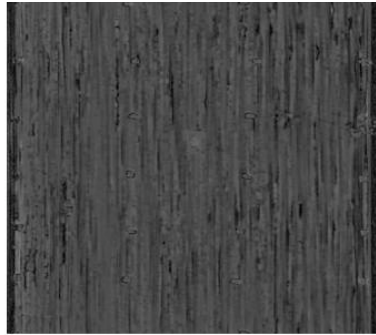
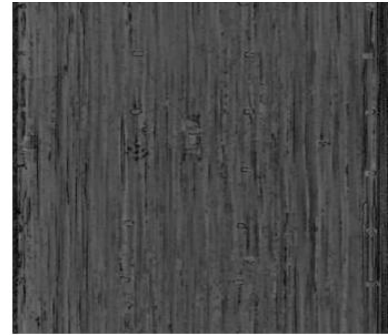
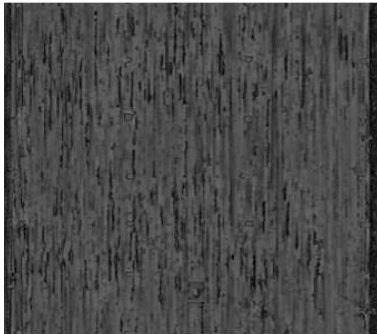
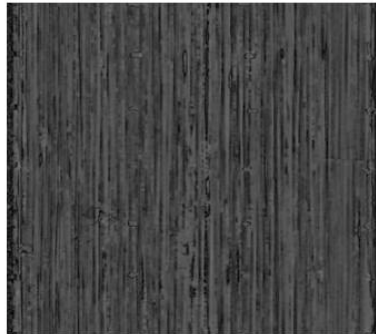
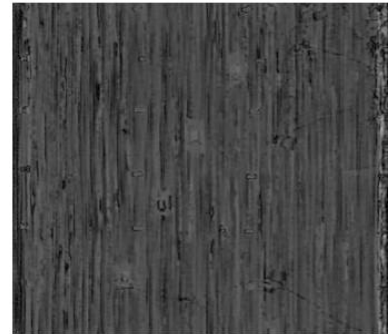
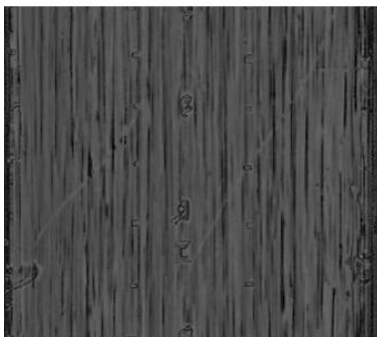
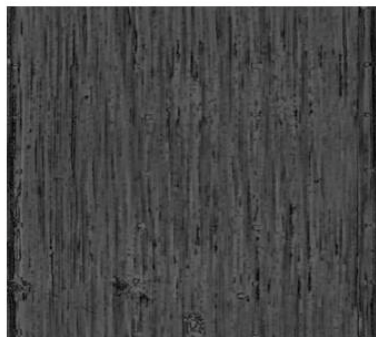
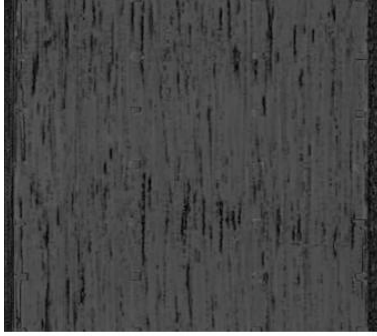
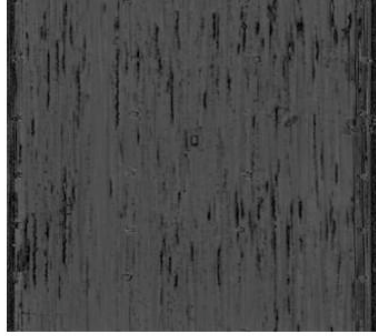
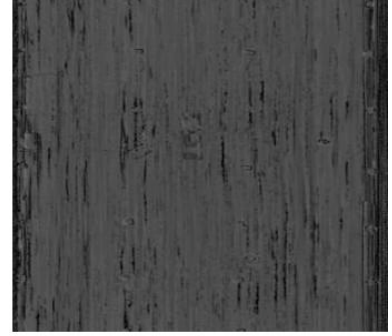
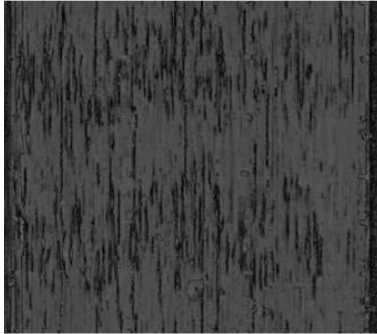
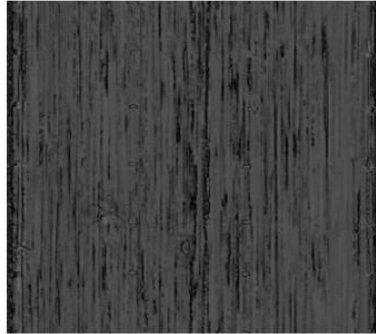
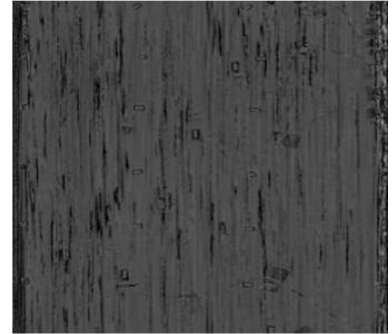
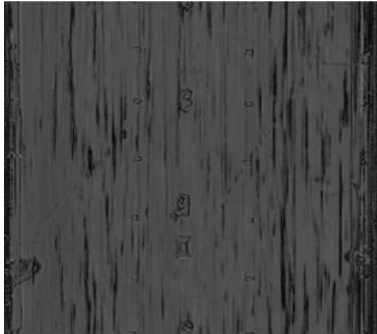
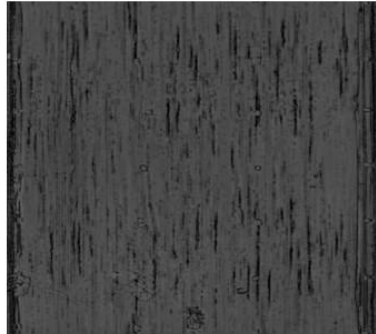
Frequency domain spectral ratio images were generated from the high temperature and high stress data. It was postulated that a shift in the spectral minima observed for Kevlar and epoxy would highlight aging dependencies. Selected spectral ratio images are shown for the high temperature data in Figure 4 through 14 and for the high stress data in Figure 15 through 25. The images in each figure are on the same scale for comparison. The metallic markers on the Kevlar surface show up as dots in a regular grid pattern. In some cases strain gauges, strain gauge wire, and thermocouples can be seen. Overall, a striated pattern corresponds with the Kevlar windings; however, there is no visually apparent demarcation in these images to suggest aging.

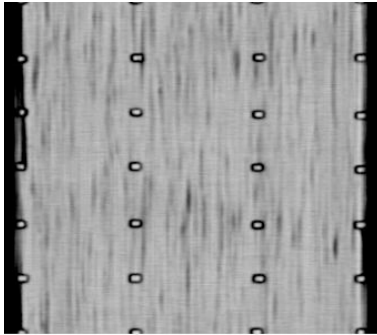
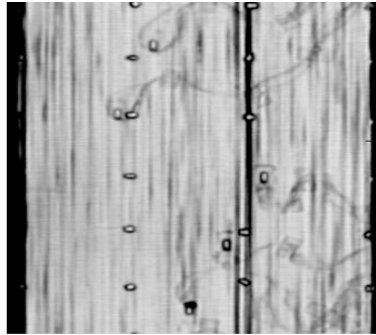
Figure 37: Peak-to-peak images of high temperature aged bottles at 150GHz.

Narrow band frequency amplitude images from the high temperature and high stress data are shown in Figure 37 and Figure 38. Frequency amplitude images were generated from the time domain terahertz data after applying a 150GHz narrow band filter to mimic MSFC's Millimeter Wave (microwave) inspection results. This was done to investigate the origins of the anomalous short dark streaks in their images. Microscopic inspection of the bottles after identifying this anomaly indicated surface variations corresponding to the dark streaks. In particular, periodic thickness variations and small bumps resulting from manufacturing processes were observed. At 150GHz, the front to back wall phase front interference is maximized as the over wrap thickness approaches 1mm. Further examination of this anomaly is required to determine any contribution to bottle failure.
