Solar Alpha Rotary Joint Anomaly: The Materials & Processes Perspective

Aging Aircraft 2009

May 5th, 2009

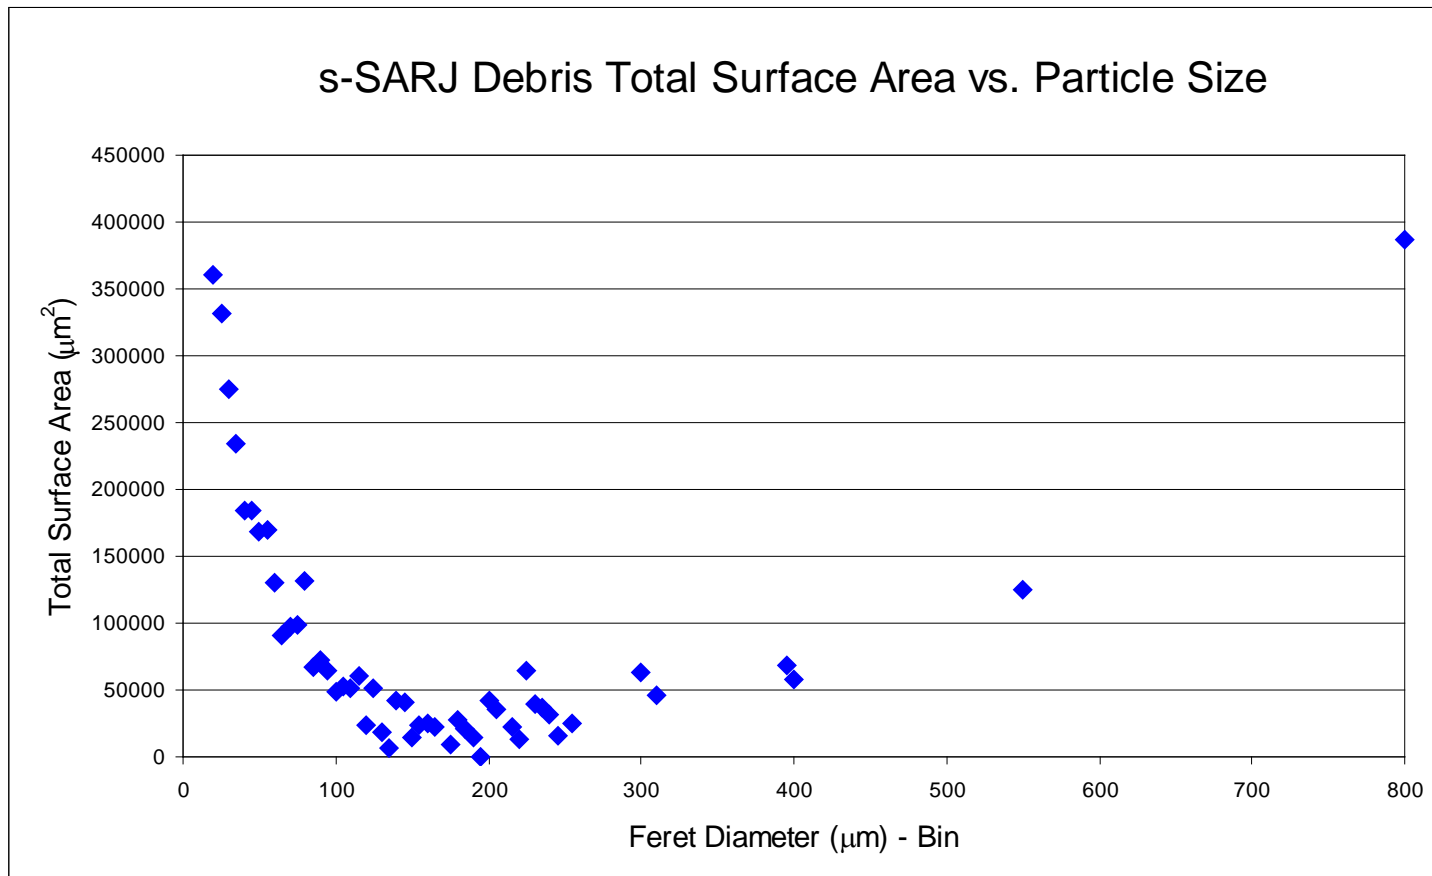
Two Types of Larger Particles Observed

- **Larger particles, though few in number, contribute significantly to the total area of particles collected during sampling**
 - **Suggests that much of the surface damage occurred as these large particles**

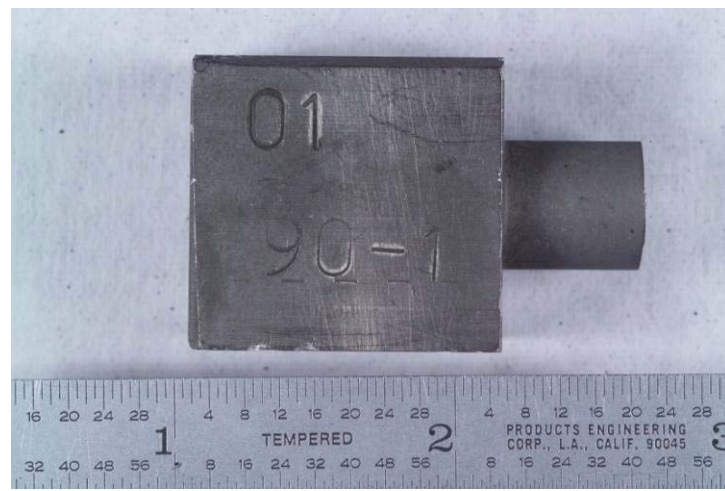
- **Metallographic examination determined white structure in excess of engineering requirements (0.0003in) is still present on the nitride control coupons (NCCs), maskant interface coupons (MICs), and on chip-type particles from the s-SARJ.**
- **While original certifications indicated that the white layer requirement was met, it appears that the specimen preparation technique was not sufficient to observe the true depth of inter-granular networking**
- **The inter-granular network (0.001 to 0.002in observed) appears as a higher concentration of iron and chromium nitrides along the grain boundaries**
- **Inter-granular separations or voids were also noted along some grain boundaries.**

Nitride Control Coupon (NCC) – Nitrided in same furnace at fixed locations as the flight SARJ race ring.
