NASA/TP-2009-214769

A Summary of NASA and USAF Hypergolic Propellant Related Spills and Fires

B. M. Nufer
Kennedy Space Center, Florida

June 2009

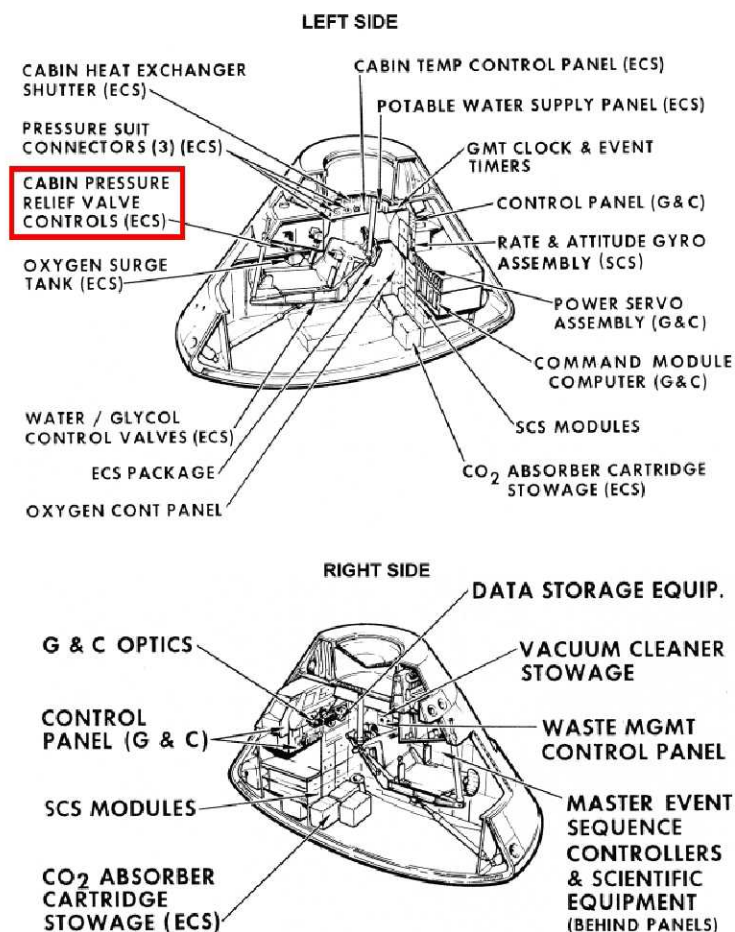
Figure 3-2: Apollo Command Module Interior Cutaway

The exposure greatly altered the astronauts’ abilities to complete assigned tasks in a timely manner; therefore, they experienced a very rough landing along with the poor luck of having the capsule splash-down in the “Stable 2” configuration, which meant it was inverted in the water. Following splash-down, the crew was forced to don their oxygen masks, but in the interim before Stafford could retrieve and distribute the masks, Brand (who was sitting closest to the relief valve, see Figure 3-2) lost consciousness.

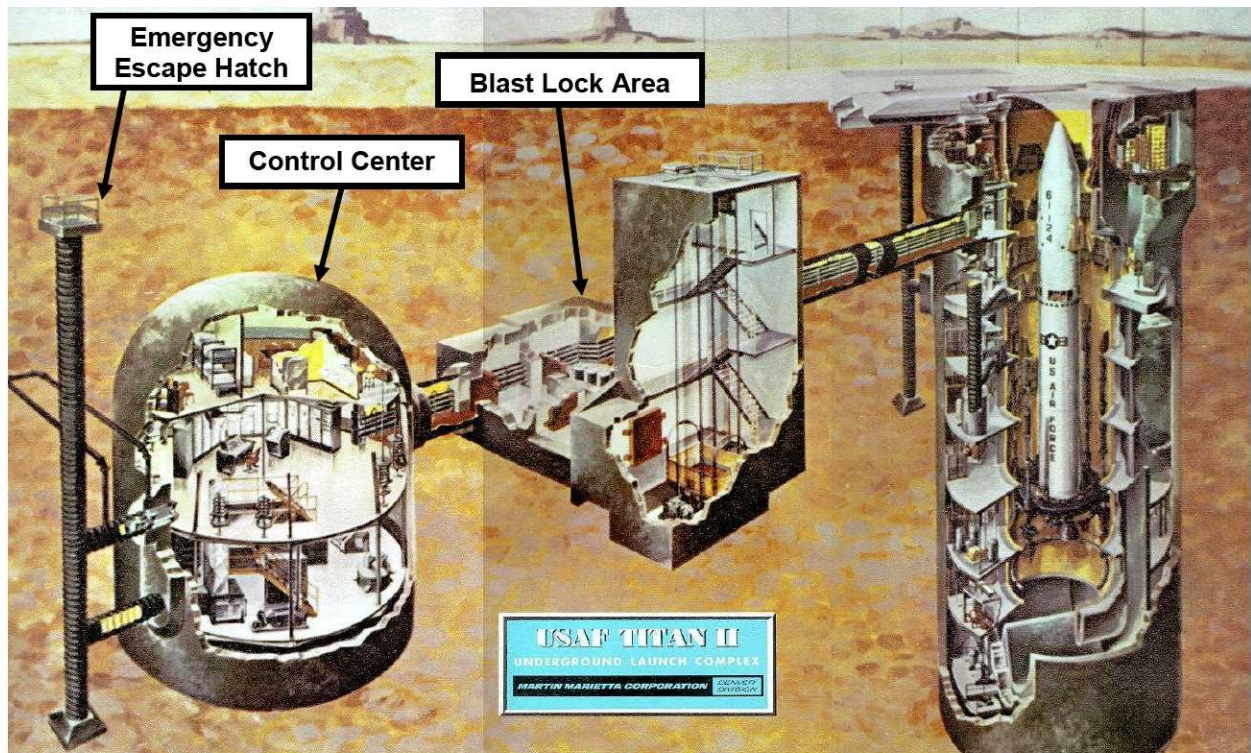
Figure 5-1: Underground Titan II Missile Complex

Very high concentrations of NO₂ vapors traveled from the silo into the connecting cableway to the blast lock area, which was located just outside of the control center where several personnel were located (see Figure 5-1). All the personnel located in the blast lock area managed to escape the vapors by exiting through the access portal at ground level. The personnel in the control center would normally be isolated from the silo; however, two technicians involved in the spill opened the airlock door to try and obtain assistance for their supervisor who was in need of immediate medical attention. The two technicians and four other control center personnel then evacuated through the emergency escape hatch, once they realized the immediate danger of the situation. The nearby town of Rock, Kansas had to evacuate about 100 people as a result of the vapors that were escaping from the silo (see Figure 5-2).

It was later discovered that the suit of the supervisor had failed, introducing him to dangerous levels of N₂O₄ (NO₂) vapors, which was ultimately fatal to him within minutes of being exposed (see section 1.1 "Properties of Nitrogen Tetroxide (N₂O₄)" for a description of what N₂O₄ and NO₂ does to the body). Two other technicians had removed their suit hoods while in the vapor cloud. One died nine days later. The extent of the injuries of the other technician is uncertain; however, he did survive. Repairs to the damaged 533-7 silo were attempted, but later discontinued for budgetary reasons. The silo was never returned to alert status.

- Proper configuration control of GSE components, in this case the filter, is highly important in the handling of toxic chemicals, especially hypergols (root cause of the incident)
- Emergency procedures and safing must always be reviewed, practiced, and ingrained in the minds of personnel working with toxic chemicals
- Procedural oversight may have been beneficial
- Proper isolation of bulk propellant should be inherently designed into any rocket propulsion system and used accordingly during loading operations
- Personal protective equipment (PPE) should be inspected prior to every use

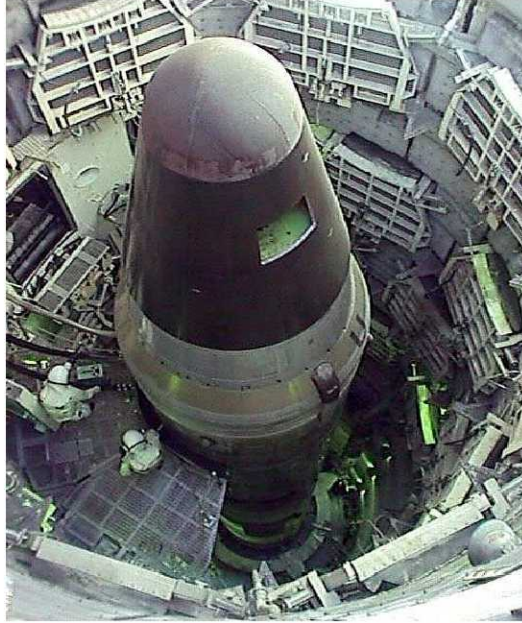
Figure 7-1: Technicians Working on Fold-Down Platform in Titan Silo Level 2

At about 6:30 PM on September 18, 1980, an airman was conducting a maintenance operation on level two (see Figure 7-1) of the underground silo when he accidentally dropped a large wrench socket. The standing platforms were hydraulically-controlled, flip-down structures with a rubber boot mounted between the platform and the rocket. The socket fell hitting the standing level two platform and bounced in the direction of the rocket where it slipped through the small gap between the rubber boot (which had become pliable over the years) and the Titan II rocket. It fell about 70 feet before hitting the thrust mount near the base of the rocket. The socket then bounced into and ruptured the stage one fuel tank (proximate cause). Approximately 11,140 gallons of A-50 drained into the bottom of the silo. Fuel vapors heated up the silo and caused the pressures in the non-ruptured propellant tanks to rise substantially.

- All workers should wear a belt with lanyards to attach tools
 - Operational human error is, therefore, the root cause
- Cloths should be placed on the platforms to prevent tools from bouncing off the metal

- The Titan II missile silo platforms should be renovated to increase safety
- The training and qualification program was insufficient prior to the incident (a root cause)

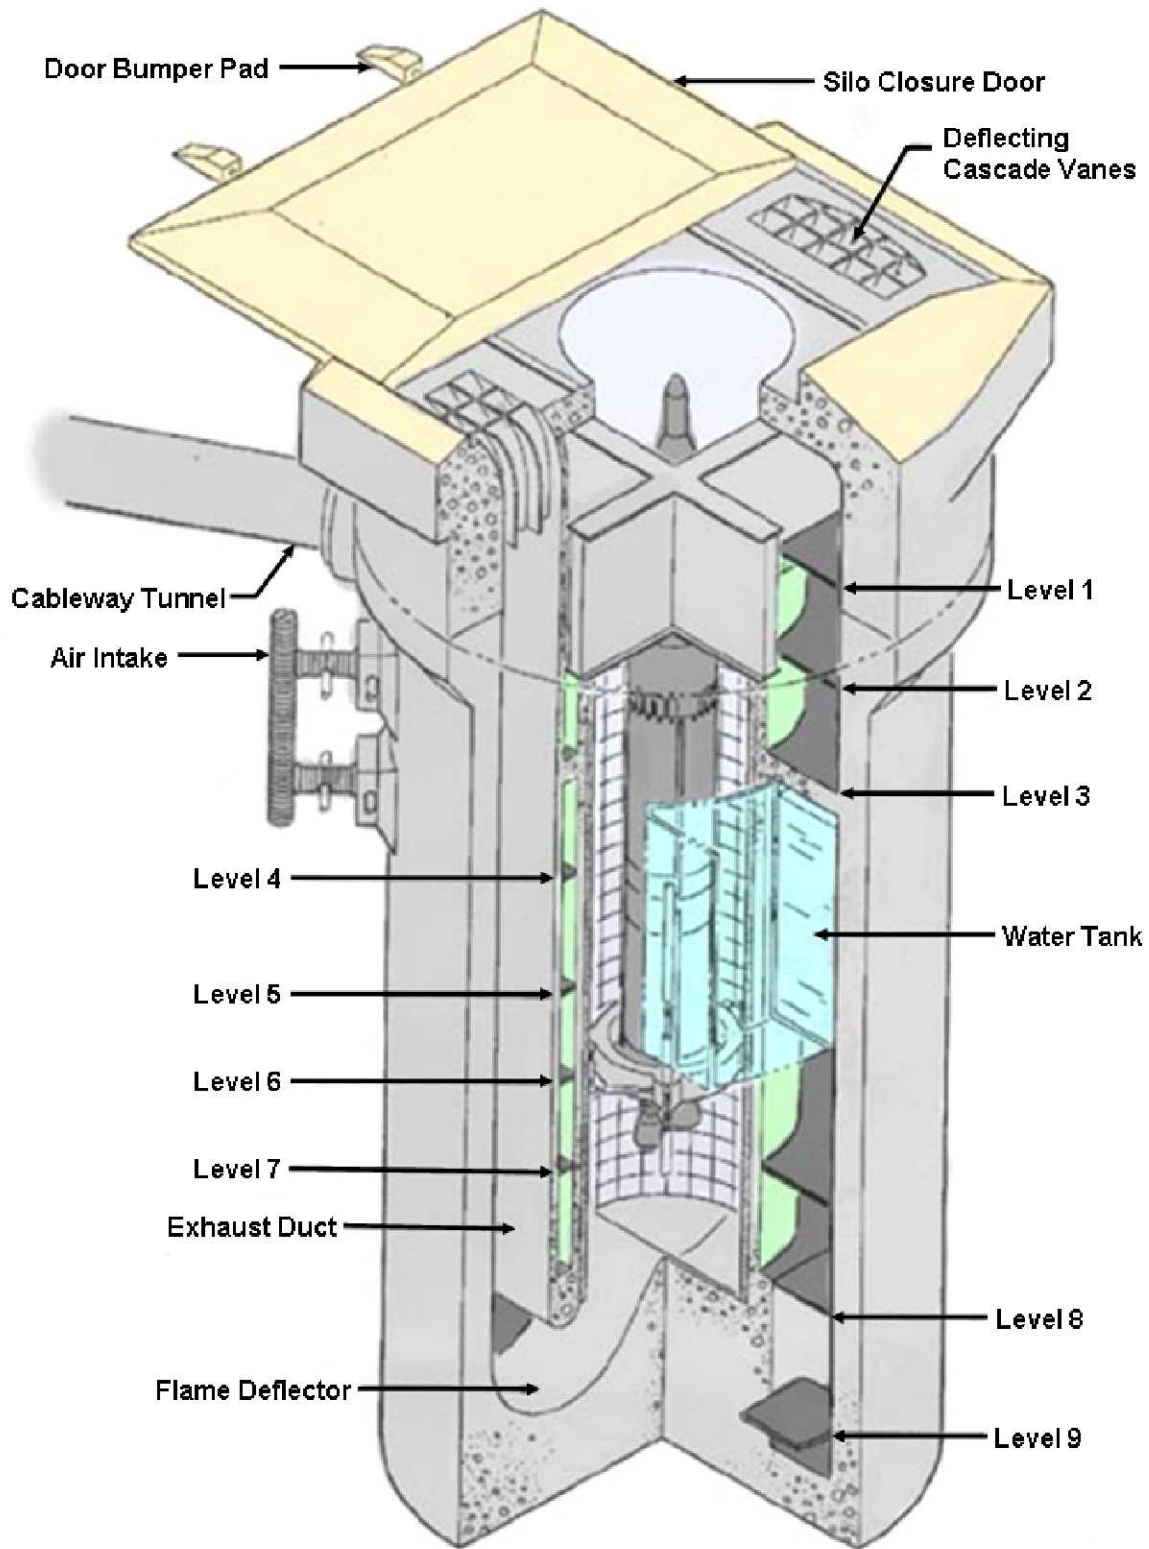
Figure 7-2: Titan II Missile Silo

It was reported that the explosion blew the 740-ton reinforced concrete and steel silo door (see Figure 7-2 for a depiction of the Titan II missile silo) 200 feet into the air and 600 feet from the silo. The rocket's second stage, with the W53 thermonuclear warhead attached, was launched out of the silo following the explosion of the first stage. The second stage then supposedly blew up in midair, (it contained about 1,730 gallons of A-50 and 3,120 gallons of N_2O_4) sending the undetonated warhead several hundred feet from the silo. The W53 warhead had a mass of 8,136 lb and a yield of 9,000 kilotons (the Hiroshima bomb "Little Boy" was estimated at about 15 kilotons). Luckily the warhead's safety features operated as they were designed. There was no reported loss of radioactive material.

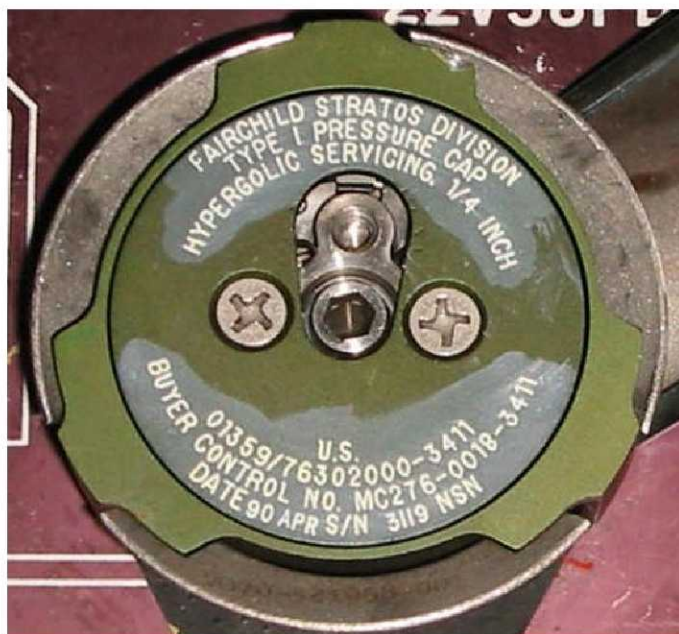
Figure 8-2: Fairchild ½-inch Flight Cap

During the MD338 flight cap installation procedure, on roughly July 14, 1981, the work step correctly called for the installation of a ½-inch cap (part number MC276-0018-2811) onto the AHC. The cap that was staged for installation was the misidentified ¼-inch cap. When a ¼-inch cap is placed onto a ½-inch

AHC, the dimensions of the stem allow for the actuation of the ½-inch AHC poppet (reference Figure 29-1 for an illustration of this) if the proper force is applied to the cap and poppet. This is exactly what happened. An oxidizer vapor release was reported when the technician tried to install the ¼-inch cap (proximate cause). The root causes are human error, improper configuration management, and improper vehicle design. The original flight cap design should not have enabled this type of incident to occur. The technician received minor injuries from exposure to NO₂ vapors. Close attention needs to be paid to the identification of flight caps and other hardware to prevent an event like this from occurring again (which it does on November 4, 1992 at WSTF).

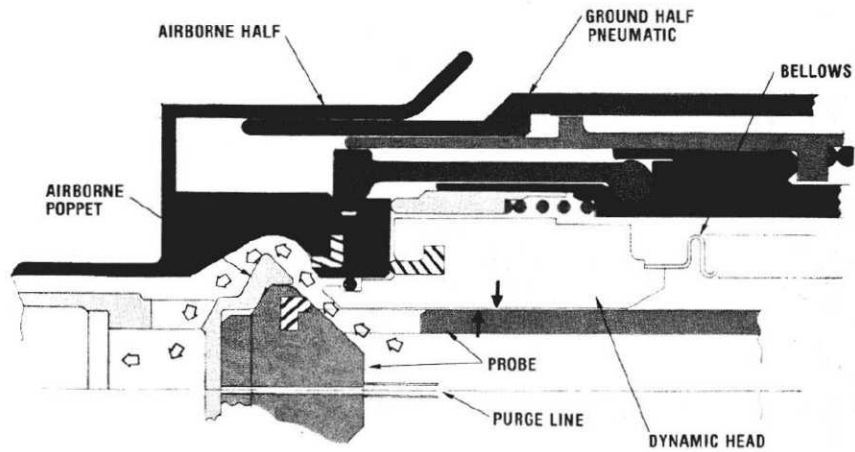
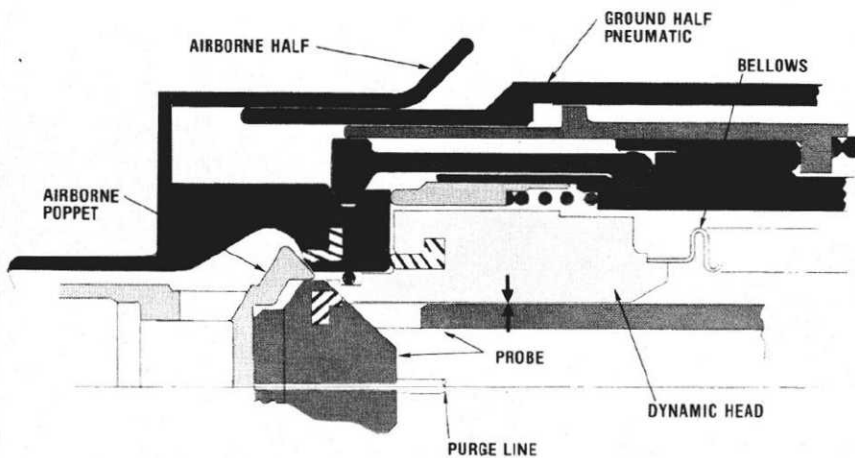
At 1:13 AM on September 22, 1981 an N₂O₄ spill occurred at Pad 39A. The proximate cause of the spill was a failed ground half coupling (GHC), MD162, at the AP28-12 door on FRC2 of OV-102 (Columbia). Failure of the GHC was a result of iron nitrate build-up between the probe and the dynamic head of the GHC along with the tight tolerances of the GHC. See Figure 11-1, Figure 11-2, and Figure 11-3 for a description of the AHC and GHC flow paths and also the failure location. Between 15 to 20 gallons of oxidizer was released into the attached scupper, which subsequently overflowed onto the vehicle. Damage to thermal tile adhesive resulted in the removal of 370 tiles (shown in orange in Figure 11-4). The photograph in Figure 11-5 shows the thermal tiles and the underlying vehicle structure along with the scupper and QD flexhoses going into the AP28-00 door (second FRCS oxidizer servicing door just beneath the AP28-12 door when the vehicle is in the vertical orientation).

- The GHC design was flawed in that there was a single point failure resulting in a leak path (a root cause)
- The scupper and apron were not large enough to contain the spill
- Using the GHC as a shut-off valve was flawed engineering practice (another root cause)
- The emergency procedure was inadequate
- All entry paths to the FRCS module should be sealed
- Care must be taken in the control of iron nitrate which is always present in an N₂O₄ system
 - Iron nitrate and its impacts to hardware were not well understood in 1981
- Proper ventilation and lighting should be added to the FRCS room on the 207-foot level of launch pads 39A and 39B
- Emergency Launch Processing System (LPS) programs could have saved time during safing
- The communications system could have been used more efficiently

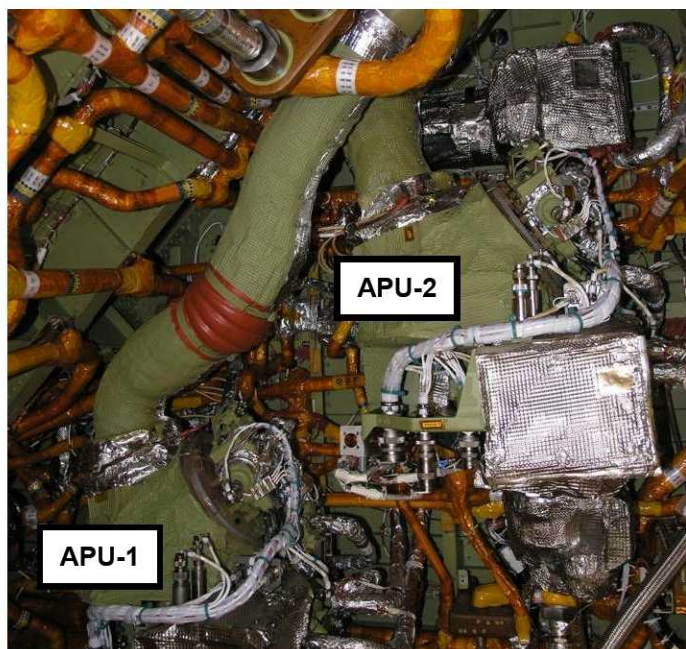
Figure 15-2: APU-1 and -2 in a Nominal Configuration

On December 8, 1983, Space Shuttle Columbia landed at EAFB at 3:48 PM pacific local time, concluding the STS-9 mission. About seven minutes after landing, an unusual series of events occurred. First, APU-1 shut down prematurely in response to a sensed turbine "underspeed" condition. About four and a half minutes later an explosion occurred in the APU. Figure 15-1 shows what remained of the APU-1 fuel pump following the explosion along with the resulting collateral damage. At the instant of the APU-1 explosion, APU-2 spontaneously shut down. Fifteen minutes later it exploded. Figure 15-2 is a photograph of APU-1 and APU-2 in the aft of OV-105 (similar to the OV-102 configuration). APU-3 ran nominally.

Following the STS-9 flight, several changes were made to the APU subsystem, including soaking of the carbon seals in hydrazine prior to installation, chromizing the injector stems to prevent corrosion, and minimizing stresses on the injector stems during manufacturing and installation. These design flaws are believed to be the root causes of the incident.

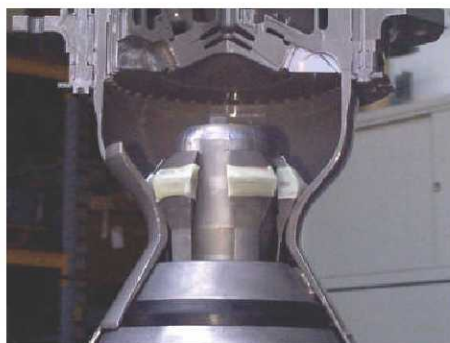
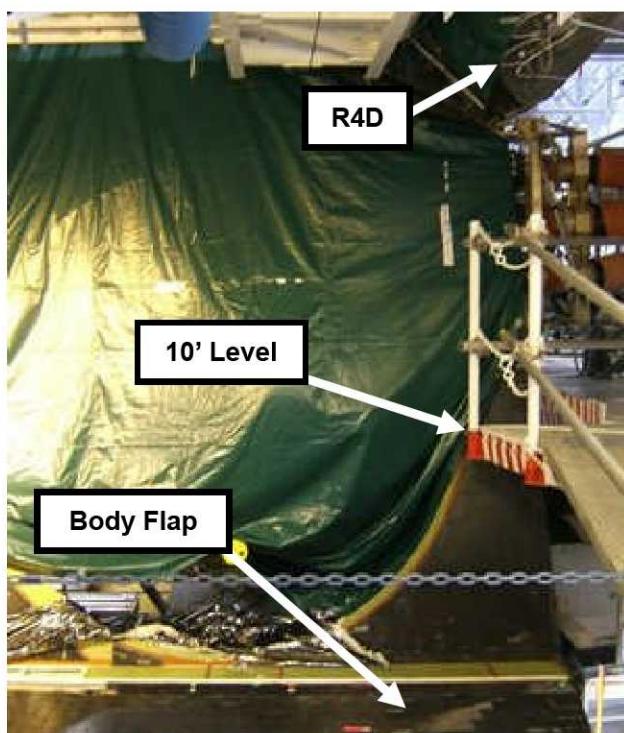
On May 24, 1985, while preparing for the removal of R4D (down-firing thruster on the Space Shuttle right pod) from OV-099, there was an MMH spill in OPF1 on the 10-foot level west side. R4D was being removed as a result of an in-flight anomaly related to a heater failure on the thruster. The manifold had been drained of its propellant and it was thought that a purge through the MD348 line (which connects to the manifold) and out the thruster nozzle purge adapter was sufficient to remove the liquid and most of the fuel vapors. Figure 18-1 shows a purge adapter in a cutaway of a primary thruster nozzle. During the part of the procedure where the purge adapter was being removed, approximately one cup of liquid MMH spilled from the thruster and down onto the body flap (which is illustrated relative to thruster R4D in Figure 18-2). The body flap was partially covered with spill protection sheets. The OPF1 hypergol exhaust fans were activated and the facility was immediately evacuated. It was recorded that some of the liquid MMH had saturated the body flap tile filler bar. It is unknown if the tile had to be removed. Unlike N_2O_4 , which was known to breakdown Koropon primer (from the STS-2 N_2O_4 spill mentioned previously), the effect of MMH on Koropon was not well known in 1985.

There are three possible proximate causes to this spill. A combination of two or more of the following causes is also possible. The first involves an improper configuration in which the flexhose that was being used for the procedure had previously been utilized for a similar operation on the left pod thruster L1U's manifold. This flexhose was several feet longer than the flexhose that was normally used for the right pod manifold evacuations. It was routed from the R4D thruster purge adapter to the 19-foot level above, then down to the eductor on the 10-foot level. This excessive length in hose may have allowed for a "u-shaped" low point trap to be formed in which liquid MMH could have collected. The second possible proximate cause involved a procedural error made by the engineers on console. The evacuation could have created a pressure differential across the liquid MMH. When the eductor was deactivated and removed, this pressure differential may have pushed the liquid into the thruster chamber. The third possible proximate cause was the liquid had collected in the thruster chamber (see Figure 18-1) and the purge was of insufficient duration to remove all the liquid MMH or the liquid trap may have prevented the vacuum source from evaporating all the residual fuel that remained around the purge adapter. A definitive proximate cause was never determined.

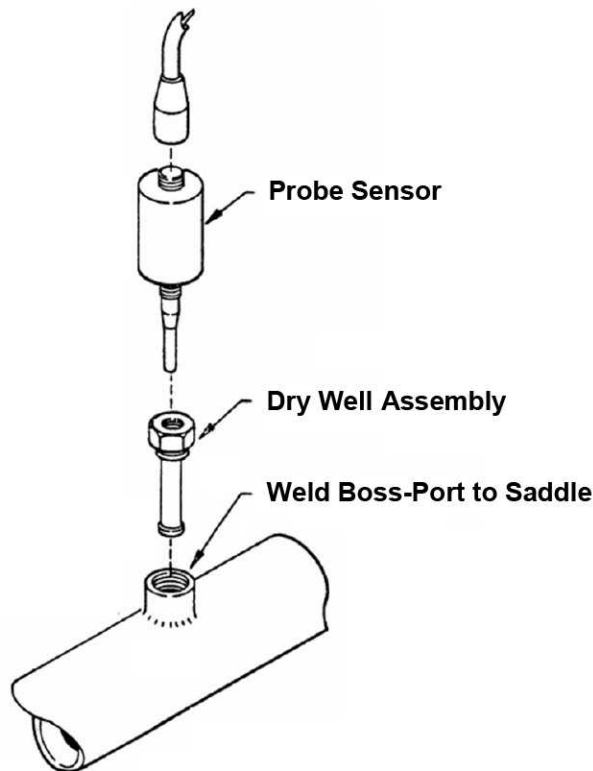
Figure 20-1: Transducer and Dry Well Assembly

This incident took place during an annual calibration of temperature transducers and other components, using an OMI. The technician was correctly informed by the engineer on console to remove a specific temperature transducer from the MMH return line. The technician mistakenly removed the dry well and temperature transducer assembly (shown in Figure 20-1) rather than the temperature transducer alone (proximate cause). If the temperature transducer was removed properly, there would not have been a spill. The following is a quote from the mishap report that explains the incident:

“The LSOC hypergolic mechanical technician actually performing the task of transducer removal used incorrect shop practice and loosened the wrong nut. Instead of using a one-inch wrench to retain the dry well in place while loosening the transducer lock nut that threads into the dry well, he used the wrench to loosen the dry well. He then used his hand to unscrew the transducer thinking he was extracting the transducer from the dry well while he was actually unscrewing the transducer dry well assembly from the three-inch MMH line. A mixture of fluid and vapor MMH immediately erupted from the line sending a column 10 to 12 feet in the air.”

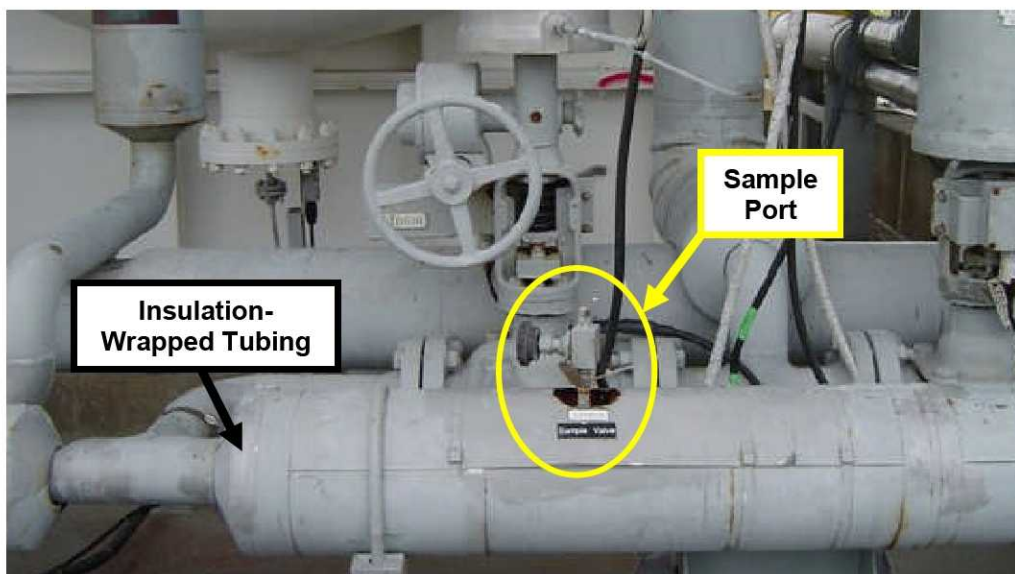
Figure 23-1: Photograph of Sample Port

On May 25, 1988, at the Pad 39B oxidizer farm, technicians were completing an N₂O₄ sampling operation. During the operation, the technicians detected a small leak at the interface between the sampling valve and the tubing (see Figure 23-1). The sampling operation was delayed until the leak could be fixed. The repair was finally scheduled to be worked about a month later during the afternoon of June 23, 1988. The removal of some local insulation was required to fix the leak along with re-torquing the fitting that connected the sample valve to the tubing. This was all completed that afternoon.

At about 10:30 PM on June 23, 1988, the sampling operation was successfully repeated. This was followed by the disconnection of the sampling flexhose from the sample port. When the flexhose was removed, liquid N₂O₄ spilled (about two tablespoons) into the small well surrounding the sample port. It was not uncommon to have a small amount of residual N₂O₄ remaining in the sample flexhose when it was disconnected. The spilled N₂O₄ reacted with the adhesive used for the attachment of the insulation to the tubing and ignited (proximate cause of the fire). The fire burned itself out in about 10 to 15 seconds before the technicians in SCAPE could return with a fire hose. There were no injuries to the personnel working the operation and the only hardware damage was to the insulation, which was replaced.

The insulation had been installed within hours of the sampling procedure; therefore, it was not given the appropriate time to fully cure. The adhesive used to attach the insulation to the tubing was found to

contain volatile hydrocarbons. This allowed for a chemical reaction to take place between the adhesive and N_2O_4 , causing ignition. The root cause of this incident was operational human error as a result of not allowing the insulation adhesive to fully cure.

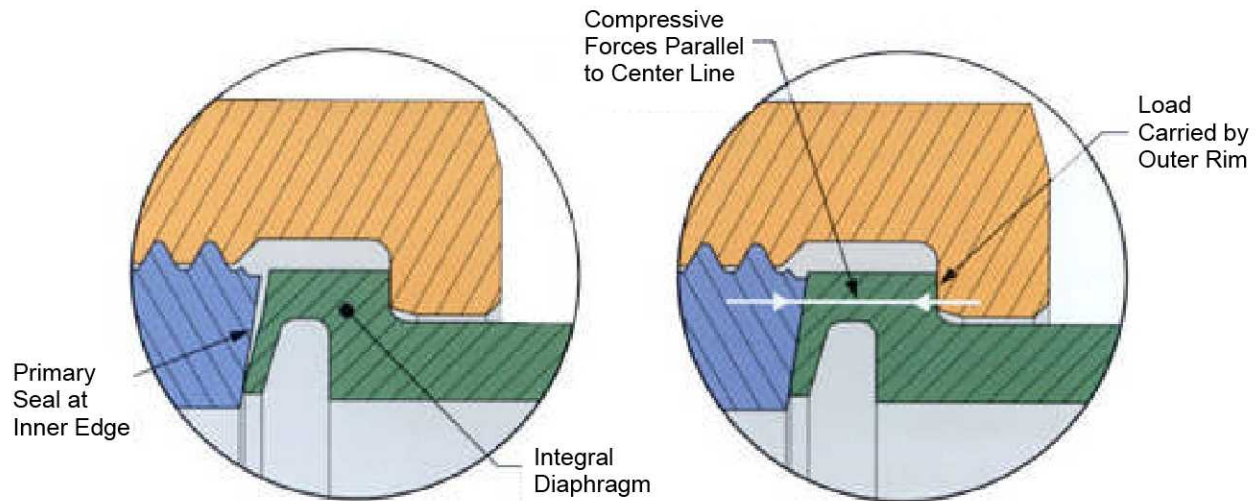
Figure 24-2: Cross-Section of Dynatube Sealing Surface

First, the exact location of the leak within the pod had to be found (a cutaway view of the Space Shuttle OMS pod can be seen in Figure 24-1). This was difficult because the internals of the aft pods and forward module are not meant to be accessed while the vehicle is at the launch pad. The location of the leak had been isolated to the LRCS N_2O_4 system or the associated tubing through monitoring of the instrumentation in the LCC. The leak was measured to be 0.26 psi per hour (about 800 standard cubic centimeters per hour) and a TVC found the concentration of NO_2 vapor to be 15 ppm at the vehicle vent door. This later decreased to 3 ppm. An access door was removed on the pod's outer skin and several internal thermal blankets were removed. A long section of PVC pipe was then inserted into the pod to function as a guide for a borescope. Using a borescope, the leak was finally isolated (after a six hour search) to a 1/2-inch dynatube fitting on the MD224 leg (the N_2O_4 propellant tank ullage vent). A cross-section view of a dynatube is shown in Figure 24-2 and a photograph of the leak location can be seen in Figure 24-3.

The proximate cause of the leak was found to be a scratched dynatube. This was discovered during ground processing two missions later when the pod was removed in the OPF and sent to the HMF for repair. It was determined that the scratch must have occurred either when the dynatube was disconnected in October of 1987 to allow access to a nearby valve for a removal and replacement or when it was reconnected in late December of 1987. Following the reconnection, the dynatube fitting passed all leak checks. Transport vibrations may have “altered” the state of the connection between the HMF, OPF, and launch pad; however, this is highly unlikely since dynatubes do not typically change mechanical state, especially with safety wire installed. The Kersey report states that “The most probable cause was that the mass spectrometer probe operator probed the wrong RCS propellant system (i.e. MMH instead of N_2O_4).” Operational human error was the root cause of this incident along with improper training. This categorization was given as a result of the incident being a consequence of either an inadequate inspection of the dynatube sealing surface or an error made during the leak check of the dynatube.

A question was raised concerning the accuracy of the mass specification leak check, which was the leak detection method used on this dynatube in December of 1987. As a result, a new policy was implemented to independently verify zero leakage using two separate methods. Currently, the Space Shuttle hypergol systems utilize a hazardous vapor (“sniff”) leak check, in addition to the mass specification leak check of individual fittings when they are disconnected for any reason.

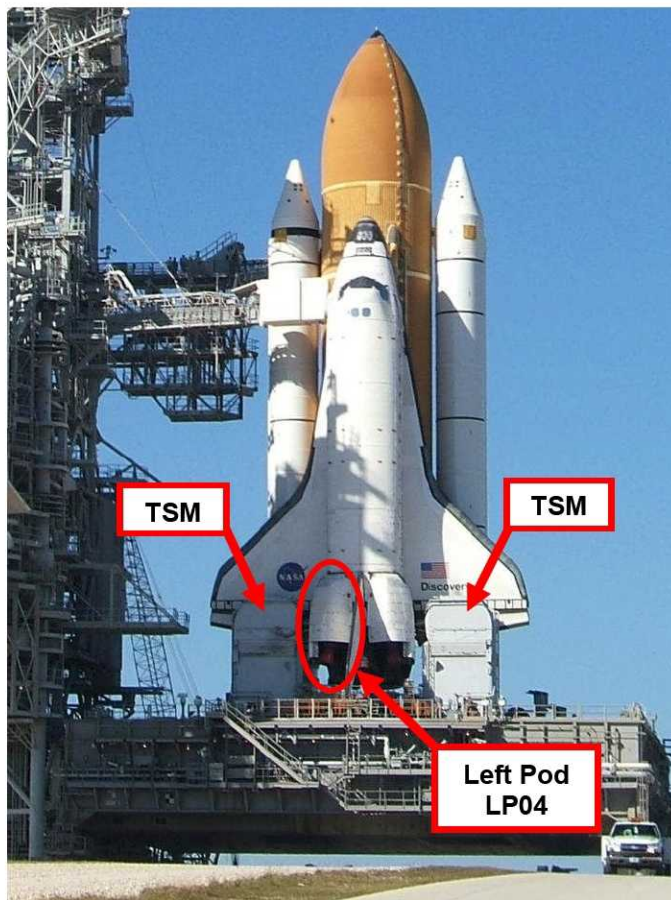
Figure 24-4: Location of Left Pod on Space Shuttle

On July 14, 1988, about three days after the loading of N_2O_4 onto Discovery at Pad 39B for the STS-26R Return to Flight mission, a small N_2O_4 (NO_2) vapor leak was detected in the left OMS pod (LP04) of Discovery. STS-26R was the first flight following the Challenger disaster on January 28, 1986. The leak did not result in any injuries or hardware damage, but it did impact the launch date of Discovery. Along with several other Return to Flight actions, the launch team at KSC was required to test fire the three main engines on Discovery while it was at the launch pad. This was known as the Flight Readiness Firing (FRF) and was scheduled to occur on July 26, 1988. The Space Shuttle Program decided to complete the FRF regardless of the known oxidizer vapor leak; therefore, the engineering team assigned to assess the leak had a couple weeks to study possible solutions, while other groups were preparing for the FRF.

After a week of deliberation, the “clamshell” was selected as it was the least invasive method to stop the leak prior to launch and it could be completed at the launch pad. Furmanite FSC-6B was used as the sealing compound as a result of it having the best compatibility characteristics with N_2O_4 . The FRF was finally completed on August 10, 1988 following a few hardware-related delays. The repair of the oxidizer vapor leak began on August 17, 1988 with the cutting of two holes in the aft 1307 bulkhead (the bottom of the payload bay with the orbiter in the vertical orientation) and the top of the pod beneath the bulkhead. The dynatube’s safety wire was removed and a “clamshell” (shown in Figure 24-5) was placed over the leak. The Furmanite sealing compound was then injected. The leak was eliminated; therefore, the Space Shuttle Program cleared Discovery for launch, which successfully occurred on September 29, 1988, a few weeks later than the original launch date of September 6, 1988. The delay was a result of multiple items including the FRF test delays, return to flight SRB testing delays in Utah, and the N_2O_4 leak on LP04.

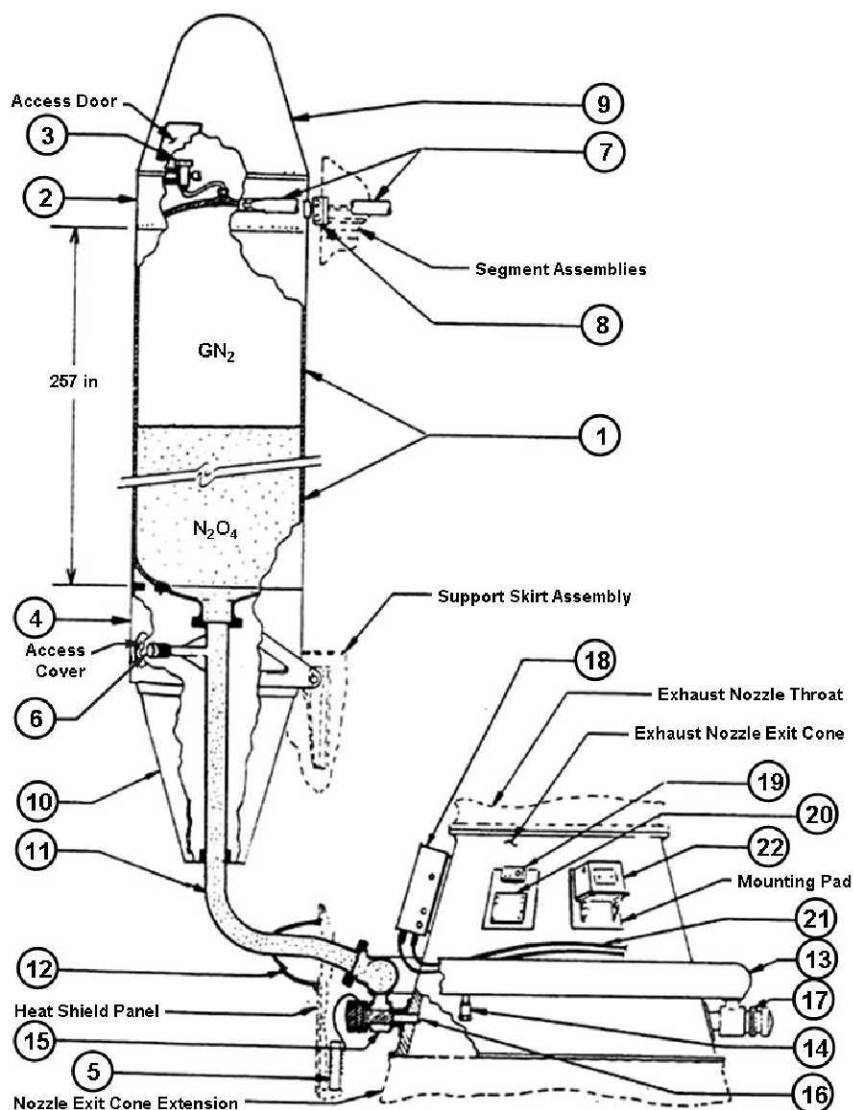
Figure 31-2: Titan IV A TVC System Schematic (see Table 31-1 for references)

On August 20, 1994, at Space Launch Complex 41 (SLC-41) on CCAFS there was a large release of liquid N_2O_4 . Oxidizer was being loaded into the Titan IV A's solid rocket motor (SRM) thrust vector control (TVC) system in preparation for the launch of the National Reconnaissance Office's Mercury Electronic Intelligence or ELINT satellite on August 27, 1994. The N_2O_4 was used to alter the combustion in the Titan IV A SRM nozzle and, therefore, provide TVC. A photograph of the SLC-41 launch pad with a Titan IV A is shown in Figure 31-1. A diagram of the Titan IV A's TVC system is shown in Figure 31-2 with the numbered callouts listed in Table 31-1. The incident occurred about three and a half hours after sunrise

when the solar heat caused the pressure to increase in the N_2O_4 tubing while the system was in a static configuration.

The pressure increase went unnoticed by the engineers and technicians. Remote data monitoring was available on the launch vehicle, but not on the propellant transfer systems (GSE). Local dial gauges likely showed the increase in pressure; however, there were no technicians monitoring these particular gauges. The pressure rise eventually caused a weld seam to fail at the base of the transfer system (proximate cause). This portion of the N_2O_4 servicing GSE lacked a relief valve, thus allowing the propellant in the tubing to become “liquid locked” since a drain-back and purge had not been completed (improper design; a root cause). There was no damage to the GSE (excluding the ruptured tubing) or vehicle hardware and there were no reported injuries.

Another root cause of this incident was determined to be frivolous procedure deviations. The loading team and Launch Conductor had experience with successfully delaying the oxidizer drain-back and purge; however, this experience was based on insulated oxidizer tubing. The tubing at SLC-41 had recently been removed and replaced with non-insulated tubing as a result of the moisture trapped in the insulation causing accelerated corrosion. The loading team and the Launch Conductor either did not recall this or they were never told.

There are requirements for launch Pads 39A and 39B to have seamless pipe throughout and to have relief valves in tubing that could become “liquid locked.” Following the incident at SLC-41, the procedures were changed to preclude this sort of incident from happening in the future. The procedure deviation approval rules were also reaffirmed to the loading team and Launch Conductor.

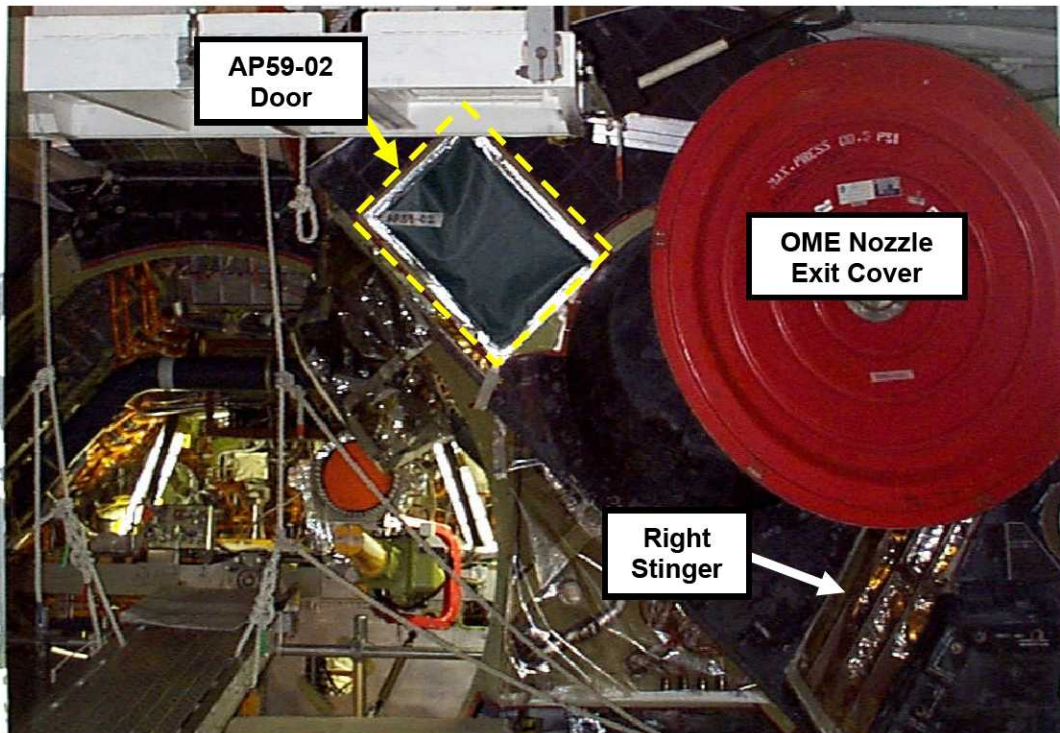
Figure 33-2: Color Photograph of Right Pod and Orbiter Aft

During the STS-69 OV-105 flow, while performing a thruster R1A removal and replacement, a fire broke out in the Space Shuttle right OMS pod stinger area. The fire burned strongly for about 30 seconds and a smaller flame burned for about one minute and 45 seconds. The size of the flame was estimated to be approximately 15 inches x 11 inches x 11 inches with a damage region of approximately 22 inches x 14 inches x 14 inches in the stinger. The materials that burned included several ounces of fuel, a shop light, and the Orcofilm spill protection (flame retardant covering films). Figure 32-1 is a still image from the video recording during the fire and Figure 33-2 is a clearer color photograph of the same area for reference.

A technician in SCAPE was disconnecting the R1A thruster MMH feedline dynatube during a thruster removal and replacement procedure. The procedure was initiated following an in-flight anomaly that occurred on the thruster during on-orbit operations (R1A primary thruster failed off due to a low chamber pressure). The N_2O_4 dynatube had already been disconnected and double-bagged in attempt to contain the residual vapors that were being released from the fitting. The technicians were told to place an aspirator near the N_2O_4 dynatube and proceed with the fuel feedline disconnect operation. When the seal of the fuel dynatube was broken by the technician using a wrench, he noted that there were “large drops of fuel being siphoned away by the aspirator.” Immediately following this, a fire erupted. There were six SCAPE personnel in the area when the fire was first reported. The proximate cause of this incident was the disconnection of the dynatube without knowing that there was liquid fuel within the tubing.

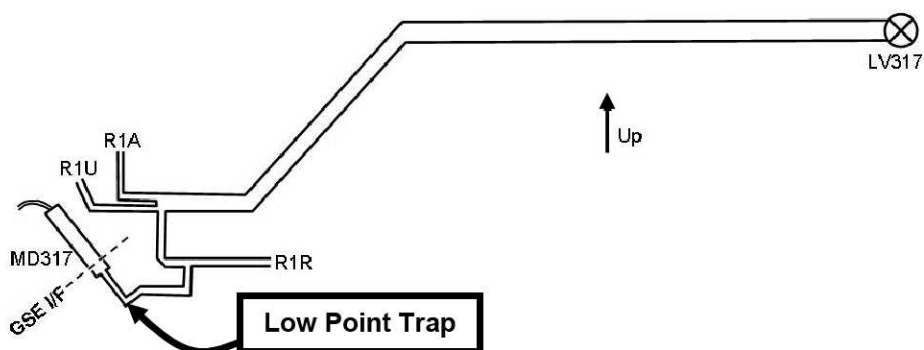
Figure 33-3: Approximate Manifold 1 Layout Schematic

The engineers on console in the LCC believed that they had purged the manifolds enough to reduce the residual MMH to manageable levels. Immediately preceding the feedline dynatube disconnect, the engineer on console incorrectly read the fuel feedline pressure transducer on the vehicle. The subject transducer indicated 16 psia (approximately atmospheric pressure). In actuality, the transducer was biased low (as determined from a previous test completed during the OMDP of RP01 about 18 months prior); therefore, the actual pressure in the manifold had increased to about eight psi above atmospheric pressure. There had also been a shift change between the venting and disconnection operations which may have led to the transducer bias going unnoticed. The increase in pressure may have been a result of a leaking manifold isolation valve (LV317, the valve holding back the bulk propellant from the feedline).

Another possible scenario (not included in the formal mishap report) for the pressure increase was put forth stating the pulse purges were unable to remove all the liquid MMH as a result of a low point trap present in the manifold near the MD317 (manifold 1 drain/purge QD) AHC interface. Figure 33-3 shows the basic layout and low point in fuel manifold 1 in the right pod stinger area. It is believed that during the purge, gas was unable to enter the line through the MD317 QD to displace the liquid MMH out of the manifold. This was a result of a small bubble that had formed in the low point as a result of helium coming out of the liquid MMH/helium solution. The helium slowly coming out of solution may have been the source of the pressure rise in the manifold rather than a leaking manifold isolation valve. Once the fire started, it heated the area thus increasing the pressure and pushing additional fuel out of the fuel feedline that was trapped. In both scenarios (leaking manifold isolation valve or helium coming out of solution), liquid MMH was present in the manifold line just prior to and during the fire and the manifold pressure increase went unnoticed.

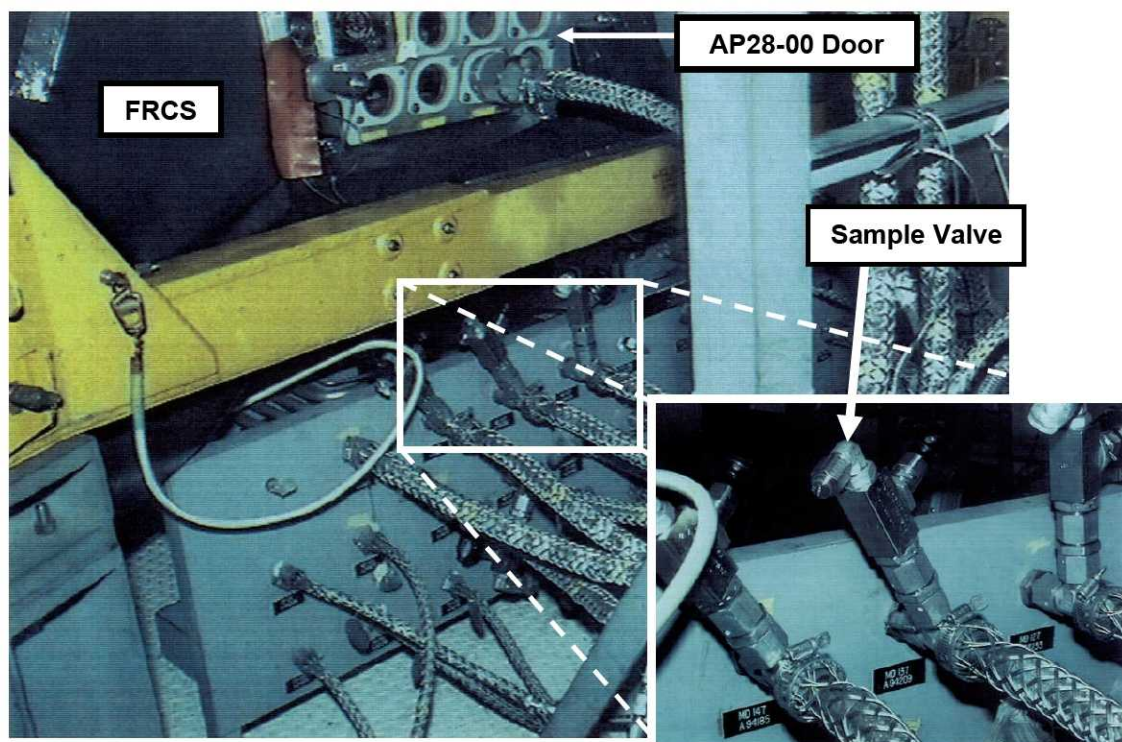
Figure 36-1: MD137 Flexhose Sample Valve

One technician powered up the aspirator and then began to remove the sampling valve outlet cap from the MD137 flexhose (see Figure 36-1 for a close-up view of the sampling valve). A TVC of the area was then performed with a resulting reading of 0.0 ppm. The technician laid the aspirator hose on the side of the rack, which was not a suitable position to capture any liquid or vapor that may be released from the valve outlet as the procedure stated.

The technicians were then at the point in the procedure where the valve was to be opened. The procedure was written to imply that there may be some vapor released from the valve when it was opened. Liquid MMH was not expected, but, as it turns out, there was a liquid release once the valve was opened. MMH splashed out of the sample valve and onto one technician's left arm, the glove of the other technician, and the surrounding area. It is estimated that approximately $\frac{3}{4}$ -cup of liquid MMH spilled from the valve. The technician immediately closed the valve and began to evacuate the test cell along with the other technicians. He exited the test cell and located a safety shower, which he began to use. A medical and fire team were immediately dispatched to the scene and the engineers on console notified the proper authorities. The technician did receive chemical burns on his arm for which he was treated at the OHF. He was released within a few hours.

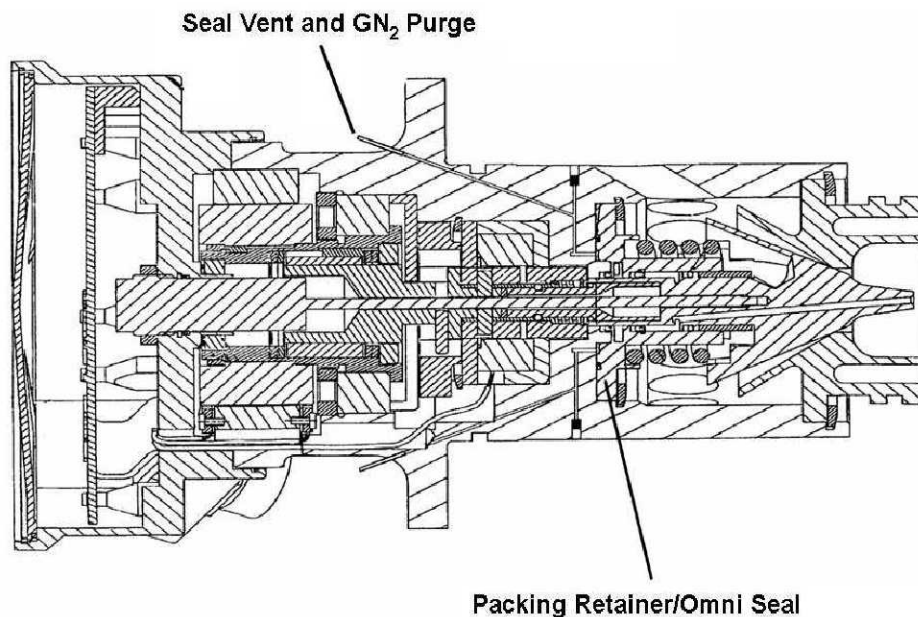
Figure 37-2: Titan IV A TVC FCV Cutaway View

The source of the leak was found to be the electronic compartment purge ports on two flow control valves (FCVs) on SRM #1 and one FCV on SRM #2. A cutaway view of the FCV is shown in Figure 37-2. These valves (along with the one remaining valve that did not leak) were removed and sent to the manufacturer for failure analysis. Upon disassembly of the three failed valves, evidence of combustion was noted at the electrical compartment's omniseal. The omniseal had been extruded through the sealing surface and the retainer ring had been ejected. The degradation of the omniseal resulted in liquid N_2O_4 flowing into the FCV's electronics compartment and out the purge port. There were no leaks found within the TVC propellant tank or the associated system plumbing.

Failure analysis determined that the proximate cause of the seal degradation was traced to a chemically reactive incompatibility of N_2O_4 with the cleaning agent, Bio T-200A, used on the FCVs during manufacturing at that time. Freon had long been the industry standard for oxidizer component cleaning; however, in 1987 the international scientific community endorsed the Montreal Protocol Treaty which phased out the use of halogenated hydrocarbons (including Freon) due to their proven role in ozone depletion. In early 1994, the Titan IV program adopted a policy to phase-out the use of Freon for cleaning of components and simultaneously phase-in the use of a trade product, Bio T-200A.

In June of 1994, a subcontractor was commissioned by the FCV manufacturer to test the compatibility of liquid Bio T-200A with N_2O_4 . Tests showed that N_2O_4 reacted violently with Bio T-200A after about five hours of exposure (at ambient pressure and temperature). As a result of this finding, precautions were added in the EMV (and later the FCV) manufacturing process that included a drying out the components via a baking process since it was known that a *dry film* of Bio T-200A is compatible with N_2O_4 . The manufacturer used a 30-minute bake at 100 °F, believing that these conditions were sufficient to remove all the liquid Bio T-200A. However, Bio T-200A has a relatively low vapor pressure and thus requires a comparatively long time for complete evaporation. Following the K-18 N_2O_4 spill, an investigation identified that the FCV manufacturing process indeed left a wet residue of Bio T-200A under the packing retainer (shown in Figure 37-2).

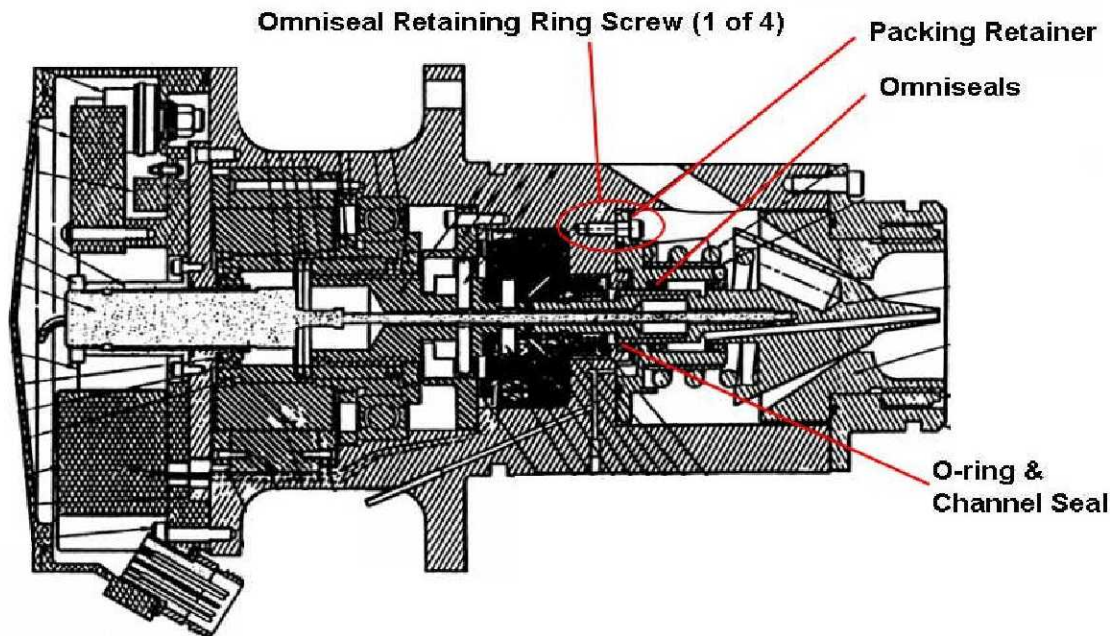
Figure 37-3: Titan IV A TVC EMV Cutaway View

The component design change was driven by the difficulty in manufacturing the EMVs, as well as some of its internal components becoming obsolete. A cutaway view of the EMV is shown in Figure 37-3. The intent of the valve redesign was to make as few changes as possible to allow for consistent manufacturing, part machining, and part procurement, as well as using the same outer housing of the valve to allow the new FCV to essentially be "dropped in" without any TVC system modifications. There are several noted differences between the two valve designs. One significant difference is their method of fastening the packing retainer to the omniseals. Both designs utilize an omniseal to isolate the N_2O_4 from the valve's electronic compartment. However, the original EMV design fastened the omniseal and packing retainer using four screws, whereas the superseding FCV design employed a snap-ring to fasten the retainer. The four mechanical screws on the EMVs left a much smaller gap (if any) between the component surfaces, whereas the FCVs snap ring design, while sufficient for its launch duty, had a large enough gap between the component surfaces that the liquid Bio T-200A cleaning solvent was able to accumulate on the omniseal spring.

A total of 74 EMVs which had been cleaned with Bio T-200A successfully flew in the Titan IV A TVC system. The Titan IV program accepted the use of Bio T-200A as the cleaning agent for the new FCVs by analysis, ground test, and similarity to the cleaning agent's use on the EMVs. The failure of three of the four FCVs on this one rocket, compared to the success of 74 EMVs on successfully launched rockets, suggests that the method of qualifying the FCVs was flawed.
