NASA/TP-2009-214769

A Summary of NASA and USAF Hypergolic Propellant Related Spills and Fires

B. M. Nufer
Kennedy Space Center, Florida

June 2009

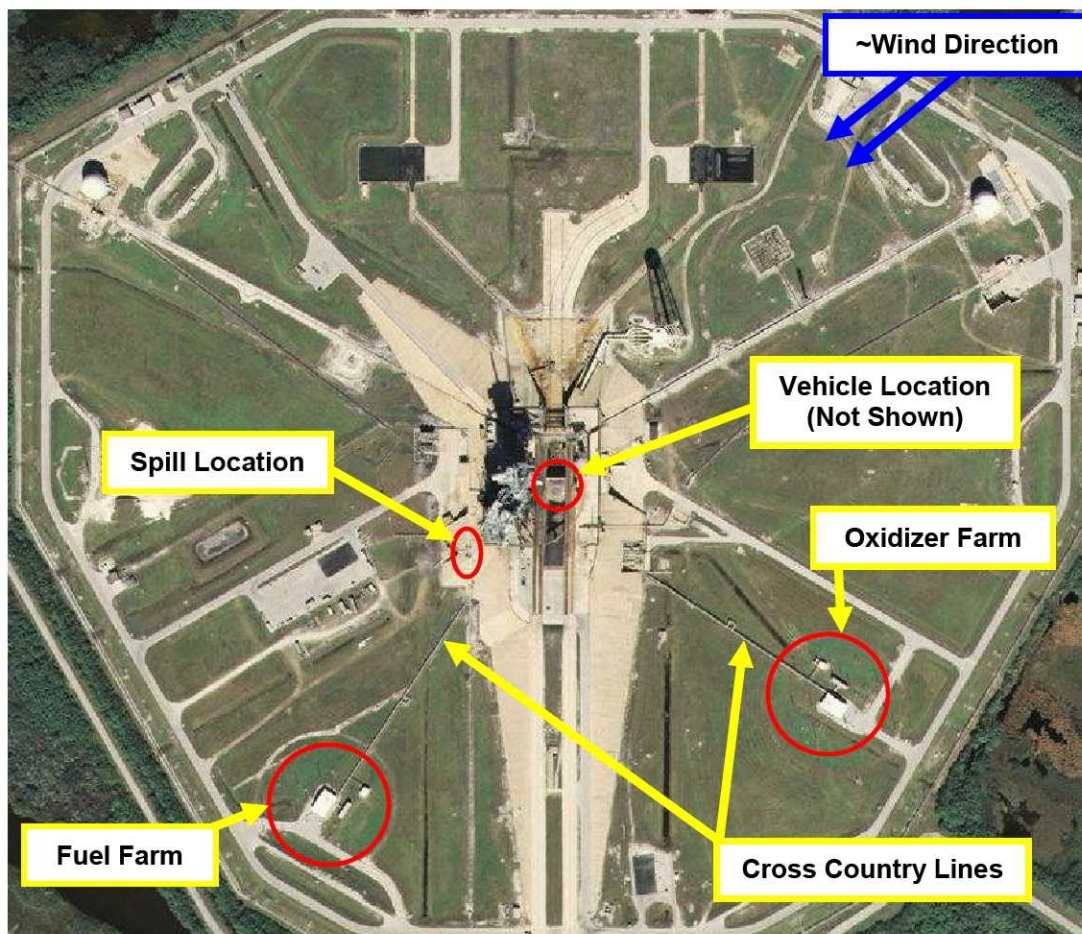
Figure 38-1: Geographic Layout of Launch Pad 39B

The SCAPE van driver was the first to detect the spill when he smelled oxidizer in the area of the fuel farm (see Figure 38-1 for a geographic layout of Pad 39B). Safety officials at the launch pad perimeter noted the source of the oxidizer vapors was the Pad 39B west slope. Three technicians in SCAPE were directed to proceed to the general area of the vapor source from their location on launch pad tower 107-foot level. Upon arrival, the technicians noted that heavy N_2O_4 (NO_2) vapors were leaking from both the inlet and outlet flanges of the return cross-over valve. They also noted that there were still several

gallons of liquid N_2O_4 on the ground near the flanges and at the bottom of the slope in a grassy area. Sparks were seen shortly after the arrival of the technicians; therefore, two of the three evacuated. Some of the liquid N_2O_4 that had flowed down the slope incline contacted the electrical conduits routed along the ground that supplied power to nearby lighting. The technicians were unaware that the N_2O_4 had dissolved some of the cabling insulation.

Since it was late at night, the technicians could not see the entire spill area very well. This was a result of the area being poorly lit during nighttime operations. Therefore, the technicians decided to activate some additional lighting at the cross-over valve complex. When power was issued to the lights there were several sparks and a small electrical fire ensued. The lights were quickly turned off and the small fire was put out with water. During the clean-up effort, one technician inhaled N_2O_4 (NO_2) vapors as a result of his SCAPE suit zipper not being secured. He was sent to the OHF and released later that night.

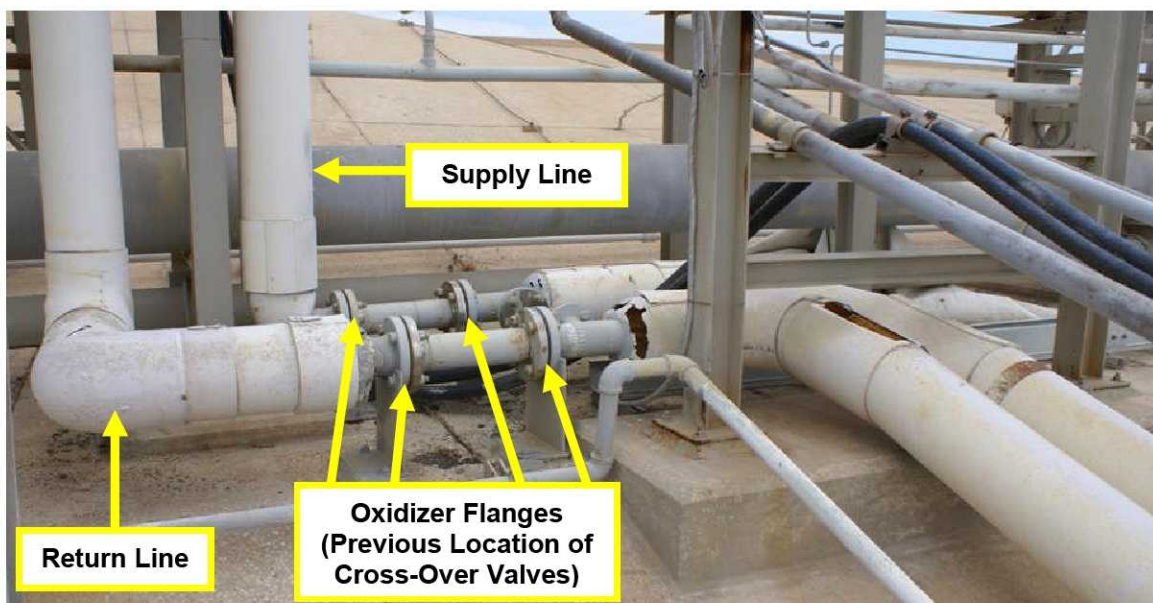
Figure 38-2: Former Site of Oxidizer Cross-Over Valve Complex at Pad 39B

Following this incident, the Pad 39B drawings were updated to require the installation of the proper flange seals. All the cross-over valves were removed and replaced with flanged pipe as they were no longer needed for hypergolic propellant loading. This reduced processing time on the valves and greatly reduced the risk of a leak at the valve flanges. Figure 38-2 is a photograph of the location where the cross-over valve complex was previously located at Pad 39B and Figure 38-3 is a photograph of the location of the Pad 39B fuel cross-over valve complex with the fuel farm and Vehicle Assembly Building in the background.

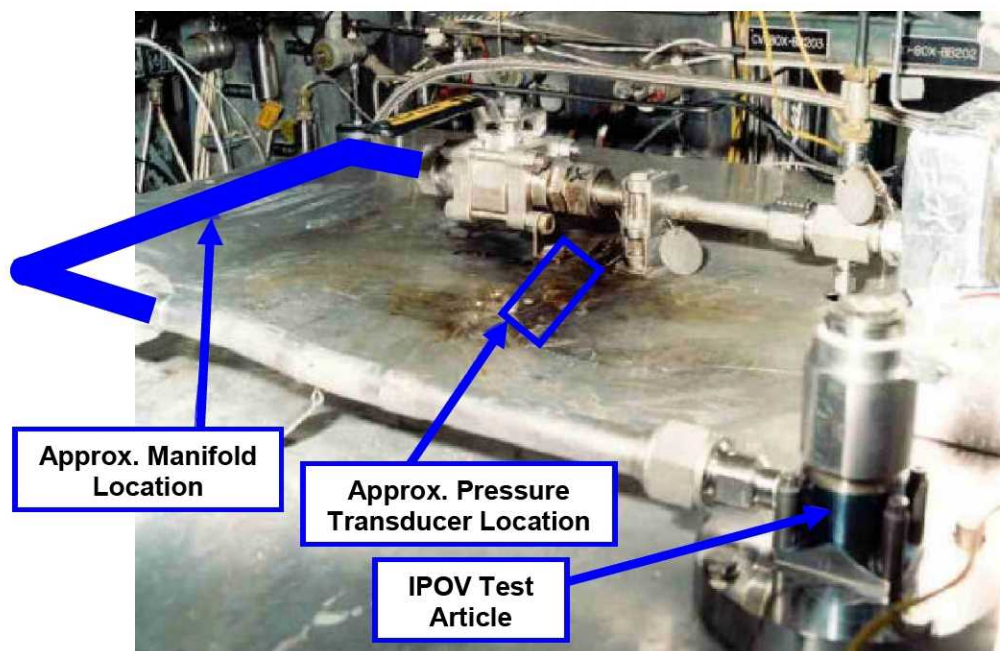
Figure 42-1: IPOV Test Setup

On March 25, 2003, in Test Cell 831 at WSTF, during the life cycle testing of an N₂O₄ Improved Pilot Operating Valve (IPOV), there was an explosion. Following the explosion, there was an N₂O₄ vapor release (approximately three quarts) into the test cell. There were no reported injuries since the cell was vacated prior to starting the test. It was found that a pressure transducer had catastrophically failed as a result of a material incompatibility within the pressure transducer (proximate cause). Figure 42-1 is a photograph of the test setup following the explosion with the relative location of the pressure transducer prior to the explosion.

The IPOV was in the process of being validated following some modifications that were made to the valve. The operating pressure at the valve inlet was approximately 276 psia. The test was simply flowing liquid N₂O₄ from one tank into another by cycling the valve. The pressure transducer was in the system to monitor this inlet pressure. Approximately 36,000 (of the planned 80,000) cycles of the valve, with a flow duration of approximately 80 ms and a maximum flowrate of 1.91 lb/sec, had been completed when the explosion occurred. The proper emergency procedures were immediately implemented following the incident. These procedures included securing the test cell and deactivating the air handler for both the test cell and the attached building. There was no reported fire following the explosion.

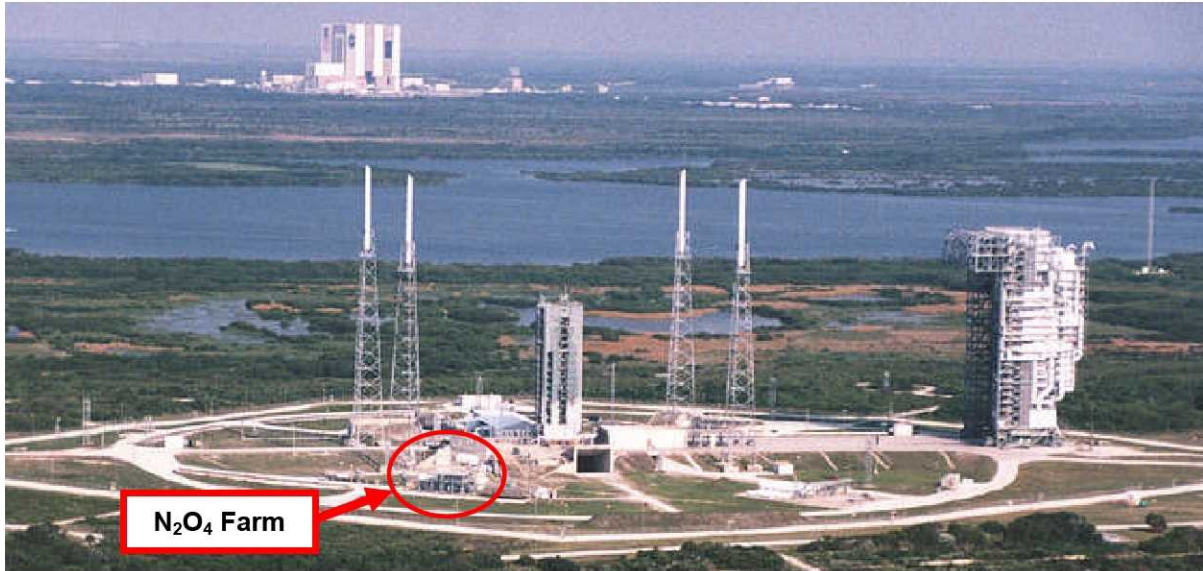
Figure 43-1: LC-40 at CCAFS

On August 12, 2003, at CCAFS launch Pad LC-40 (shown in Figure 43-1) during the bleed-in operation for the B36 Stage II (Titan IV) propellant load, the oxidizer centrifugal pump exploded (proximate cause of the N₂O₄ spill). The Titan IV launch vehicle was being loaded in preparation for the September 9, 2003 launch of the National Reconnaissance Office's payload. Along with the liquid N₂O₄ release of approximately 40 gallons, the explosion created a large amount of shrapnel which caused significant damage to the surrounding GSE. The pump was completely destroyed as shown in Figure 43-2. Fourteen people reported to an on site health facility. They were all later released without injury. The storage tank holding several thousand gallons of liquid N₂O₄ remained intact with minimal damage. An extensive investigation was initiated as a result of the Space Shuttle Program using these same pumps at Pads 39A and 39B (eight pumps in four locations) along with the Titan program which used them at LC-40.

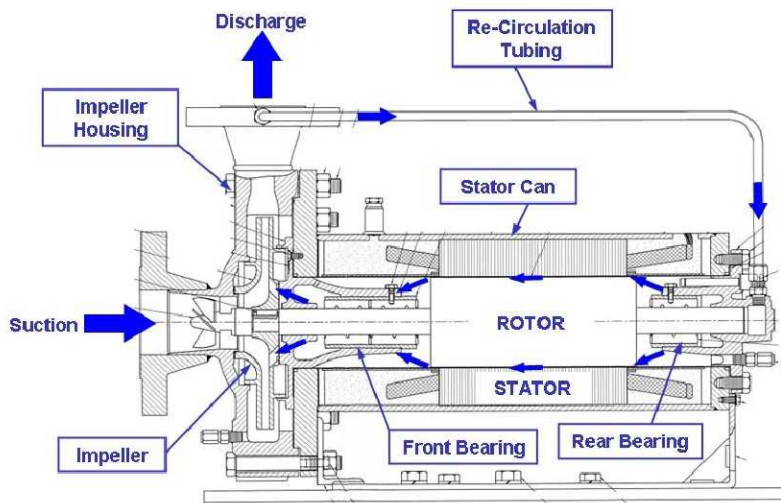
Figure 43-3: Pump Schematic

The incident failure analysis concluded, according to Crass, that there was a “cooling anomaly at the [carbon graphite journal] bearings...leading to [an explosion] in the stator can winding area.” It was found that the most likely contributor to this was a clogged filter in the pump recirculation loop that circulates liquid through the rotor cavity to cool the front and rear bearings as illustrated in Figure 43-3. Data analysis showed that the upstream and downstream temperature transducers indicated an increase in temperature of 8 °F across the pump. The low flow rate of 40 gpm and high ambient temperatures (high of 86 °F for 8/12/2003) accelerated the failure of the pump. At these flow conditions, the pump was not

able to be properly lubricated as a result of the high vapor pressure of liquid N_2O_4 (these particular pumps are designed to be lubricated with the liquid that they are pumping). The excessive bearing wear led to damage to the stator liner can, allowing oxidizer to leak onto the hot copper windings. The N_2O_4 reacted with the copper winding insulation and caused the coil wire to short, which was the proximate cause of the explosion.

Following the explosion, there were some design changes made to the pumps since an improper pump design was a root cause, these changes include the following:

- Machining of the pump from a single billet of stainless steel rather than casting them
- Serrations were added on the impeller housing and rear bearing housing for improved sealing capability
- The addition of a thermowell for thermocouple monitoring rather than the old thermostat which proved to be unreliable

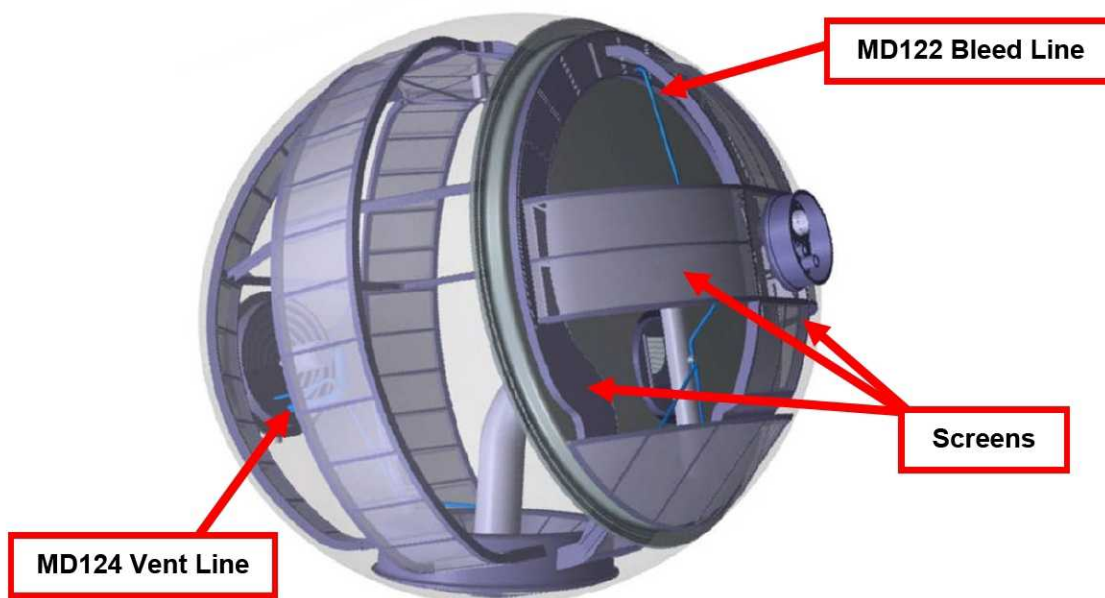
Figure 46-1: Solid Model of RCS Propellant Tank in (Roughly) the Horizontal Orientation

With the vehicle in a horizontal orientation, the MD122 line runs from the high point of the oxidizer tank lower compartment channel, through an interface at the tank outlet flange, and out to an AHC located in an externally accessible door on the FRCS outer mold line (AP28-00 door). It is known through pressure measurements that the MD122 and MD120 connected GSE lines were clear of any liquid immediately following the two, five-minute purges; however, it is not known if the propellant acquisition system channel in the lower compartment was broken down (i.e. it did not contain any liquid). If the screen was not completely broken down, it is possible that liquid oxidizer “wicked” up the screen following the purges to the point where MD122 connects to the acquisition screens. See Figure 46-1 for visual aid of the propellant acquisition system screens and the MD122 line. The absence of liquid in the lines can be confirmed by noting that there was not any significant pressure increase in the lines. The tank was *not* in thermal equilibrium. The tank shell (skin) temperature rose from 49 °F, when tank venting was complete, to 58 °F, when MD124 GSE vent valve was opened for the emergency vent through MD124 in the upper compartment of the tank. When the two purges were complete the tank shell temperature was 54 °F. From the time of the spill to the emergency MD124 vent, the tank shell temperature rose from 57 °F to 58 °F. The fluid and gas temperatures likely rose by a degree or two during this time.

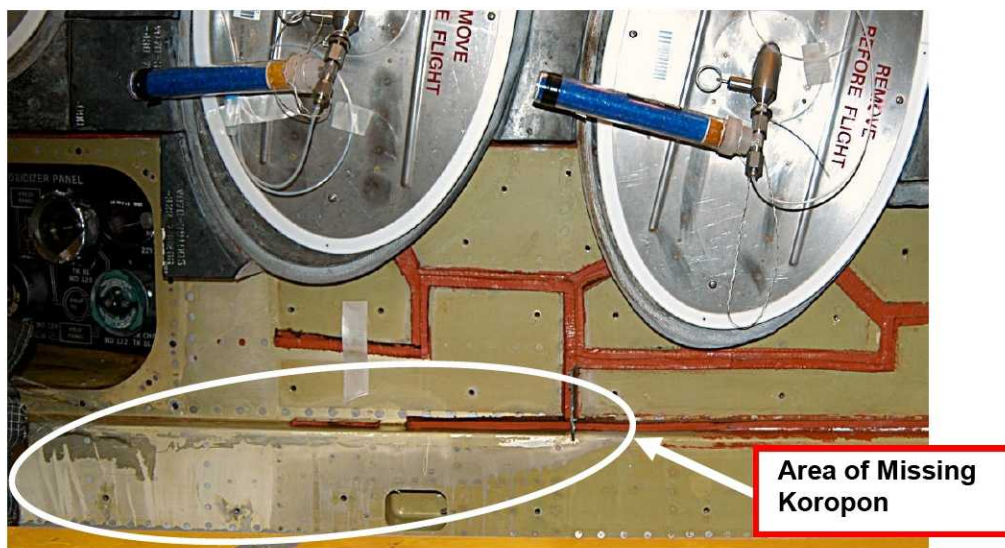
Figure 46-3: View Looking at R/H Side Down-Firing Thrusters (F2D & F4D)

The spilled oxidizer appears to have reacted with Koropon, RTV, and silver plating (nutplates and barrel nut elements). The oxidizer vapors reacted with the Koropon and removed a large area, as shown in Figure 46-3, and passed through the nutplate holes and around the perimeter of the phenolic QD service panel into the interior of the FRCS module, as shown in Figure 46-4, causing damage to the Koropon on the interior side of the FRCS module.
