Problems Encountered During the Recertification of the GLORY Solar Array Dual Axis Gimbal Drive Actuators

Marc Saltzman⁽¹⁾, Joseph P. Schepis⁽²⁾, Michael J. Bruckner⁽³⁾

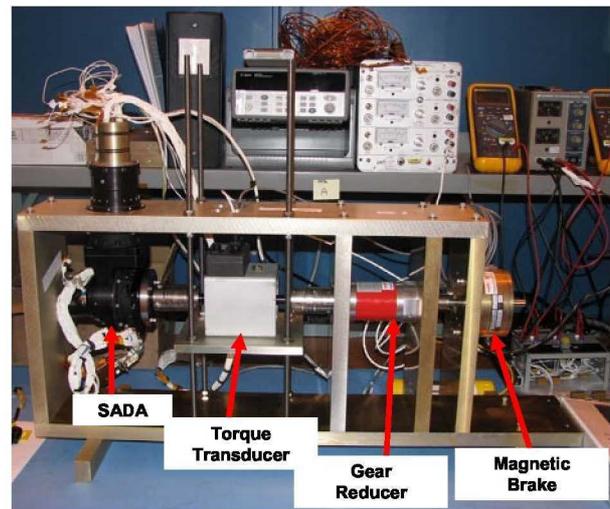
Figure 3 Torque Test Setup

Fig. 3 shows the setup for ambient torque testing at full flight driver voltages. The test arrangement included a Himmelstein torque transducer and a Planetrol gear reducer to amplify the effect of the Placid Industries hysteresis brake. Flexible couplings and careful alignment ensured there were no misalignment induced torque errors. The torque versus time plot of Fig. 4 shows a typical loss of synchronization (torque dropout). The simultaneously generated position versus time plot shows the same dropout. The objective was to find a brake induced torque resistance which the

Torque capability in the 150 in-lb to 190 in-lb (16.9 N-m to 21.5 N-m) range was produced prior to shipment but, as demonstrated by the plots in Fig. 4, there was either 30% degradation in torque or a serious flaw existed in the test apparatus. At least two days were spent checking the calibration of the torque test setup. The final test results for both SADAs are shown in Tab. 2. In this table, “N/A” indicates the configuration could not be tested without disassembly.

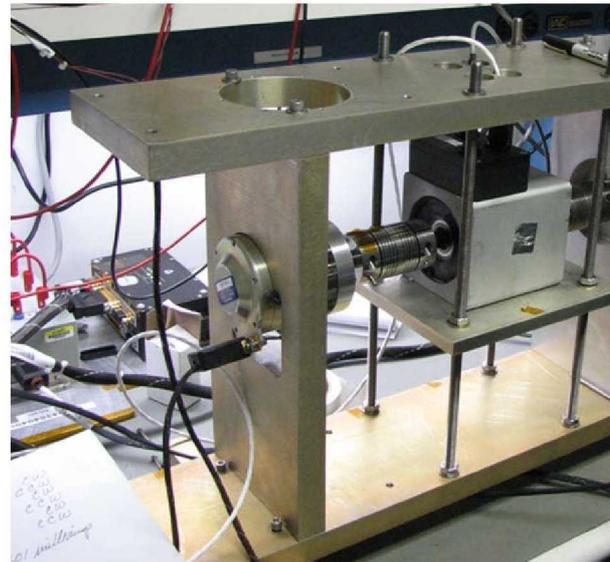
Figure 5 Moog Test Actuator Mounted in Altered Glory SADA Test Apparatus

using their test equipment but testing across the entire range of operation in the way Orbital had tested the SADAs. While this was accomplished at Moog, Orbital adapted their torque test setup to accept the Moog test actuator shown in Fig. 5. The Orbital torque results for the test actuator were in close agreement with those from Moog indicating approximately 30% torque loss and thus adding even more concern that the SADAs had, in fact, degraded over the past several years of storage and occasional use with Glory integration and test activities. The original test program was completed and an executive test summary written to document the results.

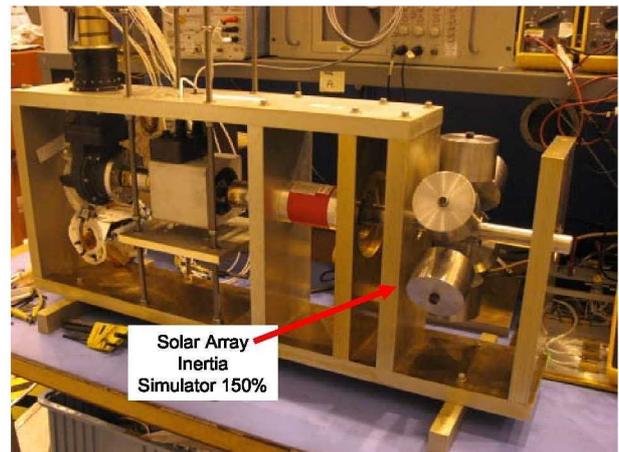
Figure 6 Inertia Testing Setup

The inertia used in this test setup was 150% of the solar array inertia that the Alpha actuator will be required to drive during each orbit. The inertia wheel consisted of 6 masses which could be positioned using threaded

spokes to adjust inertia. While the test increased confidence that the inertia can be started at 2°/second the amount of backlash in the test system precluded complete certainty of that conclusion. The majority of backlash was attributed to the test setup gear reducer and not in the SADA itself. The presence of backlash is non-conservative with respect to starting the inertia because more time is available for the momentum to increase which means the torque required from the actuator can be lower.

To achieve a more conservative, test the actuator speed was increased to 4°/second and then 6°/second. In all cases the inertia was started without any lost steps. Additional test were conducted with the backlash

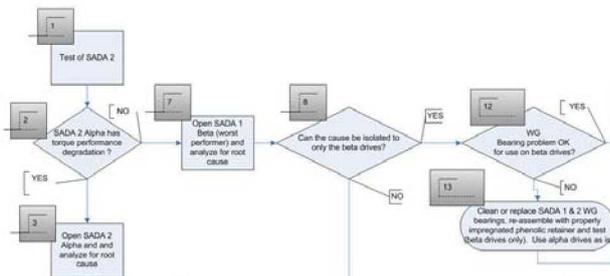
Figure 8 Initial Steps in a Detailed Test Strategy

The test services agreement with Moog was expanded to include return of the worst case SADA S/N 1 to Moog for testing followed by SADA S/N 2 if the torque findings continued to evidence degradation. This was a small part of a detailed test strategy, which is shown in Fig. 8.
