NASA/TM—2009-215802

Failure Analysis of Sapphire Refractive Secondary Concentrators

Jonathan A. Salem
Glenn Research Center, Cleveland, Ohio

George D. Quinn
National Institute of Standards and Testing, Gaithersburg, Maryland

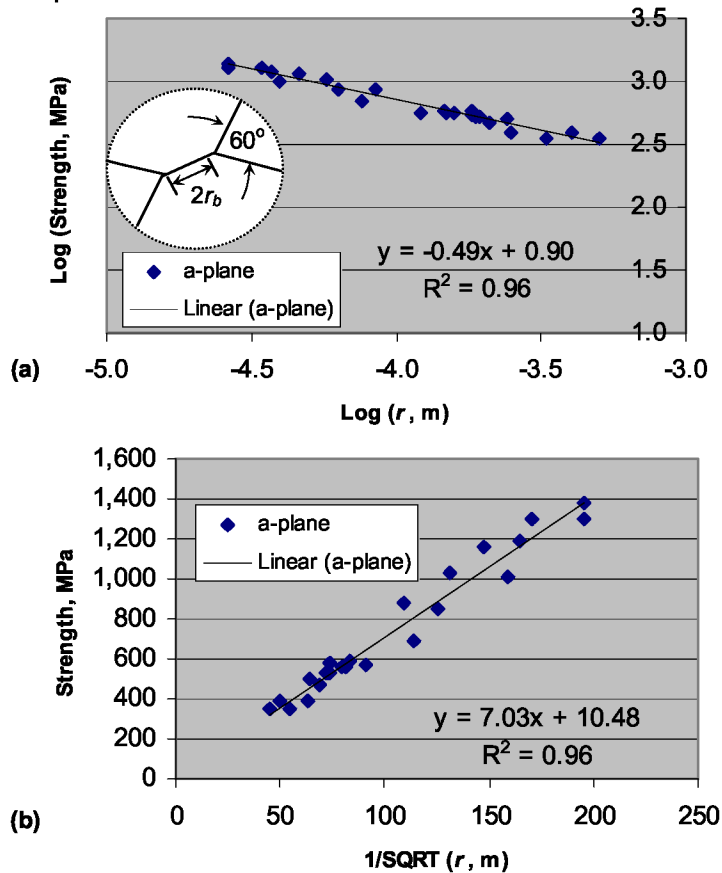
where σ_{th} is interpreted as either a threshold stress for branching or a residual stress (Refs. 7 and 13). Equations 1 to 3 yield A_b of 7.2 ± 0.6 , 7.9 ± 1.5 , and $7.0 \pm 0.3 \text{ MPa}\sqrt{\text{m}}$ for the sapphire respectively, with $M = -0.49$ and $\sigma_{th} = 11 \text{ MPa}$, as shown in Figure 30. These results compare well with those in (Ref. 7), implying a relatively constant value for alumina. The presence of a slight residual stress is not surprising, considering the grinding damage observed on the specimens via X-ray topography (Ref. 8), but this would be very shallow. During measurement of the branch lengths, several specimens were observed to exhibit fracture on the r -plane and bifurcation onto another r -plane. When the principal stresses were resolved on the r -plane, similar A_b resulted.

Figure 30.—Room temperature fracture strength as a function of branching length for the a-plane of sapphire tested in four-point flexure: (a) fit to Equation (2) and (b) fit to Equation (3). Strength data from Reference 8.

Assuming that the room temperature fracture constants are applicable, the 44 mm bifurcation distance used with Equation (3) implies a stress of only ~44 MPa. This is much less than the 250 MPa or larger strengths exhibited by well polished sapphire tested at low temperatures (Ref. 8). This very low stress estimate is consistent with the observation that the contact crack origin was moderately large. Large cracks require very little stress to trigger fracture.

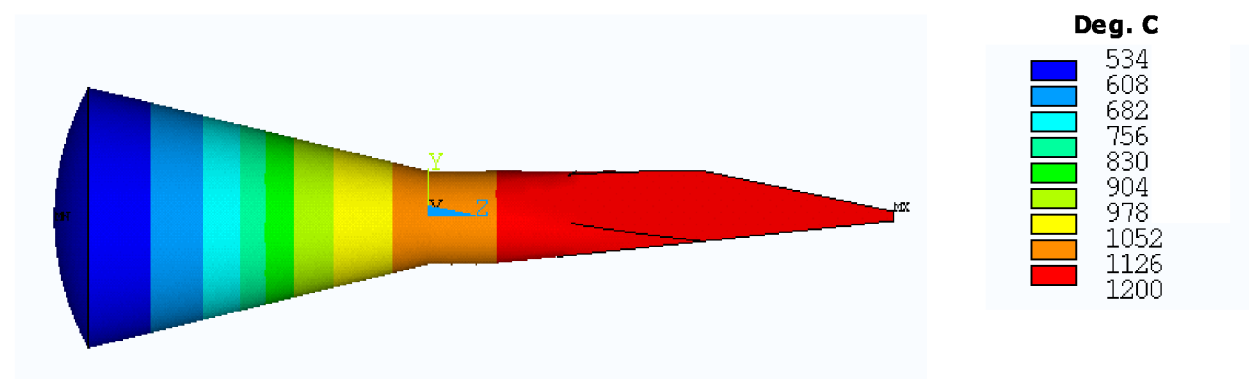
In order to understand the stress state in the RSC and design better RSC systems, finite element analyses were performed by using the single crystal thermal and elastic constants (Ref. 14). The resulting thermal and stress profiles are shown in Figures 31 and 32 for the first concentrator and indicate a maximum principal tensile stress of 57 MPa at the rim of the front lens face of the concentrator where the *a*- and *m*-axes exit, near the actual failure. This is in reasonable agreement with the value of 44 MPa based on fractographic measurement.

Figure 31.—Temperature distribution in sapphire crystal for receiver temperature of 1200 °C with exposed cone design.

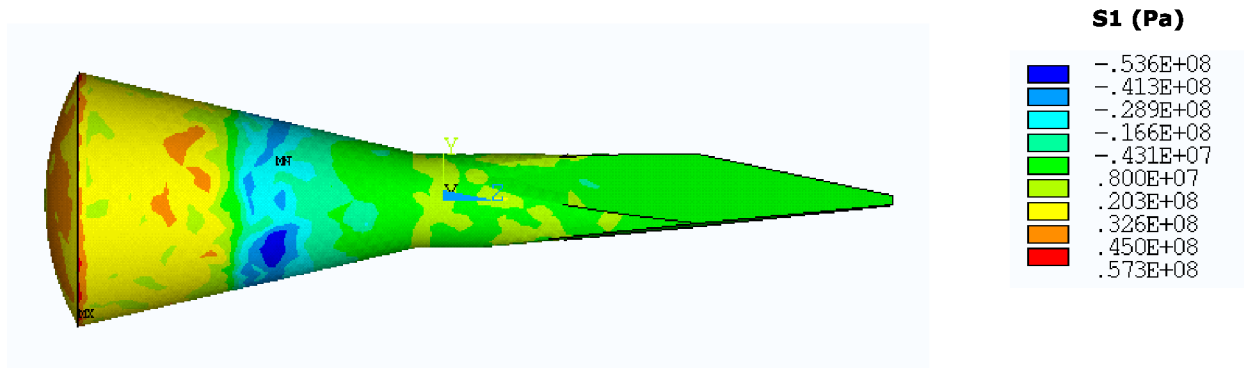
As noted previously, the radial cracking suggests that tensile hoop stresses at the rim caused fracture in both concentrators. The origins were also located near the rims, where shielding and clamping may alter the temperature profiles relative to those estimated by the FEA analyses based upon the assumed boundary conditions. Better modeling with more realistic boundary conditions may give improved stress estimates in the front face rim regions.

Figure 32.—First principal stress distribution in sapphire crystal for receiver temperature of 1200 °C with exposed cone design. Stress results are in Pa.

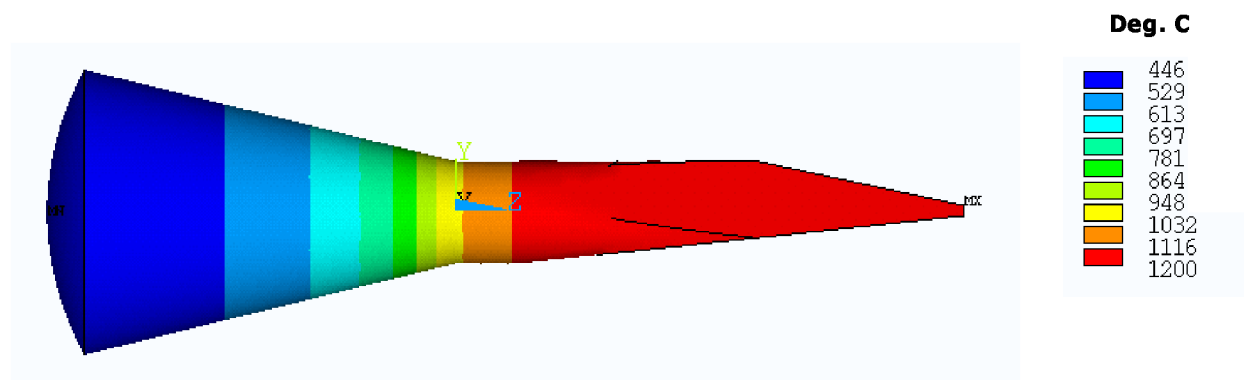
For the second concentrator, FEA modeling (covered cone design, 1200 °C) shown in Figures 33 and 34 indicates somewhat lower tensile stress of about 20 to 25 MPa on the lens face. Peak stresses up to 52 MPa occur just before the transition from the lens cone to the extractor rod.

Figure 33.—Temperature distribution in sapphire crystal for covered cone design with a receiver temperature of 1200 °C.

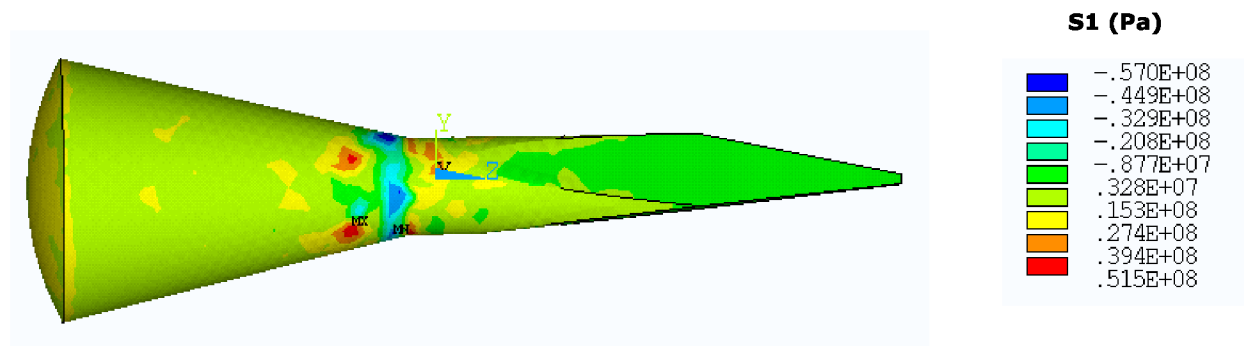
Figure 34.—First principal stress distribution in sapphire crystal for receiver temperature of 1200 °C with covered cone design. Stress results are in Pa.

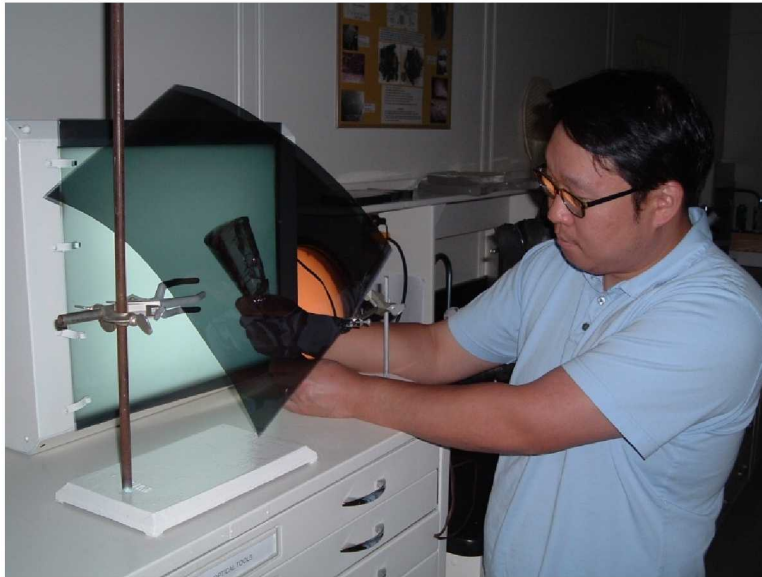
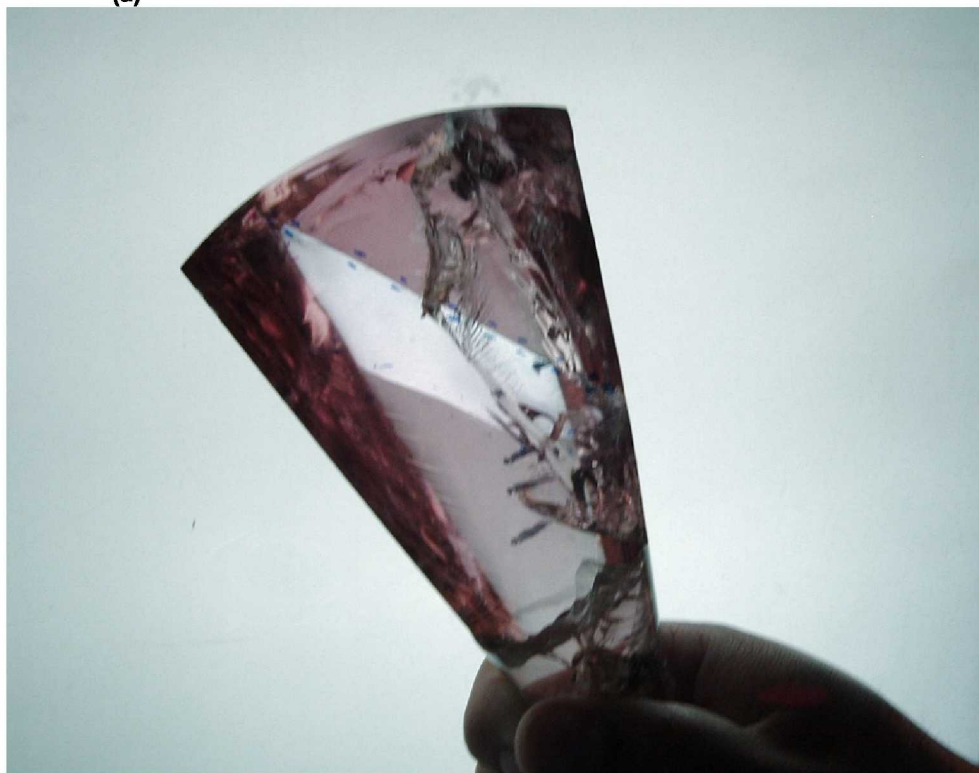
Figure A2.—An improvised Polariscope examination device. (a) shows a common light box is with two polymer polarizing sheets. One is clipped to the light box, the other is held by a clamp on the post in the foreground. Piece 1 of concentrator 1 is placed in between and rotated about. (b) shows a photo of the twin.
