NASA/TM—2010-216071

Current Space Station Experiments Investigating Component Level Electronics Repair

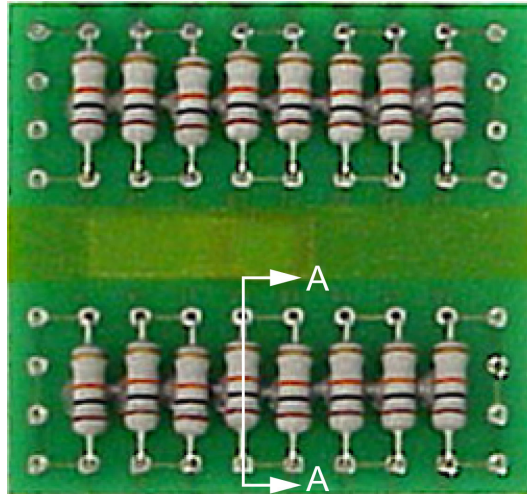
Figure 1.—An unused SoRGE circuit board and drawing of a resistor and two joint locations. The soldering occurs on the bare leg of the resistor, forming the soldered fillet. Solder flows into the through hole and forms the flowed fillet on the resistor body side of the circuit board.

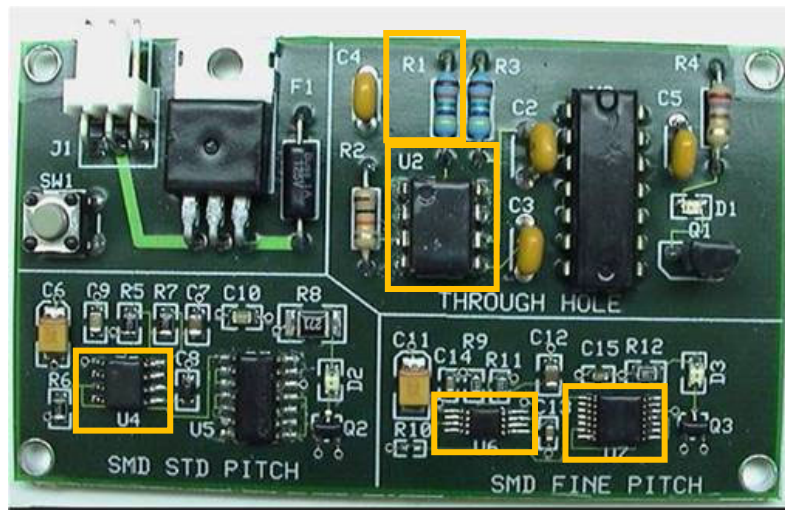
Figure 3.—The CRE-1 circuit board, with R1, U2, U4, U6, and U7 positions highlighted.

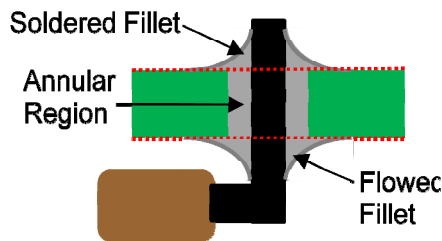
Figure 6.—Drawing of the three regions of a solder joint: the soldered fillet, where heat and solder are applied, the annular region within the circuit board through-hole, and the flowed fillet near the resistor.
