Investigation of Cracks Found in Helicopter Longerons

Abstract: Four cracked longerons, containing a total of eight cracks, were provided for study. Cracked regions were cut from the longerons. Load was applied to open the cracks, enabling crack surface examination. Examination revealed that crack propagation was driven by fatigue loading in all eight cases. Fatigue crack initiation appears to have occurred on the top edge of the longerons near geometric changes that affect component bending stiffness. Additionally, metallurgical analysis has revealed a local depletion in alloying elements in the crack initiation regions that may be a contributing factor. Fatigue crack propagation appeared to be initially driven by opening-mode loading, but at a crack length of approximately 0.5 inches (12.7 mm), there is evidence of mixed-mode crack loading. For the longest cracks studied, shear-mode displacements destroyed crack-surface features of interest over significant portions of the crack surfaces.

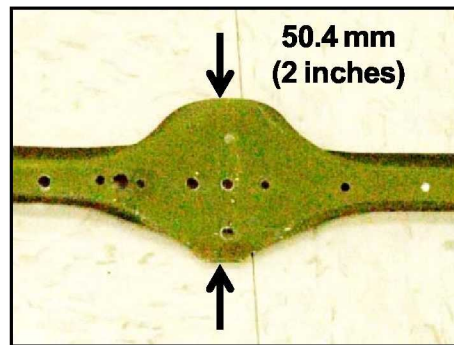
(c) Photograph of low-stiffness region.

sections that are bent into a “J” shape for increased bending stiffness, as shown in Figure 2b. Between the stiffened sections, the longeron remains a flat 0.025-inch-thick (0.635 mm) sheet, approximately 2 inches (50.8 mm) wide, as shown in Figure 2c, to allow the longeron to pass between a bulkhead and the skin (Stations 146.62, 155.75, 164.87, and 174.00, as indicated in Figure 2).[†] Each end of a longeron terminates under a bulkhead with a flat low-bending-stiffness region (Stations 137.50 and 185.89, as indicated in Figure 2).

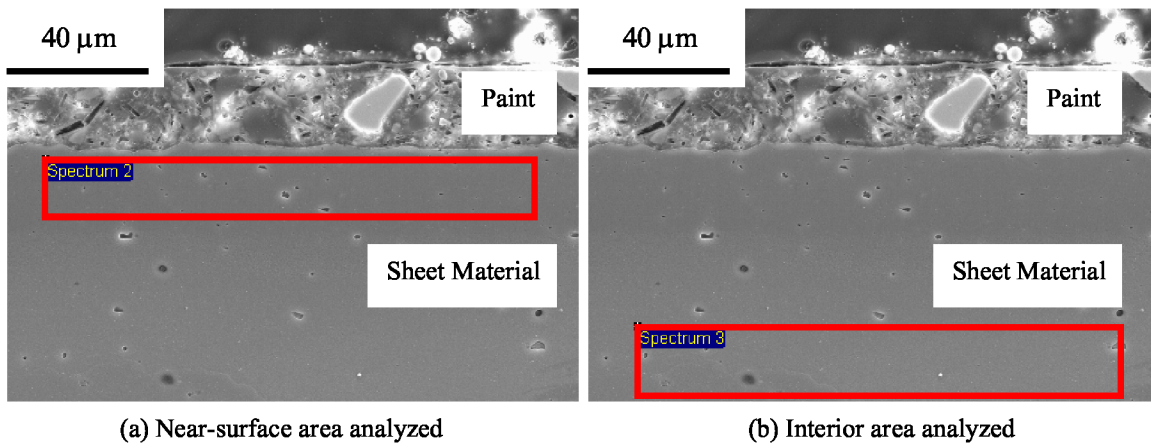
Figure 15. Near-surface and interior regions used for chemical analysis.

Examination of the orthogonal metallurgical cube of Figure 13b reveals the presence of what appears to be a dark band near the outer surface of the sheet material (see bottom of Figure 13b). This discoloration occurred in the same near-surface region where small grain sizes were observed (recall Figure 14). A chemical analysis (EDX) was performed on near-surface and interior regions of the polished surfaces. SEM images of regions examined are shown in Figure 15. In these images, the sheet material is seen at the bottom with the paint layer near the top. The near surface region selected for analysis is shown with a box in Figure 15a and the interior region (approximately 60 μm from the surface) is indicated by a box in Figure 15b. The chemical analysis results, which are summarized in Table 2, indicate that the near surface region contains less alloying elements (zinc, copper, and magnesium) than the interior region, which has a composition typical of aluminum alloy 7075 (ref. 4). This depletion of alloying elements at the surface may result in a degradation of mechanical properties, such as poor resistance to crack initiation. In all cases where crack surface observations permitted (recall Figures 5, 6, and 11), crack initiation sites were always located on the corner of the longeron cross-section near the intersection of sheet surface (where a depletion of alloying elements was observed) and the top edge of the longeron where bending stresses are likely greatest. Further study is needed to determine if the chemical depletion contributed to the cracking.

During metallurgical analysis of the longeron sheet material, an unusual feature was observed on polished surfaces of near-surface samples. (Recall, this layer appeared as a dark band near the bottom of Figure 13b.) Chemical analysis of near-surface region (Figure 14a) revealed that, in comparison to both the interior chemistry and typical aluminum alloy 7075 chemistry (ref. 4), it was relatively poor in the alloying elements copper, zinc, and magnesium, and appeared to contain traces of iron. This alloying element depletion may result in a local degradation in mechanical performance, including resistance to cracking. In the examples where crack-surface features were used to determine an apparent crack initiation site (Longeron #1, Crack #2; Longeron #1, Crack #3), these crack initiation sites occurred near the longeron sheet surface (where alloying element depletion was observed). EBSD results (Figure 15) revealed that the typical grain sizes within this near-surface alloying-element-depletion region were significantly finer than those within the longeron sheet interior. Additionally, the absence of corrosion pits, scratches, dents, or tool marks, suggests that corrosion and handling (e.g., installation and maintenance) were not contributing factors on crack initiation.

Table 2. Comparison of near-surface and interior alloy chemistry.

Element	Near-Surface (weight %)	Interior (weight %)	Nominal (ref.4) (weight %)
Aluminum, Al	93.71	89.69	88.90
Magnesium, Mg	1.25	2.26	2.40
Copper, Cu	0.53	1.80	2.20
Zinc, Zn	4.30	6.25	6.40
Iron, Fe	0.22	-	-
