# International Space Station USOS Potable Water Dispenser On-Orbit Functionality vs. Design

The International Space Station (ISS) currently provides potable water dispensing for rehydrating crewmember food and drinking packages. There is one system located in the United States On-orbit Segment (USOS) and one system in the Russian Segment. Shuttle mission STS-126 delivered the USOS Potable Water Dispenser (PWD) to ISS on ULF2; subsequent activation occurred on November 2008. The PWD is capable of supporting an ISS crew of six, but nominally supplies only half this crew size. The PWD design provides incremental quantities of hot and ambient temperature potable water to US food and beverage packages. PWD receives iodinated water from the US Water Recovery System (WRS) Fuel Cell Water Bus, which feeds from the Water Processing Assembly (WPA). The PWD removes the biocidal iodine to make the water potable prior to dispensing. A heater assembly contained within the unit supplies up to 2.0 L of hot water (65 to 93 °C) every 30 min. During a single meal, this quantity of water supports three to four crewmembers' food rehydration and beverages. The unit design has a functional life expecta

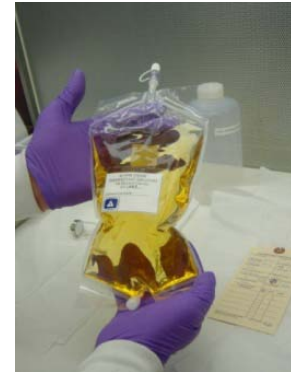
The PWD team needed to determine the ideal delivery method of this high concentration of  $I_2$  into the on-orbit PWD, including the design of supplementary tools required to carry out the task. The team decided to deliver the 40 ppm  $I_2$  in Teflon bags with a Luer lock interface, allowing the chemical to inject into the PWD Microbial Filter vent port via a Filter Flush Assembly (see Fig. 6 and 7). The basis for the choice of Teflon bags derived from the fact that these bags were previously approved by the NASA Materials Analysis and Fracture Control group for compatibility with high concentrations of  $I_2$ . The Filter Flush Assembly consists of a female Luer lock, which interfaces with the Teflon bag male Luer lock, and a female Swagelok at the other end with the ability to connect to the vent port of the PWD Microbial Filter, Fig. 8.

**Figure 6. Teflon Bag filled with 40 ppm  $I_2$**

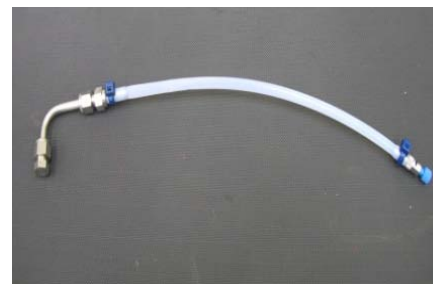
In order to ensure the  $I_2$  injection would be successful, the team needed to take into consideration the effects of high concentrations of  $I_2$  injected into the noncompatible filter media. Subsequently, the PWD team worked with the JSC Water Quality group to determine the amount of flushing required to completely clear out the residual  $I_2$  from the filter after injection. The JSC Water Quality group tested the Nylon 6,6 media with 40 ppm of  $I_2$  and determined that at least 10 L of water must flush through the Micro Filter in order to desorb the chemical from the filter media. These results were critical, since the Microbial Filter absorbs  $I_2$  and desorbs  $I^-$ , both of which are hazardous for crew consumption. The crewmember iodine ingestion limit is 0.02 mg/L of Iodine, either  $I_2$  and  $I^-$ .<sup>2</sup> The 10 L flush quantity derives from the filter ability to desorb  $I_2$  and  $I^-$  under the required crew consumption limits.

**Figure 7. Filter Flush Assembly**

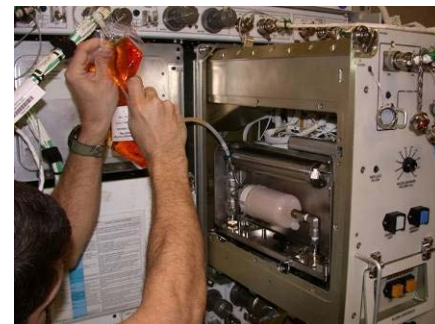
**Figure 8. PWD Engineering Development Unit.**

(Mocking the iodine injection procedures into the PWD Filter ORU Microbial Filter vent port.)

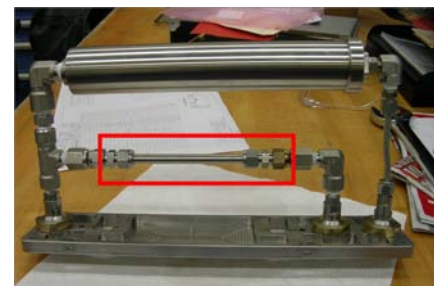
In the event that the Microbial Filter did not recover with the deiodinated water 10 L flush, the PWD team conceptualized a recovery backup plan. The PWD Tube Assembly (Fig. 9) was designed to replace the Microbial Filter within the PWD Filter ORU, if the filter was not fit for use due to the inability to desorb all the highly-concentrated  $I_2$ . The crew would only use the PWD Tube Assembly in worst case scenarios to recover the PWD, since removing the PWD Microbial Filter would mean that the water would no longer filter bacteria. Therefore, the PWD could still deliver water to the crew, but there would always be a risk of illness to a crew member

**Figure 9. PWD Filter Tube Assembly (boxed in red)**

because the Microbial Filter would not be in line for a water dispense. To date, the PWD Tube Assembly has never been used.

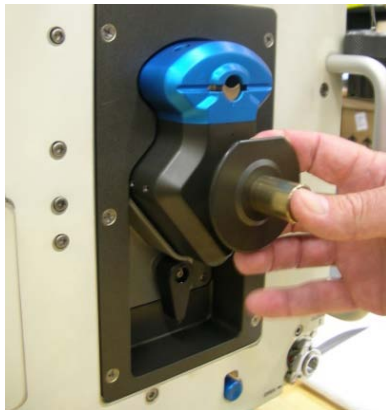
On June 6, 2009, the crew reported to Houston Mission Control Center (MCC) that the PWD stopped dispensing. One possible cause for a no dispense scenario includes a not fully active Package In Place (PIP) Switch. The PIP Switch resides behind the Beverage Adapter (see Fig. 11 and 12). The PIP Switch is a safety feature for the PWD, designed to prevent inadvertent dispense. The PIP Switch ensures that a food or drink package is in place before a dispense can occur (see Fig. 12). The PIP Switch activates via a plunger on the back of the Beverage Adapter, which fully extends when a food or drink package is in place, signaling the switch to allow a dispense to occur (see Fig. 13).

**Figure 11. PWD Beverage Adapter Extended**

To validate the cause for the PWD malfunction, the team recommended that a crewmember use their finger to lightly press the PIP Switch, which would confirm that a dispense could occur with switch activation. The crewmember reported back that when they manually pressed the PIP Switch, the PWD began to dispense nominally. This verified why the PWD stopped dispensing, but did not establish a root cause for the Beverage Adapter Plunger failure to fully extend and actuate the PIP Switch. While the team continued to investigate the anomaly, the Operational Support Officer (OSO) recommended a temporary resolution to the problem. The OSO requested the crew add a small layer of tape on top of the PIP Switch to increase the area between the Beverage Adapter Plunger and PIP Switch. This would allow the plunger to make contact with the switch and actuate a dispense (see Fig. 14). This temporary workaround allowed the crewmembers to continue to use the Beverage Adapter nominally, while troubleshooting continued on the ground.

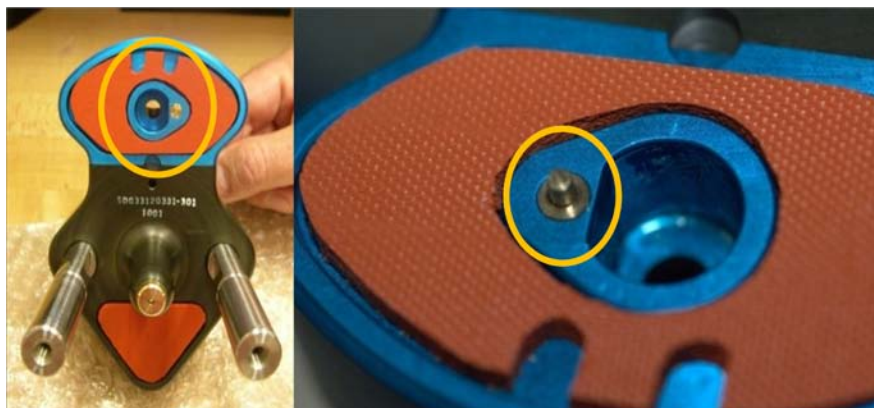
**Figure 13. Back Side of the Beverage Adapter, Beverage Adapter Plunger (ORANGE)**

Although the temporary workaround was a good short-term fix, team concerns remained regarding the untested and unknown stresses induced on the PIP Switch, due to the off-nominal configuration of the layer of tape on the switch. The team requested a stress analysis to verify that the tape configuration on the switch was safe for continued use. The stress analysis found that the life of the PIP Switch potentially reduced from 1,000,000 cycles to less than 5000, if the switch continued in this off-nominal configuration. The PWD team created instructions for tape removal and a return to nominal switch configuration, while continuing to research the length of the Beverage Adapter plunger more closely.
