Failure Analysis in Space: International Space Station (ISS) Starboard Solar Alpha Rotary Joint (SARJ) Debris Analysis

¹ *National Aeronautics and Space Administration, Kennedy Space Center, USA;*

Failure Analysis in Space

International Space Station (ISS) Starboard Solar Alpha
Rotary Joint (SARJ) Debris Analysis

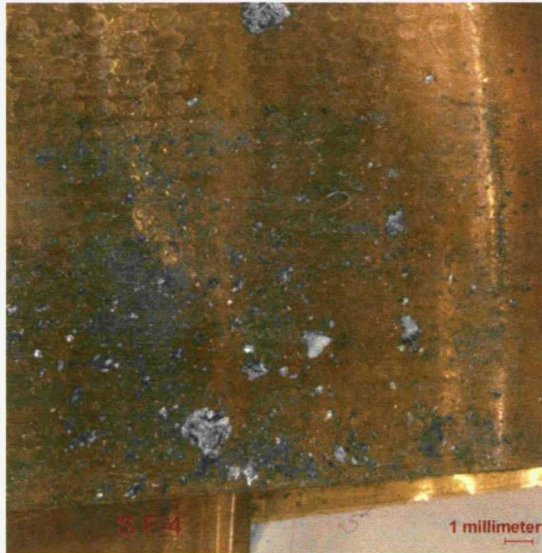
6.3X

- Wide particle size distribution.
- Distinct particle morphologies.
- Scale bars are 1mm.

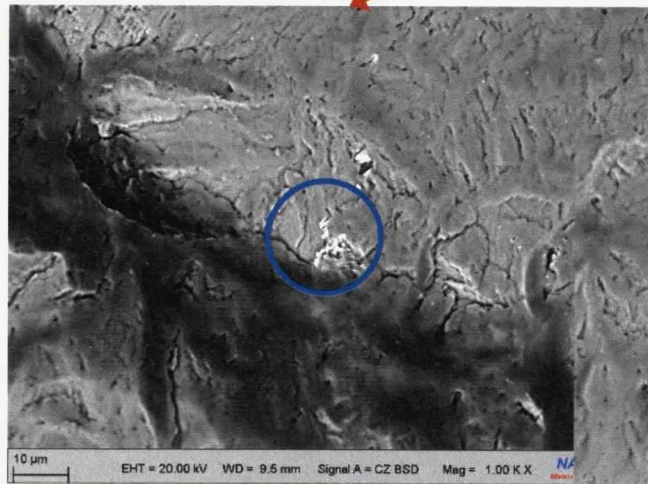
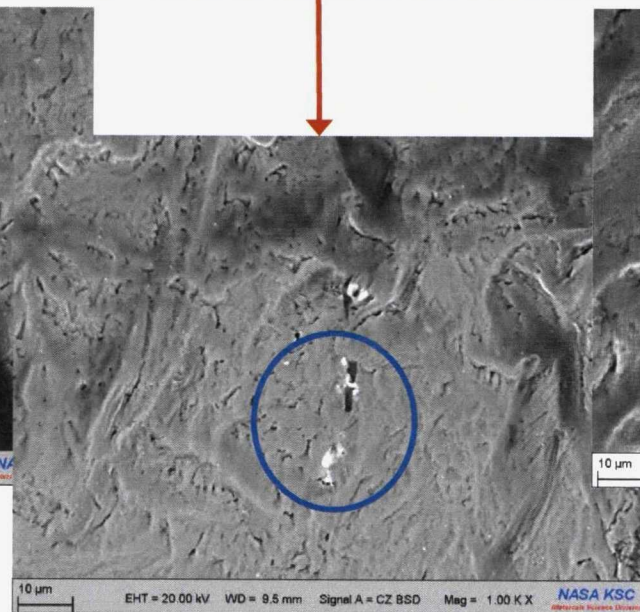
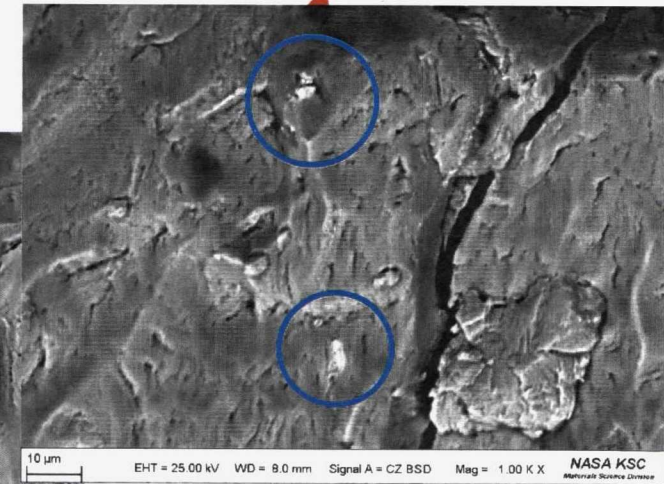
SEM images showing the 3-dimensional topography of the SARJ fragments. Note the relatively flat fracture path and the sharp, perpendicular edges.

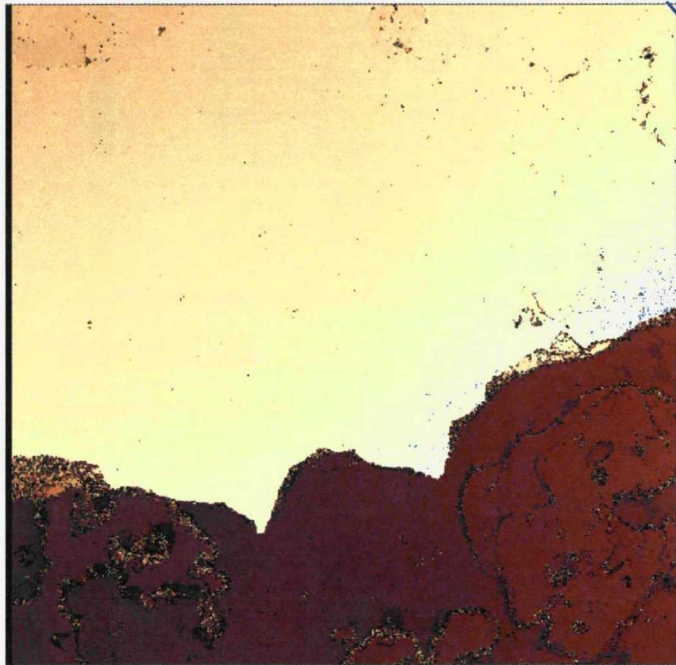
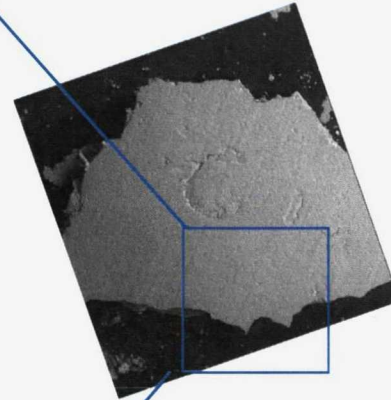
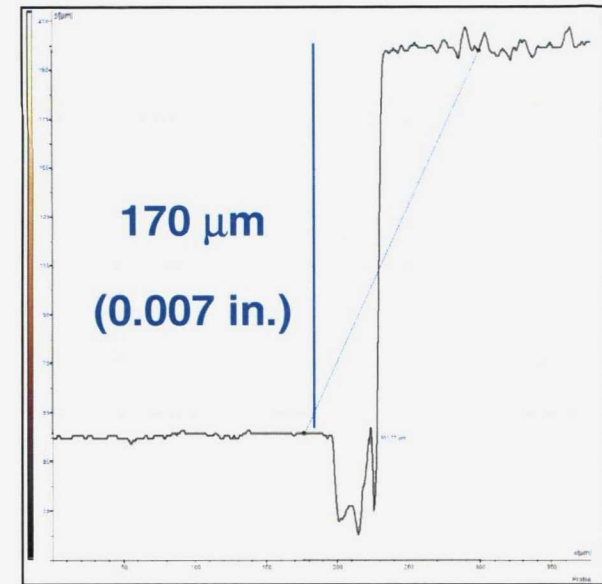
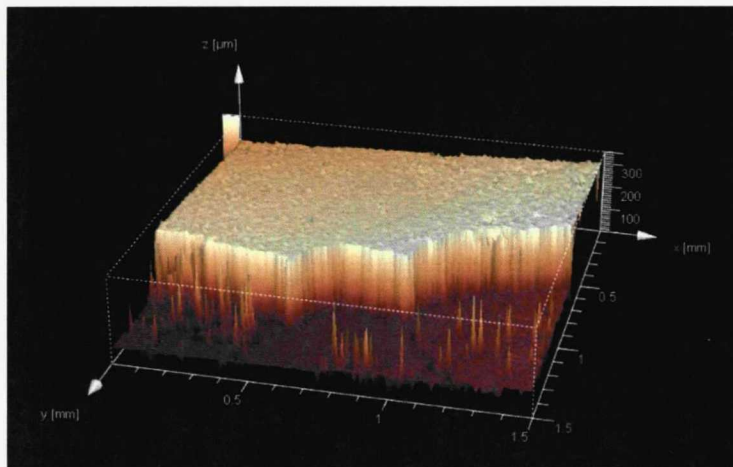
Typical confocal topographical images (2D, 3D) and resulting chart.

Confocal microscopy was used for in-situ (non-destructive) thickness measurements at 100X magnification of several particles.

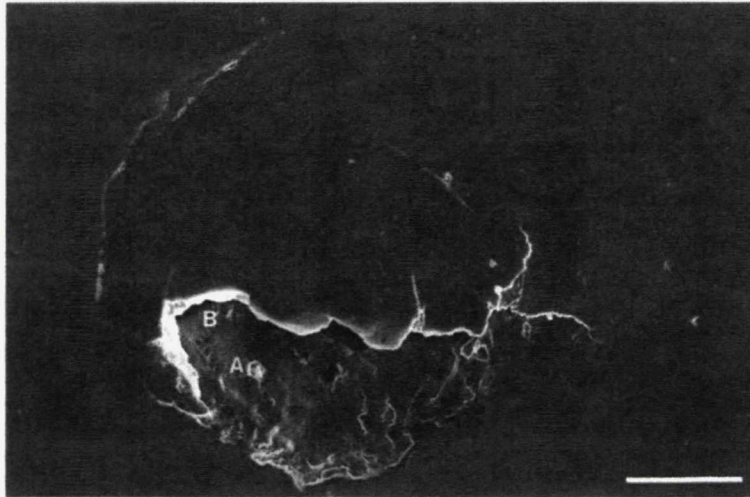
- Contact stress fatigue, i.e. spalling, with subsurface initiation:
 - Location of origin – “Short distance below surface, usually at a nonmetallic inclusion”
 - Initial size – “Small”
 - Initial shape – “Irregular”
 - Crack angle with respect to surface – “Roughly parallel at bottom, perpendicular at sides”
 - Apparent occurrence – “Sudden”

Image and text from Wulpi, D.J., *Understanding How Components Fail*. ASM International. 1985. p. 199.
