Pressure Testing of a Minimum Gauge PRSEUS Panel

Andrew E. Lovejoy¹ and Marshall Rouse²
NASA Langley Research Center, Hampton, VA 23681

Kim A. Linton³ and Victor P. Li⁴
The Boeing Company, Seal Beach, CA 90740

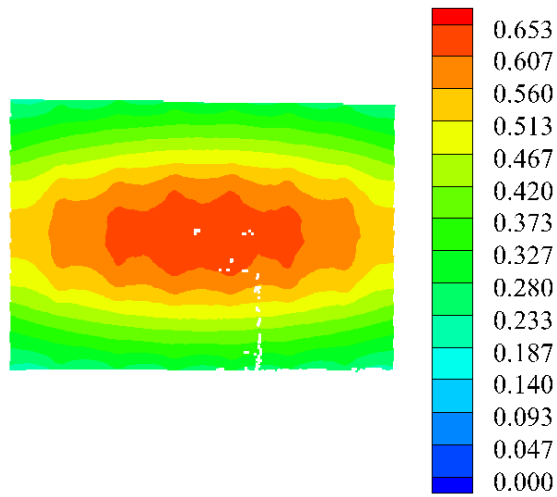
a) Experimental VIC

The VIC out-of-plane displacement plot from load level 2 (Fig. 15a) shows a slight offset in the displacement field. This offset suggested unsymmetric response of the frames during pressurization, and is a possible cause for the difference between analysis and load level 2 test response for some gages near the edge of the panel. Unsymmetric response of the frames could be due to initial geometric imperfections in the frames or boundary condition effects. Therefore, also prior to applying load level 3, the frames were checked for straightness using a twisted pair of white and black thread as shown in Fig. 23. This straightness check indicated that both frames appeared to be very straight, and therefore it is unlikely that initial imperfection of the frames caused this unexpected frame response. In order to monitor bending of the frames during load level 3, additional strain gages were added to either side of the frame tops at the center of the frame length, and were identified simply by numbers 42 – 45. Gages 42 and 43 are back-to-back on the frame top adjacent to the gages at the edge of the panel shown in Figs. 7 and 8, with gage 42 being located on the side of the frame toward the center of the panel. Gages 44 and 45 are back-to-back on the other frame top, with gage 44 being located on the side of the frame toward the center of the panel.

Fig. 15. Comparison of panel out-of-plane displacement contours at 2P. The outlined regions in b) and c) correspond to the portion of analysis plots covered by the VIC data.

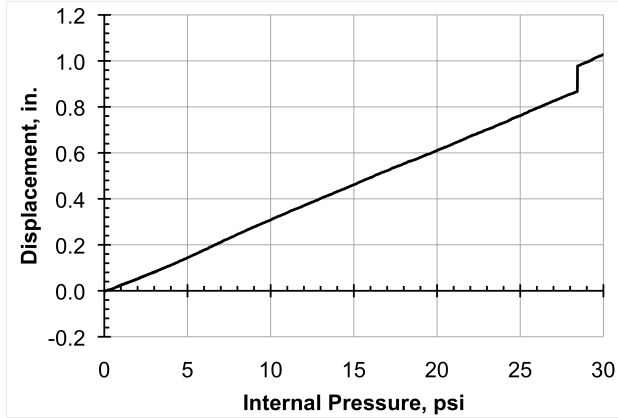
The pressure panel was tested to 30 psi for load level 3. The VIC system was available only for real-time monitoring during load level 3 due to errors that occurred with the VIC data recording that precluded post-processing. The laser displacement transducer out-of-plane displacement measurement is shown in Fig. 24. A jump in displacement occurred at a pressure of 28.44 psi, and was accompanied by a loud bang from the panel. This loud bang was the first audible sound emitted by the panel throughout the three test sequences. Loading continued up to 30 psi with no additional sounds emanating from the panel. Strain gage data is plotted in Figs. 25 – 30 for load level 3 and shows similar jumps in value at the 28.44 psi pressure level. Figs. 25 – 28 show the strain data for the same gages as presented for load level 2, with the same response up to 18.4 psi. Strain response continued in an expected manner up to a pressure of 28.44 psi. Specifically, the response for strain gage number 1, shown in Fig. 25 and located on the center stringer, indicates a failure of the stringer. The sudden strain drop in the center stringer gages shown in Fig. 25, coupled with the outer surface strain increases in the skin and flange gages adjacent to the center stringer shown in Figs. 26 – 29, are clear indications that the failure occurred in the center stringer.

Fig. 24. Load/displacement response for load level 3 at laser displacement sensor location.

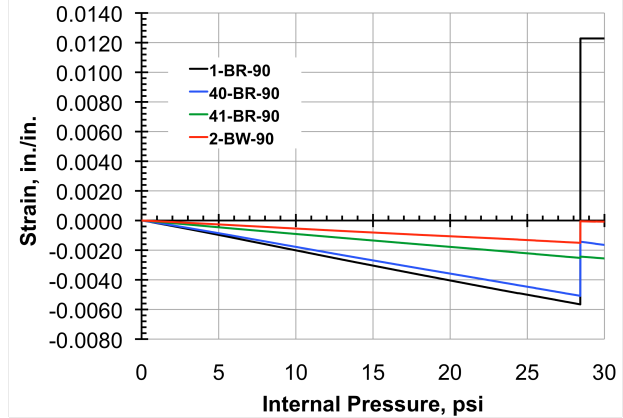
Fig. 25. Center stringer 90-degree strain gage response for load level 3.

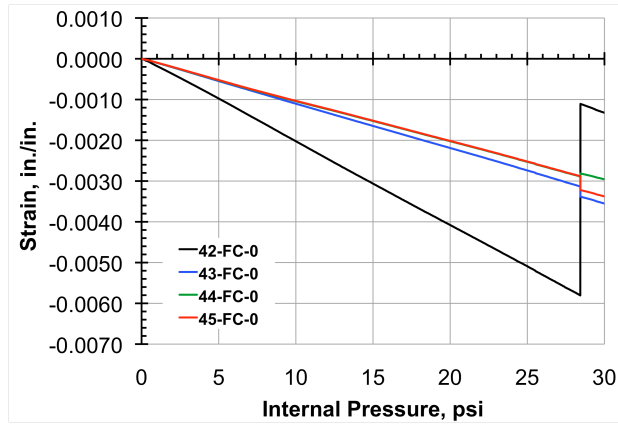
Fig. 30 shows the response for frame gages 42 – 45. Gages 42 and 43 clearly indicate bending of the frame. The lower strain value on gage 43 indicates that the frame is bending toward the edge of the panel until the center stringer fails, at which time the frame jumps to bending toward the center of the panel. Gages 44 and 45 show that the other frame does not exhibit any bending until after the center stringer fails, as the strain plots are coincident up to failure of the center stringer. After failure of the center stringer, this frame also bends towards the center of the panel. This unsymmetric response of the frames exhibited during the test is contrary to the finite element analysis, which predicts that both frames exhibit symmetric behavior and bend toward the center of the panel throughout the entire pressurization sequence.

Fig. 30. Frame 0-degree strain gage response at frame center tops for load level 3.
