## 47th AIAA/ASME/SAE/ASEE Joint Propulsion Conference & Exhibit

### Lessons Learned from the Space Shuttle Engine Hydrogen Flow Control Valve Poppet Breakage

Abstract authored by Hugo E. Martinez, in collaboration with John Albright, Stephen Damico, and John Brewer of NASA's Johnson Space Center, Engineering (EP4)

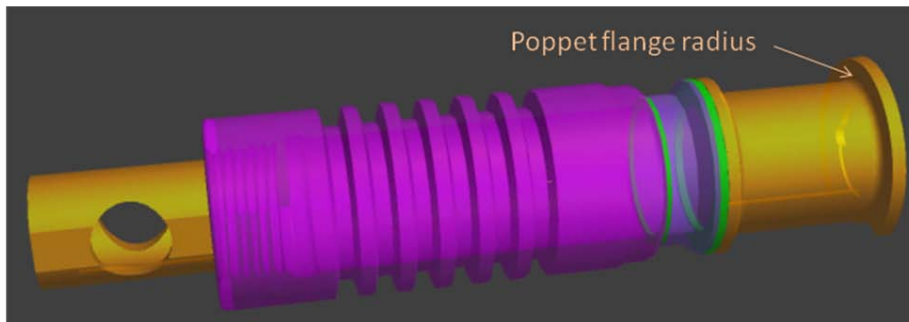
Figure X: FCV Poppet and seal assembly

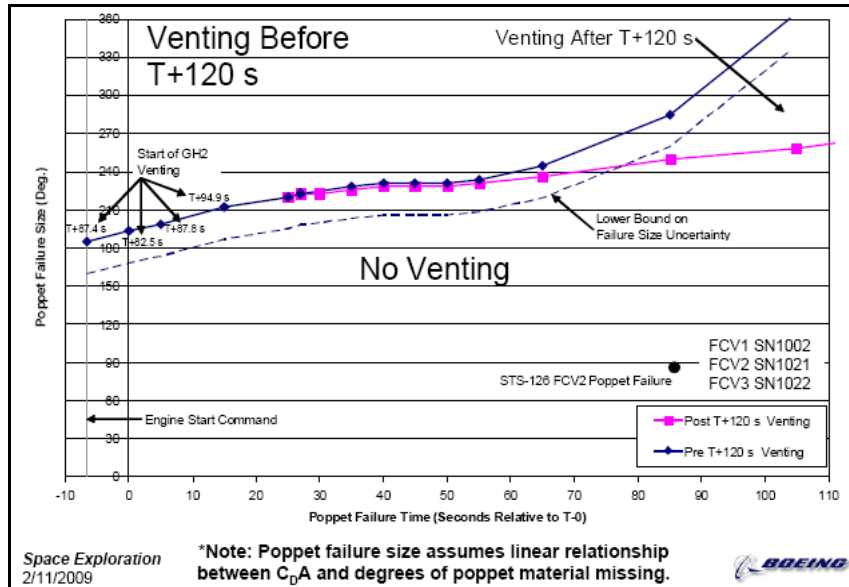
The ET pressure prediction model was used to determine the size of poppet circumference break needed to produce venting earlier than 120 seconds. This tool is used every flight to perform ET pressure predictions. STS-126 pressure profile after the poppet was broken was used to calculate the discharge coefficient ( $C_D$ ) of a broken poppet. That  $C_D$  was then used to calculate mass flow rate for any size poppet break. A parametric analysis was then run for one single poppet failure, varying the size of the poppet break and the time during flight that the poppet failed. From that data the chart in Figure X was developed showing the size of the poppet break as a function of mission elapsed time necessary to produce relief valve cracking prior to 120 seconds from lift-off. Fig. X shows that a poppet break of 150 to 180 degrees or larger would produce tank venting if it happened prior to 30 seconds into flight. After approximately 30 seconds single poppet breaks greater than 220 degrees would be required to produce venting.

**Figure X: Risk assessment analysis for overboard GH2 venting during first 120 sec of flight resulting from poppet failures given failure size and time of occurrence.**

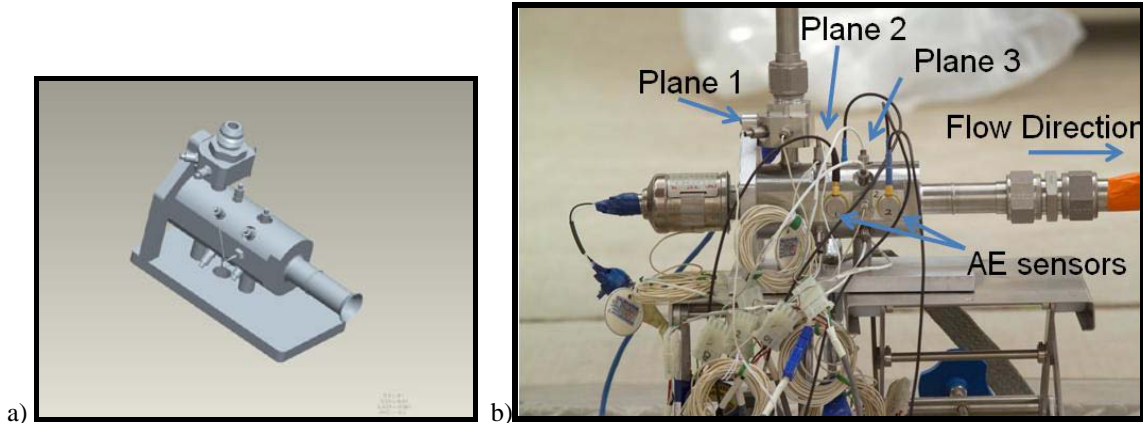
The solution was to build a ‘battleship’ FCV housing, see figure X. This housing was machined to match the current configuration FCV housing and outlet tube. The added thickness allowed each measurement to be custom fitted into the housing and sit flush with the flow stream.

**Figure X**– a) Battleship test fixture design model, b) Battleship test fixture shown with the three instrumented planes. Also shown are the acoustic emission sensors mounted on the flat side of the battleship. NOTE: 2 more acoustic emission (AE) sensors are mounted on the other side of the Battleship that mirror the ones shown.

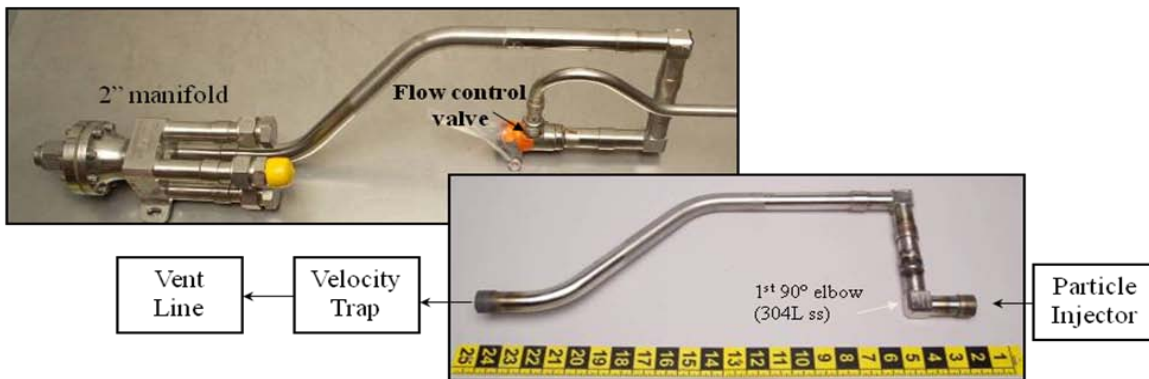
Figure X: WSTF FCV and particle injector Test Setup

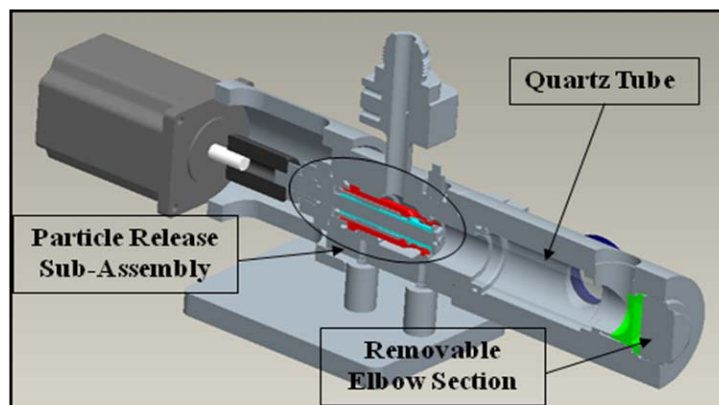
At the Stennis Space Center (SSC) a mock up of the ET line was created and particles released into the flow stream of hydrogen at flight like conditions. Poppet particles were filmed by high speed cameras at locations before and after the critical elbow. 194 particles were released during testing with particles ranging in size from 45 to 180 degrees of circumference and up to twice the mass of the STS-126 particle. On the 194th test, with a particle similar to STS-126 in size, the test article was ruptured. Velocities correlated very well to the analytical predictions. This test data was able to give a good statistical evaluation of the likelihood of getting an impact in the narrow orientation and velocity combination to produce the maximum effect. Another important conclusion derived from the particle impact tests and the SSC test was the nature of the pipe rupture. In all cases the ruptures appear as a material crack of small area as opposed to a hole with missing material. This was important information when making assumptions to calculate potential pressurant mass leaking from the area of rupture.

Figure X: SSC Particle Release Test Article with Quartz tube for optical access

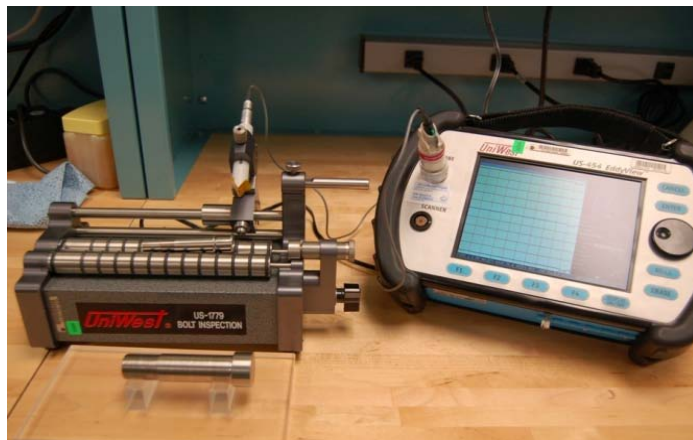
Following the STS-126 failure, other techniques were considered. Not having a clear understanding of the environment that drove the failure, and not having a forward fracture analysis, a critical crack size could not be determined. For this reason, a technique that could reliably detect the smallest crack size was desired. Borescope was known to be very limited as an inspection technique, but could be performed without removing the valve from the vehicle. During development of the x-ray imaging technique used on the failed FCV right after STS-126 landed, it was shown that, while it was possible to detect a broken poppet via high powered x-rays, the resolution for detection of small cracks did not exist. Computed Tomography (CT) on the fully assembled FCV component could detect a broken poppet more easily, but again it suffered from the inability to detect small cracks. Thus, it was concluded that disassembly of the valve was required in order to inspect for small cracks.

**Figure X:** Eddy Current Inspection tool
