Inspection for Damage to Carbon/Epoxy Composite Overwrapped Pressure Vessels

**NASA White Sands Test Facility
August 2010**

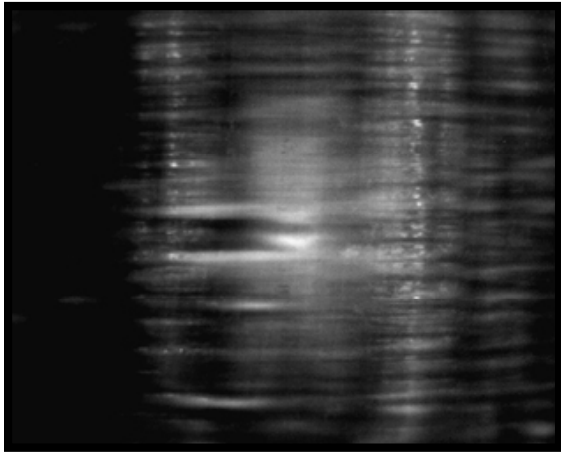
Circular impact site at center w/ delamination, damaged tow, and subsurface spreading around impact

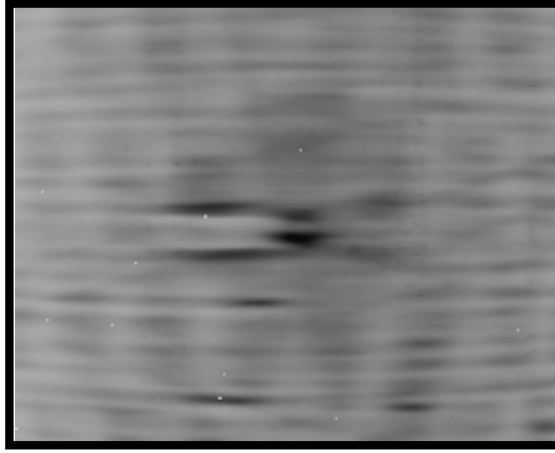
Damaged tow w/subsurface delamination shown as darker regions above and below impact site

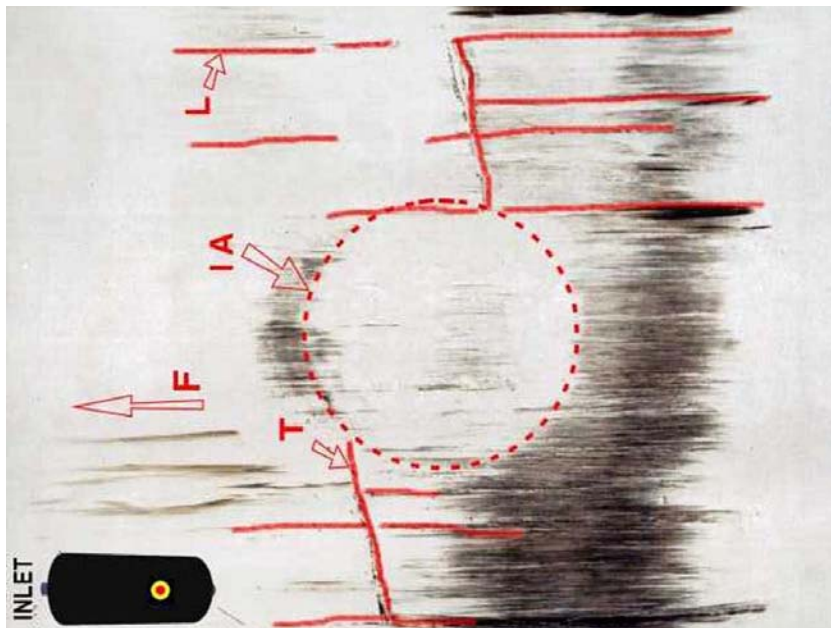
Small Cylinder, Unpressurized, 5 ft-lb Impact, 0.5 in. Tup

A low-energy impact to an unpressurized cylindrical COPV in the hoop region usually results in a shallow indentation. Note the transverse cracks emanating from the indentation edges and joining/ending at the longitudinal cracks parallel to the fiber winding direction. Typically there are no significant transverse cracks in the indentation itself at this energy level. This type of impact damage is near the visible threshold and is easily overlooked.

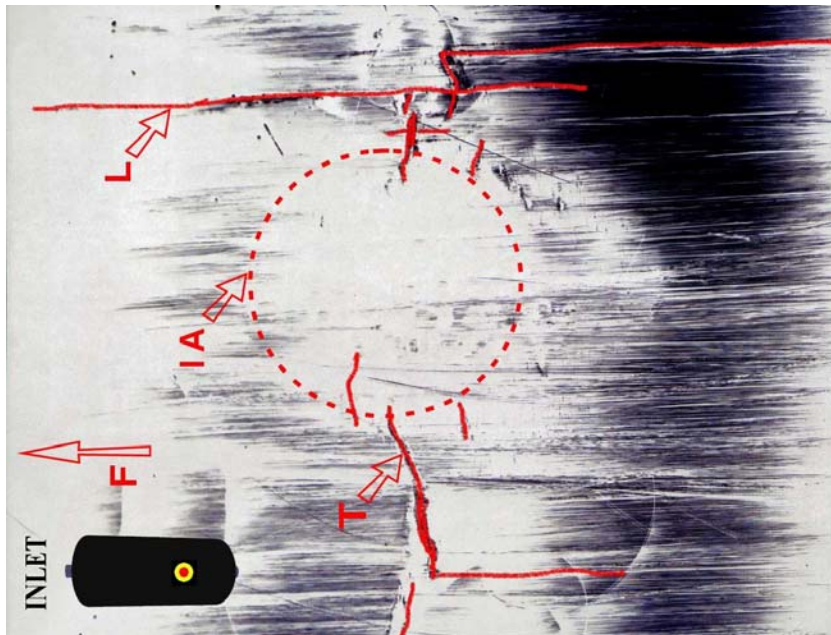
Small Cylinder, Unpressurized, 15 ft-lb Impact, 0.5 in. Tup

This is very similar to the previous example, except minor transverse cracking is now seen in the indentation. This was impacted at the damage threshold level.

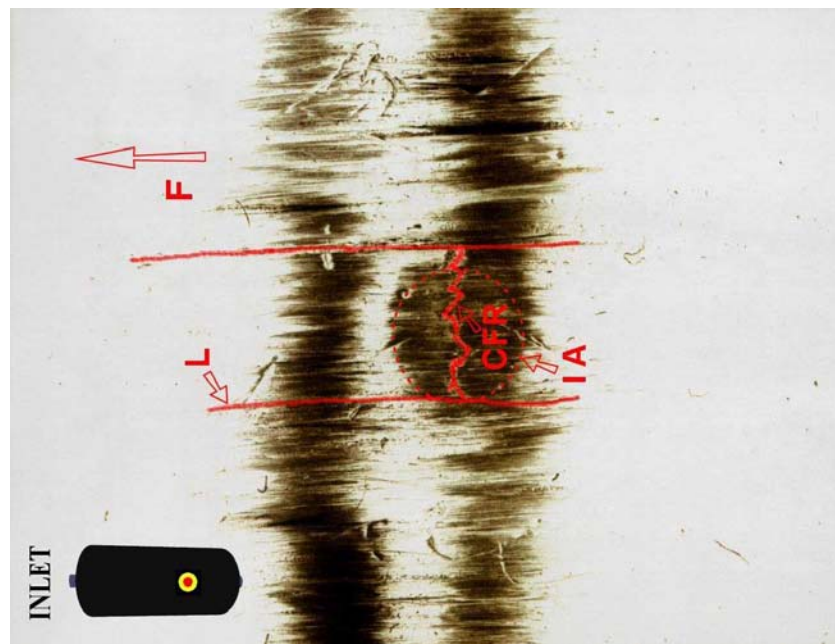
Small Cylinder, 6000 psi Hydraulic, 15 ft-lb Impact, 0.5 in. Tup

An impact to a hydraulically pressurized to MEOP cylindrical COPV in the hoop region usually results in a very shallow indentation. Note the continuous transverse crack bisecting the indentation and joining/ending at longitudinal cracks parallel to the winding direction. Trans-impact site cracking is a prominent feature of this type of impact damage and can result in fiber delamination. 15 ft-lb is the designated damage threshold level for this type of COPV.

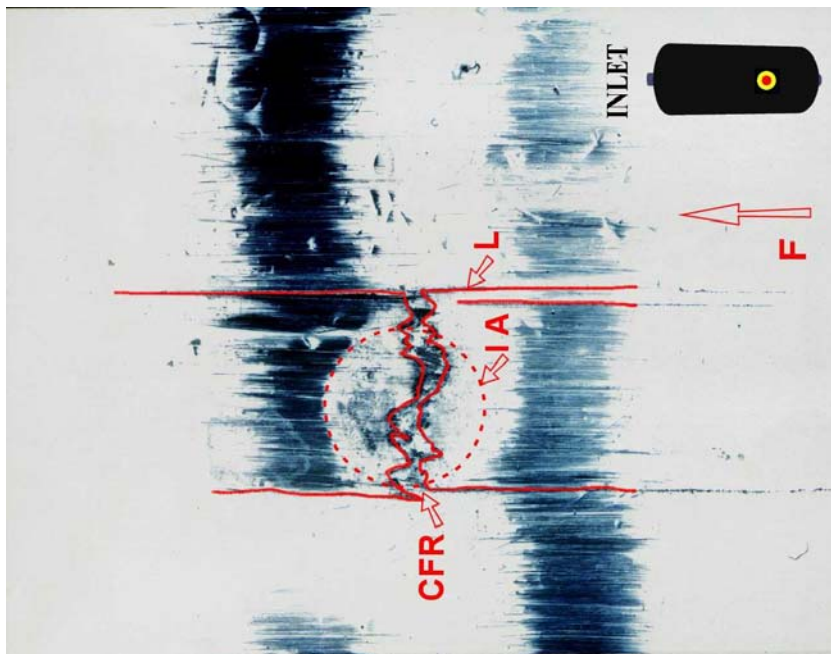
Small Cylinder, 6300 psi Pneumatic, 15 ft-lb Impact, 0.5 in. Tup

An impact to a pneumatically pressurized to MEOP cylindrical COPV in the hoop region usually results in a clearly visible indentation. Transverse damage site cracking and fiber low delamination are characteristic and more highly visible than the hydraulic case.

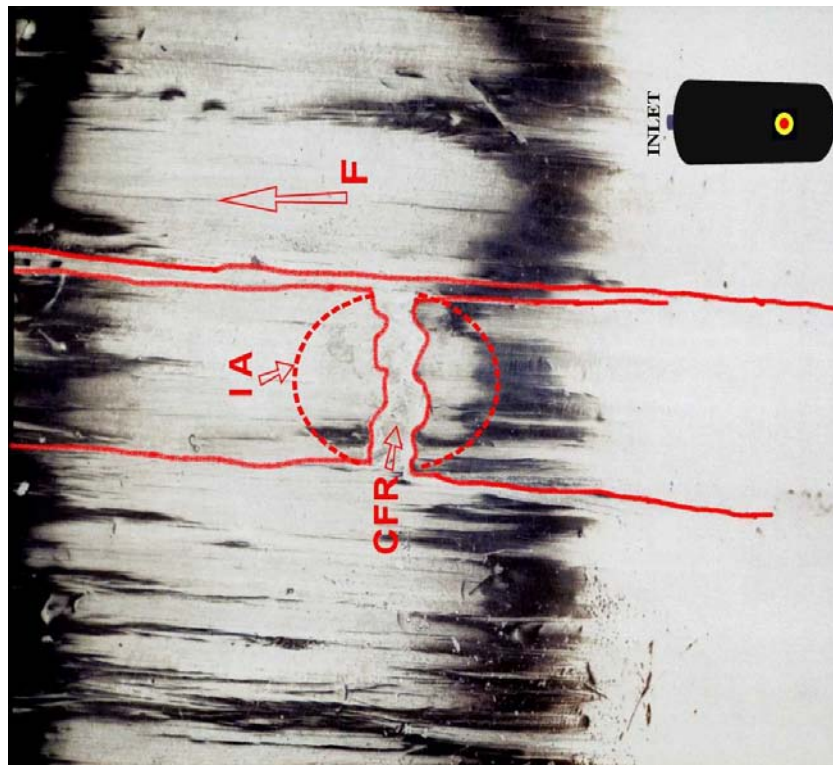
Small Cylinder, 6000 psi Hydraulic, 15 ft-lb Impact, 0.5 in. Tup

Another example of the same type of impact conditions as previous. Note the more highly visible transverse impact site cracking, separation and delamination. This impact resulted in a 31.1 percent degradation of strength with the resulting burst occurring just below the proof pressure level (7500 psig) for this type of COPV.

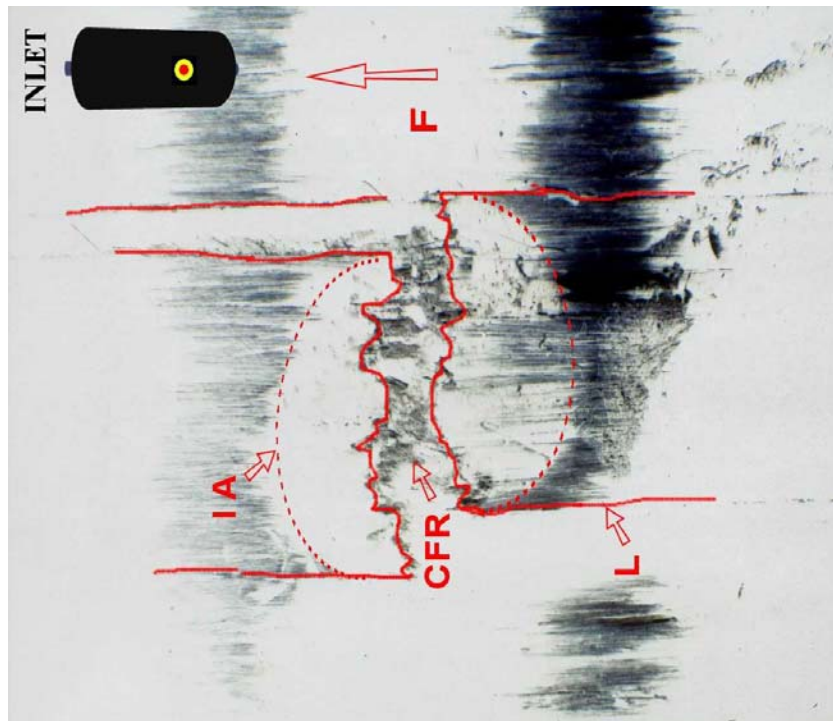
Small Cylinder, 6300 psi Pneumatic, 15 ft-lb Impact, 0.5 in. Tup

Another example of the same type of impact conditions as in a previous example. Here indentation, transverse damage site cracking, and delamination are more evident. This example indicates pneumatic damage is more visible than the hydraulic or unpressurized cases.

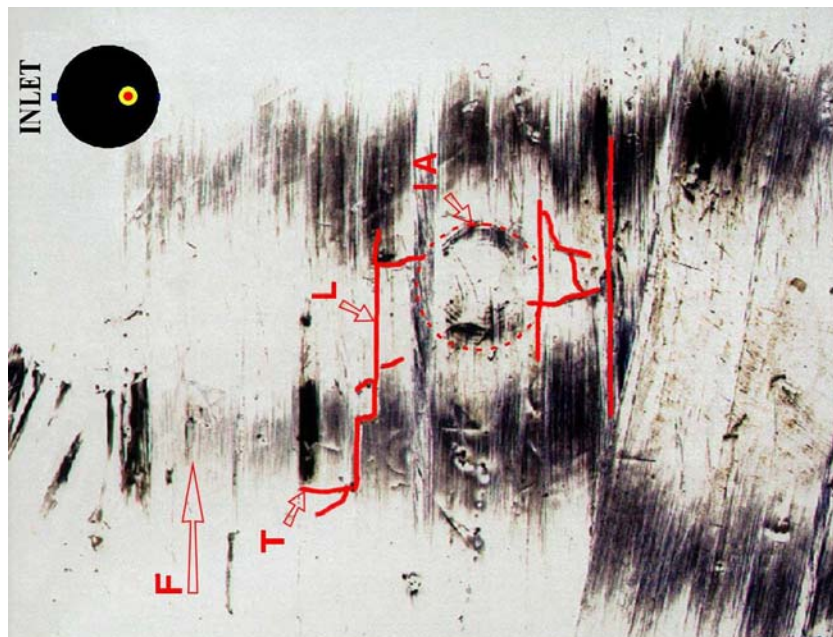
Small Sphere, Unpressurized, 25 ft-lb Impact, 0.5 in. Tup

A low energy impact to an unpressurized spherical COPV in the membrane region usually results in a shallow indentation. Note the transverse cracks emanating from the indentation edges and joining/ending at the longitudinal cracks parallel to the fiber winding direction. Typically, significant transverse cracks in the indentation itself are not found at this energy level. The concentric circular lines seen in the indentation are of unknown origin as the tup surface is basically featureless, and may be some sort of low energy resin response.

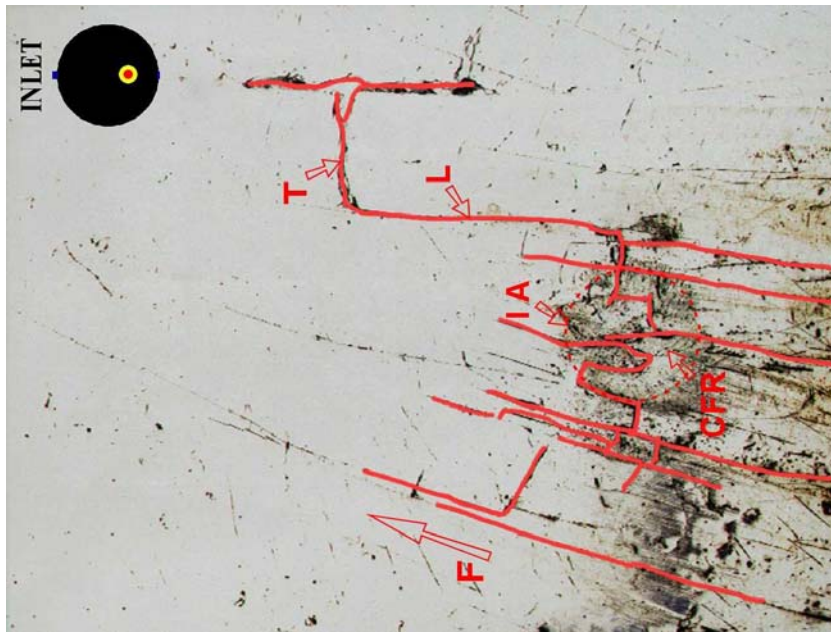
Small Sphere, Unpressurized, 35 ft-lb Impact, 0.5 in. Tup

A slightly higher energy level impact than in the previous example. In this case, the vessel was impacted at the damage threshold level, which resulted in more widespread cracking in and around the impact site. Note the transverse crack path in the impact indentation area is still discontinuous. This COPV failed just below its proof pressure level.

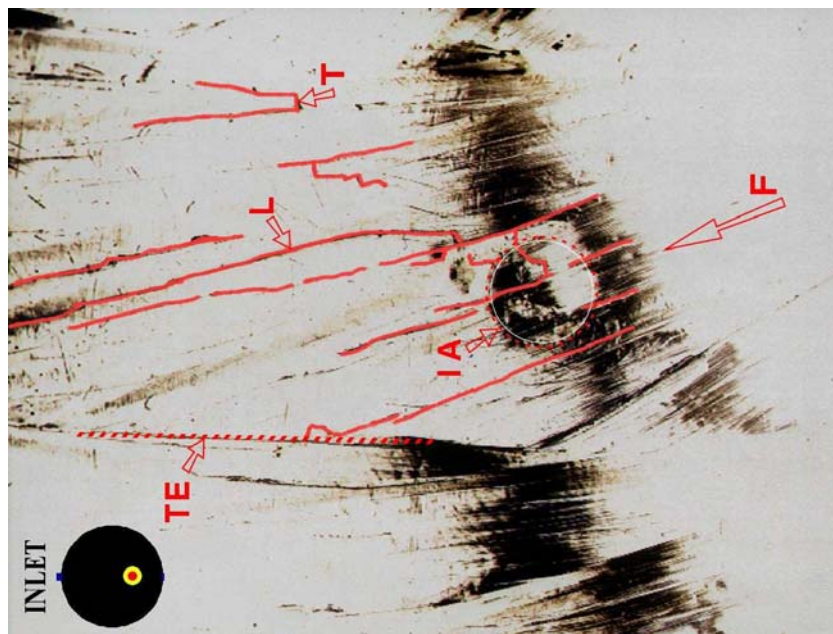
Small Cylinder, Unpressurized, 50 ft-lb Impact, 0.5 in. Tup

A higher energy impact to an unpressurized spherical COPV. Visible damage is not significantly different (or worse) than previous examples, but the resultant burst was well below the proof pressure. This is a good example of the statistical variation in visible damage. Even for a given energy level, several impacts can vary from easily detected to almost invisible and still have a significant effect on strength degradation.

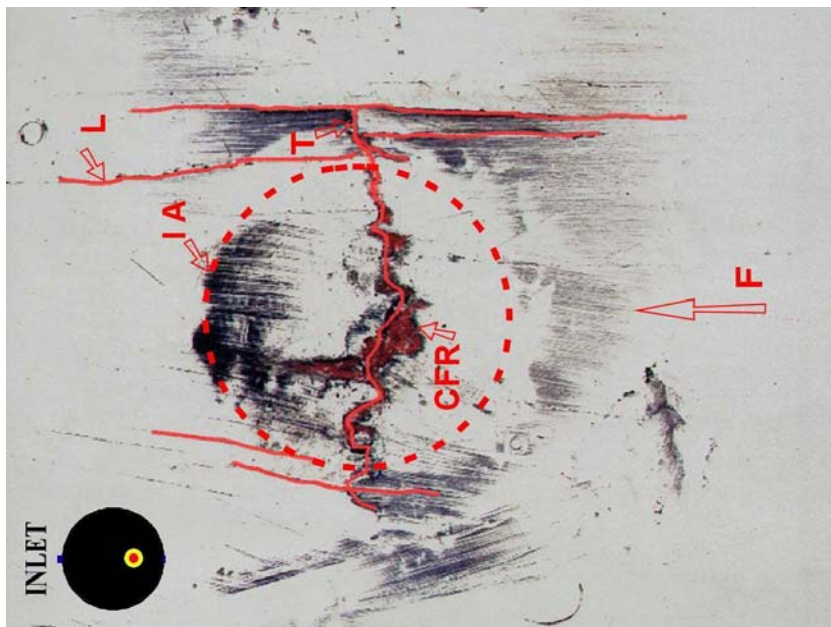
Small Sphere, 6000 psi Hydraulic, 35 ft-lb Impact

An impact to a hydraulically pressurized to MEOP spherical COPV in the membrane region normally results in a highly detectable impact indentation with full width transverse cracking. Outside the indentation, transverse cracking continues until joining/ending at longitudinal cracks that are running parallel to the fiber winding directions. This impact energy level, again represents the damage threshold level.

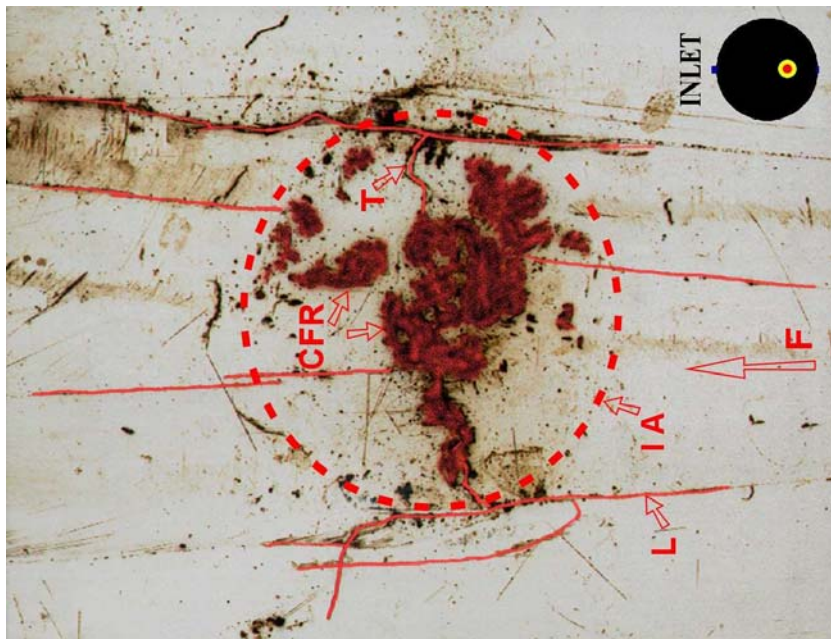
Small Sphere, 6000 psi Hydraulic, 35 ft-lb Impact

Another example of the same type of impact conditions as the previous one. Damage associated with the impact site is slightly more detectable under oblique lighting conditions.

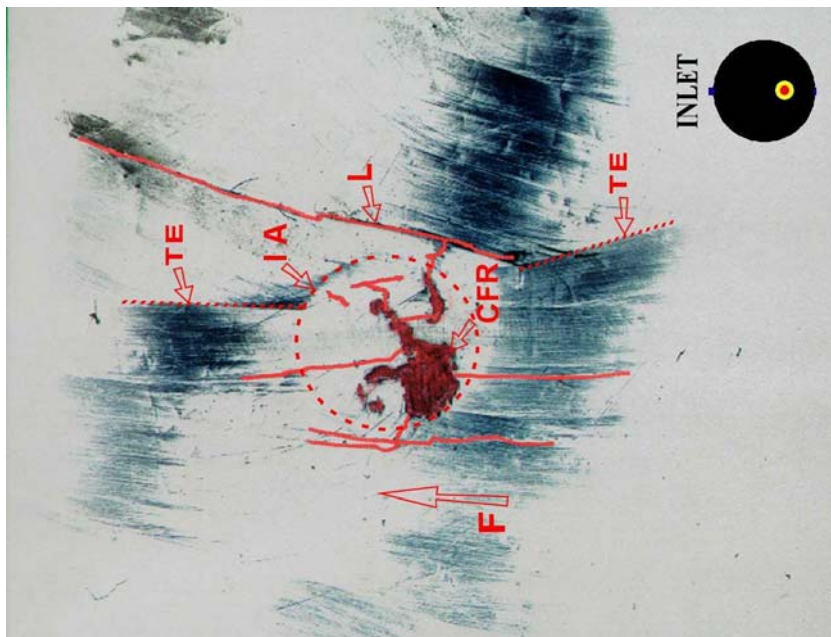
Small Sphere, 6300 psi Pneumatic, 35 ft-lb Impact, 0.5 in. Tup

Another example of the same type of impact conditions as previous only now using direct lighting. Indentation and transverse cracking are easily detected only not as clearly highlighted as before. Using both has a definite advantage.

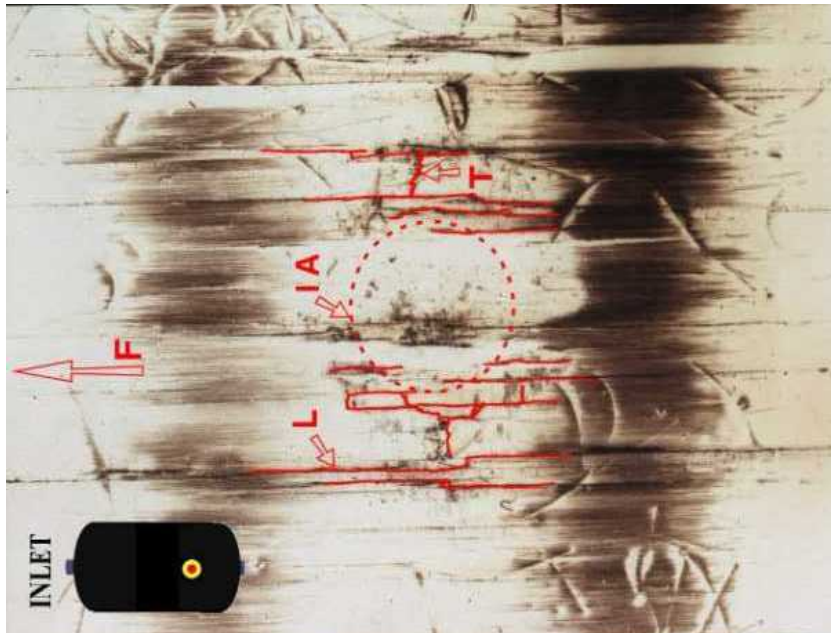
Large Cylinder, Unpressurized, 50 ft-lb Impact, 0.5 in. Tup

A slightly higher than damage threshold level impact energy example conducted on a large cylindrical COPV in the unpressurized condition. Lower level impacts produced very little visible damage. Damage seen consists of a shallow indentation with little or no transverse cracking. Longitudinal cracking is evident.

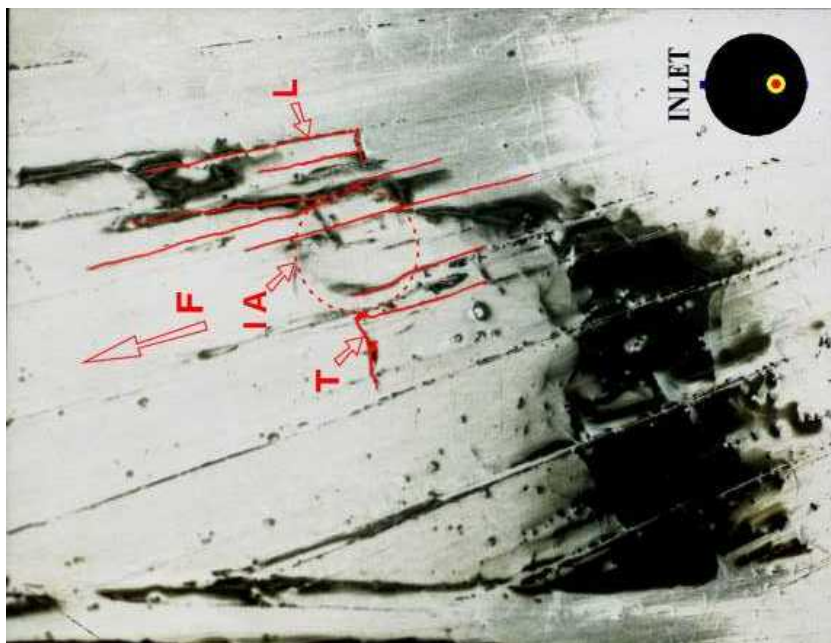
Large Sphere, Unpressurized, 25 ft-lb, 0.5 in. Tup

A low energy impact to an unpressurized large spherical COPV in the membrane region is almost undetected except for some associated fracture.

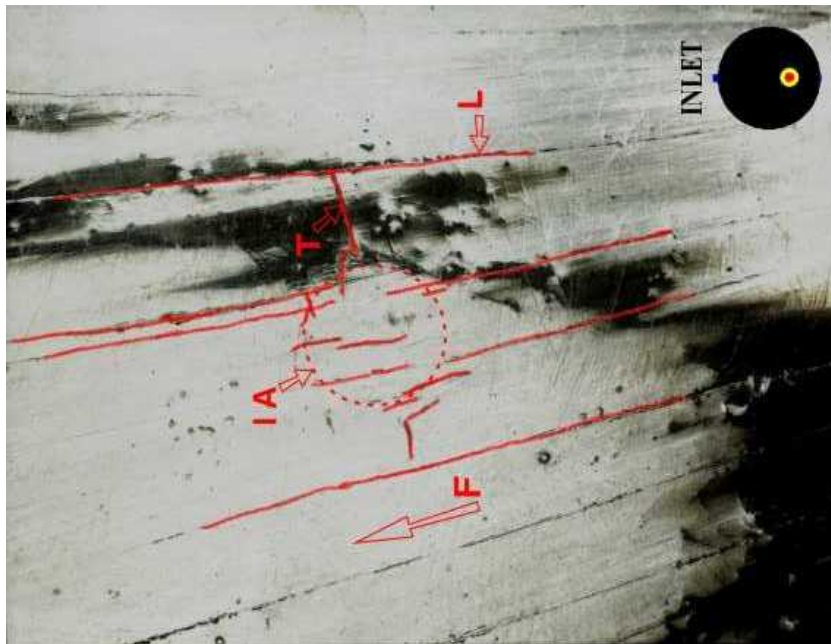
Large Sphere, Unpressurized, 35 ft-lb Impact, 0.5 in. Tup

A slightly higher impact energy to the same COPV (different location) produces some visible transverse cracking.

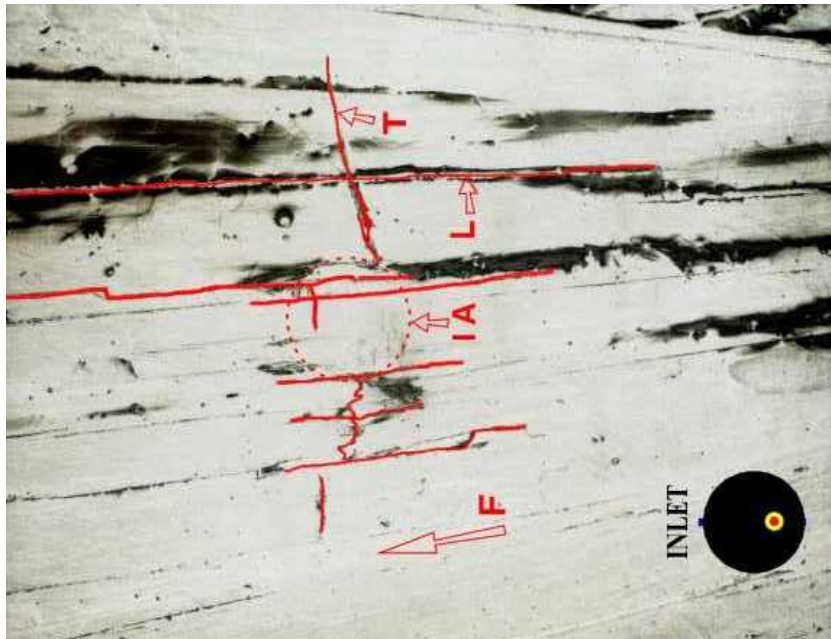
Large Sphere, Unpressurized, 45 ft-lb Impact, 0.5 in. Tup

A shallow indentation is now barely visible at a slightly higher energy level. Associated transverse cracking is visible connecting up with longitudinal cracks in the traditional manner.

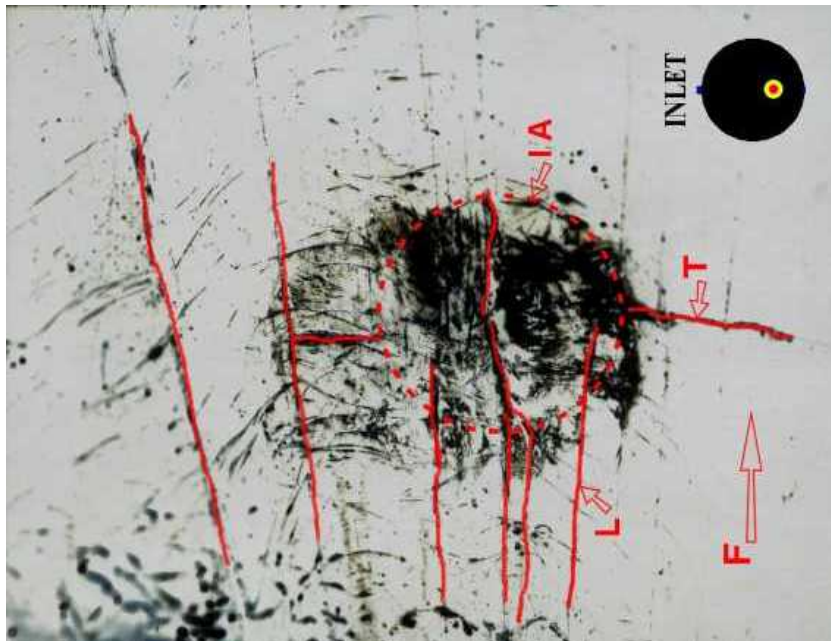
Large Sphere, Unpressurized, 100 ft-lb Impact, 0.5 in. Tup

A damage threshold energy level impact to an unpressurized large spherical COPV in the membrane region produces a highly visible traditional impact damage site (indirect light).

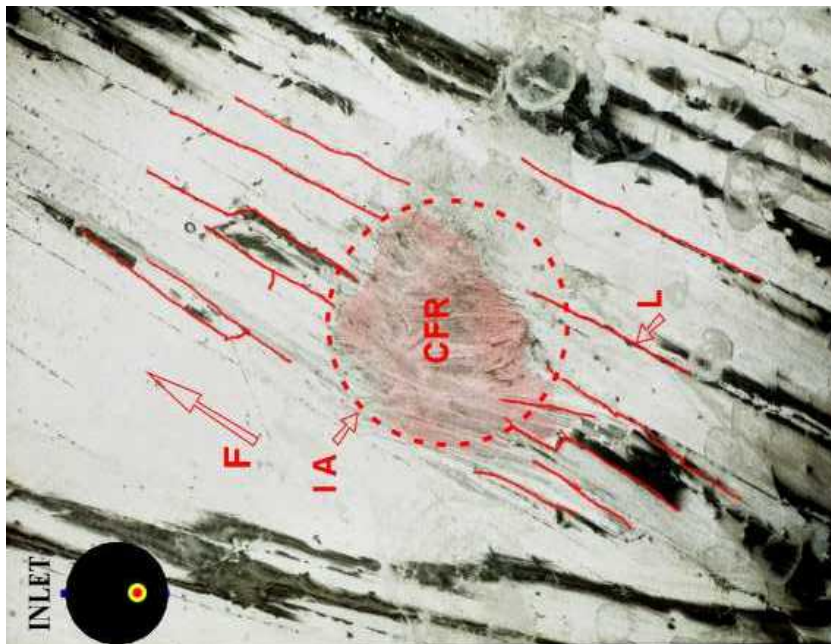
Large Sphere, 4500 psi Hydraulic, 15 ft-lb Impact, 0.5 in. Tup

A slightly higher impact energy level produces clearly evident mashed and distorted fiber in the damage site.

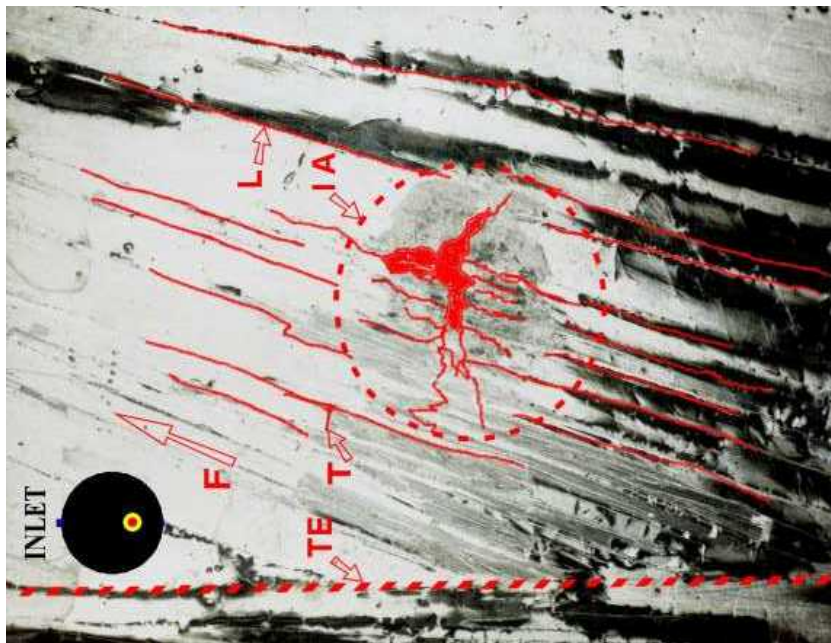
Large Sphere, 4500 psi Hydraulic, 35 ft-lb Impact, 0.5 in. Tup

An even higher impact energy level produces more of a traditional impact damage site with both transverse and longitudinal cracking. Compared to the unpressurized condition, one clearly sees the visible damage added due to pressurization.

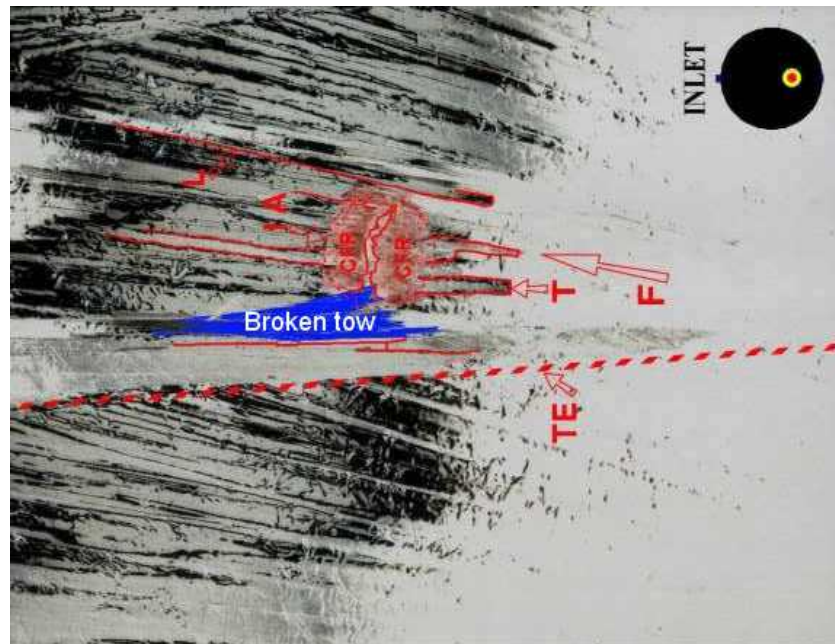
Large Sphere, 4725 psi Pneumatic, 100 ft-lb Impact, 0.5 in. Tup

An impact to a pneumatically pressurized to MEOP large spherical COPV in the membrane region results in a highly visible damage site composed of transverse fracture, tow detachment and delamination.

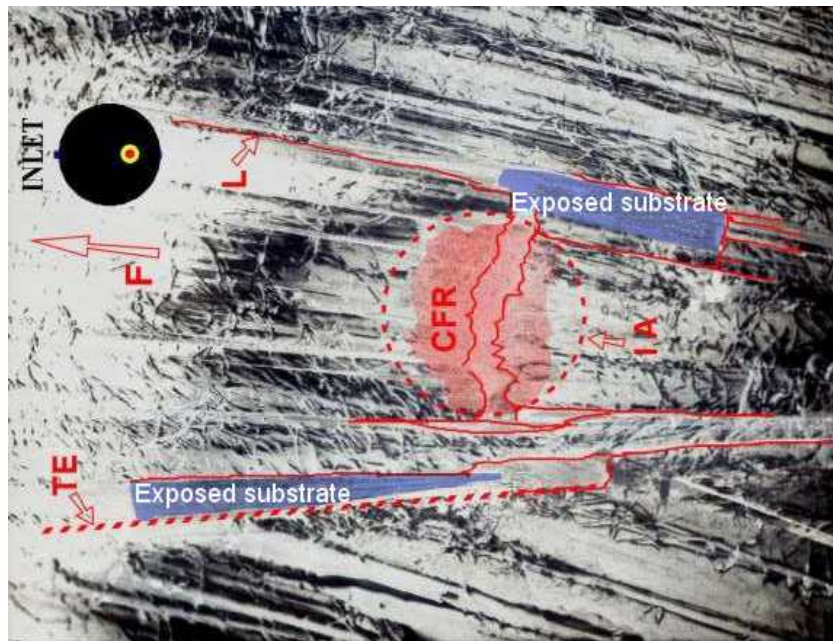
Large Sphere, 4725 psi Pneumatic, 100 ft-lb, 0.5 in. Tup

An impact to a pneumatically pressurized to MEOP large spherical COPV in the membrane region results in a highly visible damage site composed of transverse fracture, tow detachment, longitudinal cracking, and delamination.

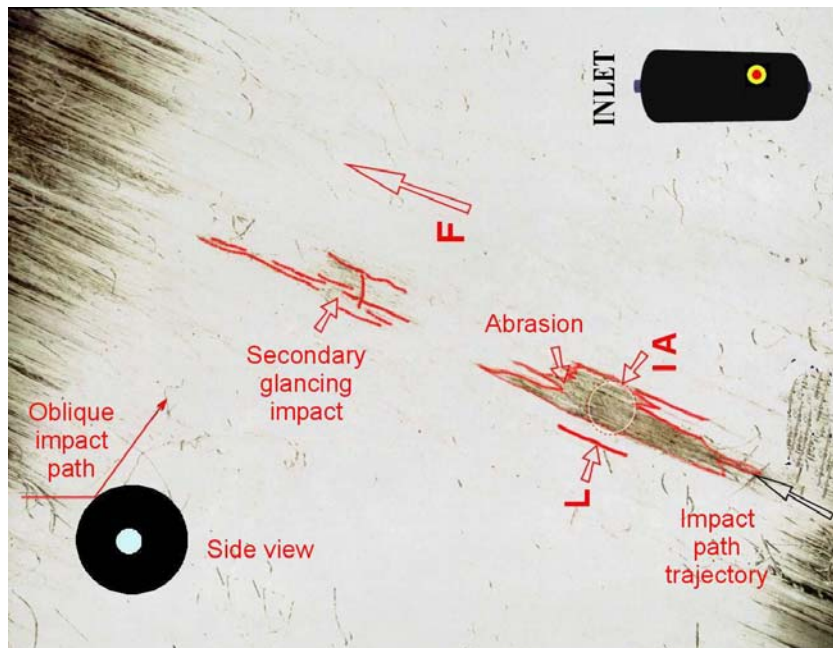
Small Cylinder, Unpressurized, Oblique Impact, 0.5 in. Tup

Shown is the case of an oblique (~45°) impact in the hoop region of an unpressurized cylindrical COPV. Initial impact is seen as a very pronounced scuff or smear. The point of impact is seen with some slight cratering or sliding type indentation with a second slight impact just ahead of it. This damage, while significant had no measurable effect on COPV burst strength. This example is shown as it represents a “real world” impact, such as that from the glancing blow of a dropped tool.

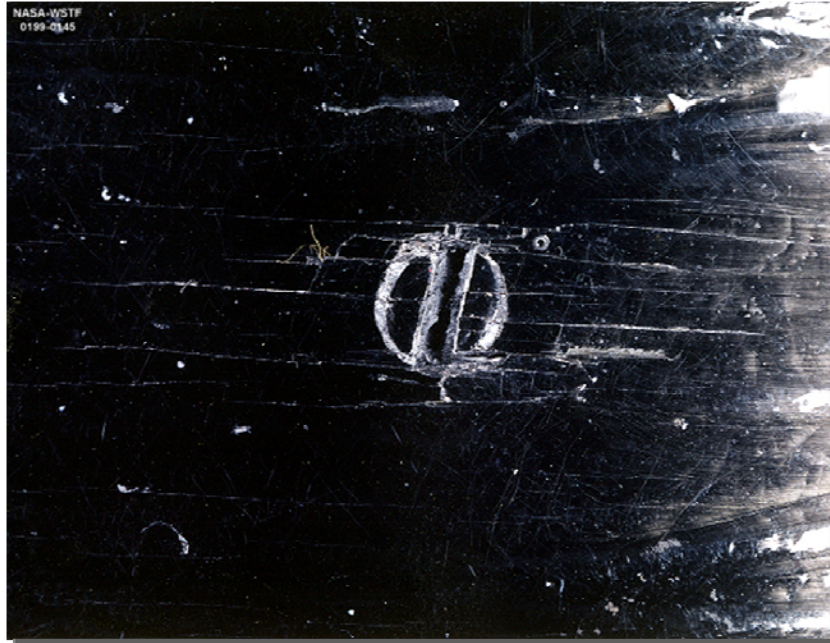
Small sphere, unpressurized, screwdriver tup

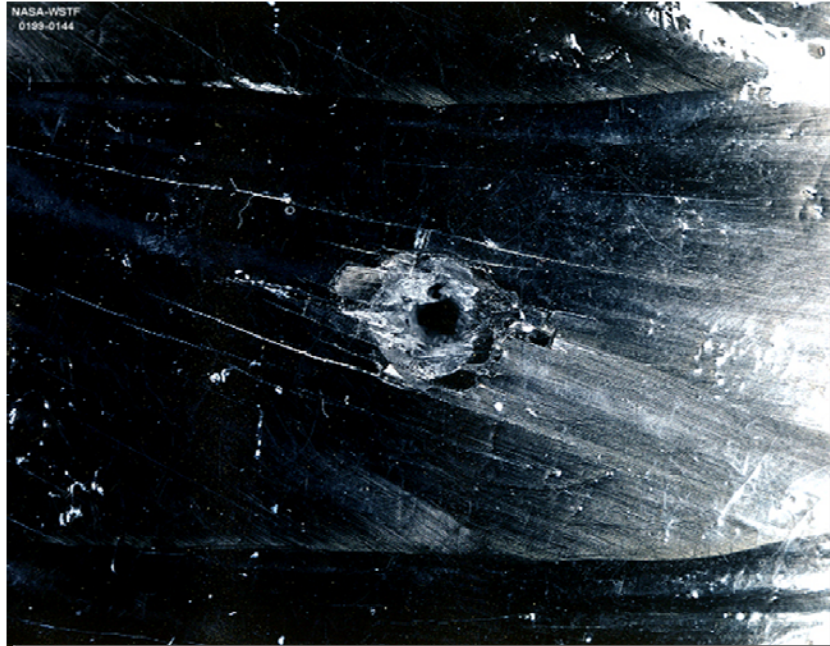
Small sphere, unpressurized, 0.25 in. hemispherical tup

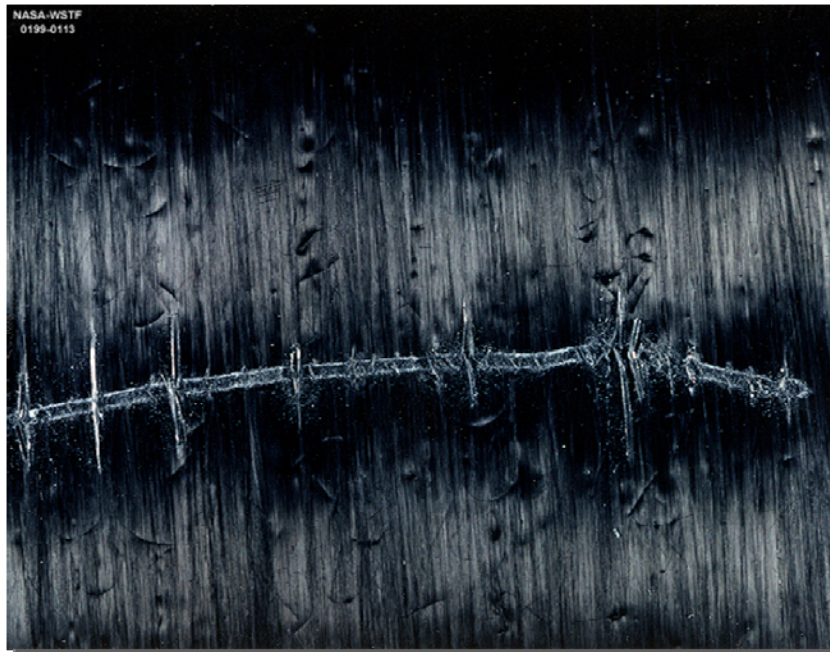
Small cylinder, significant scratch, transverse to winding direction

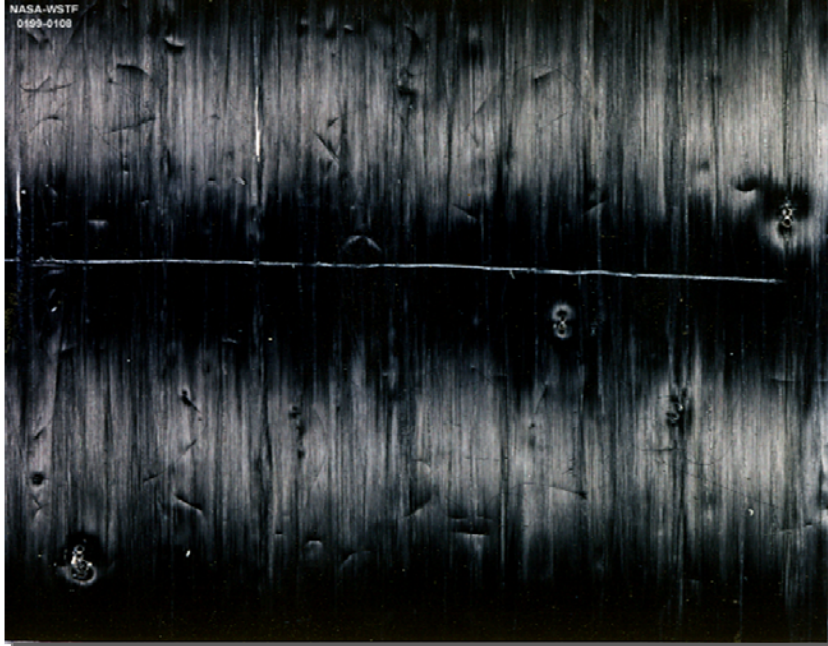
Small cylinder, cut, transverse to winding direction

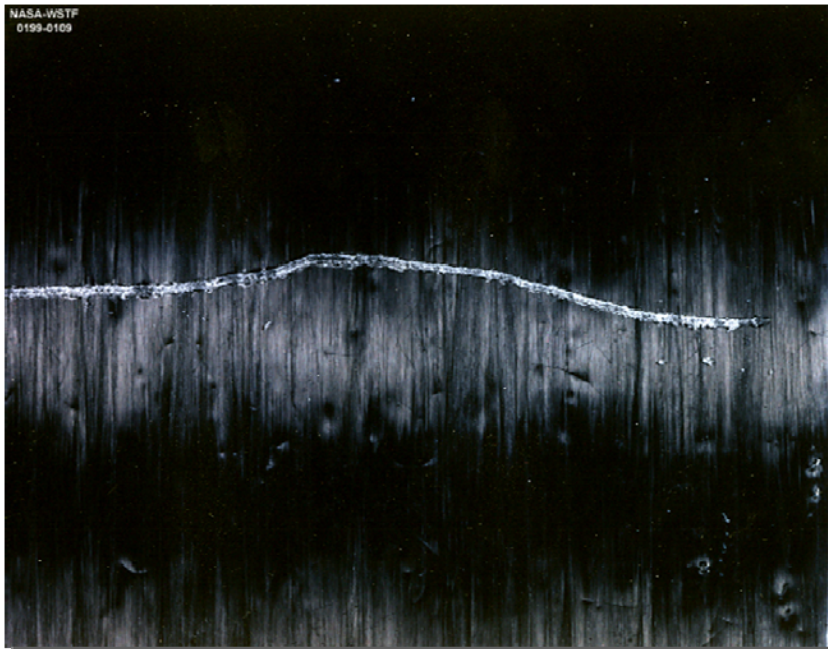
Small cylinder, significant cut, transverse to winding direction

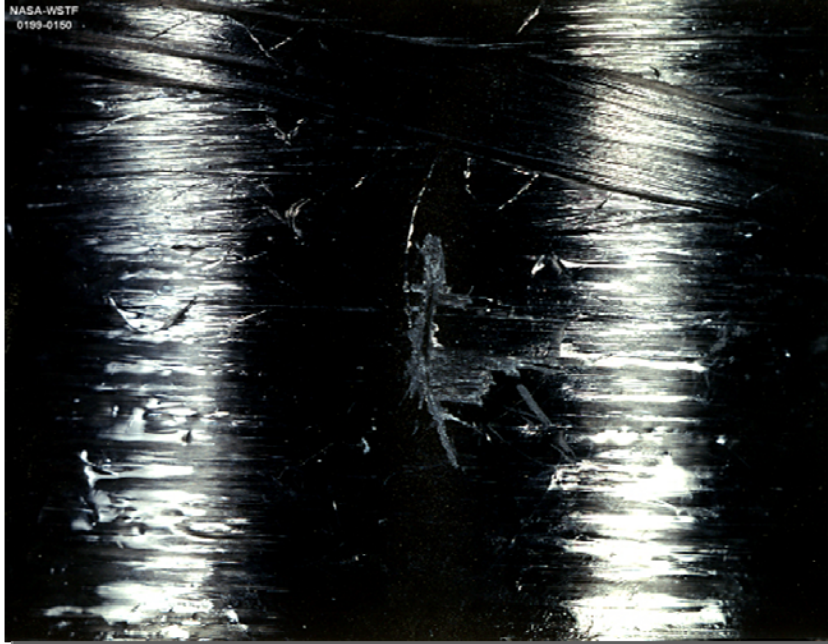
Small sphere, deep cut, transverse to winding direction

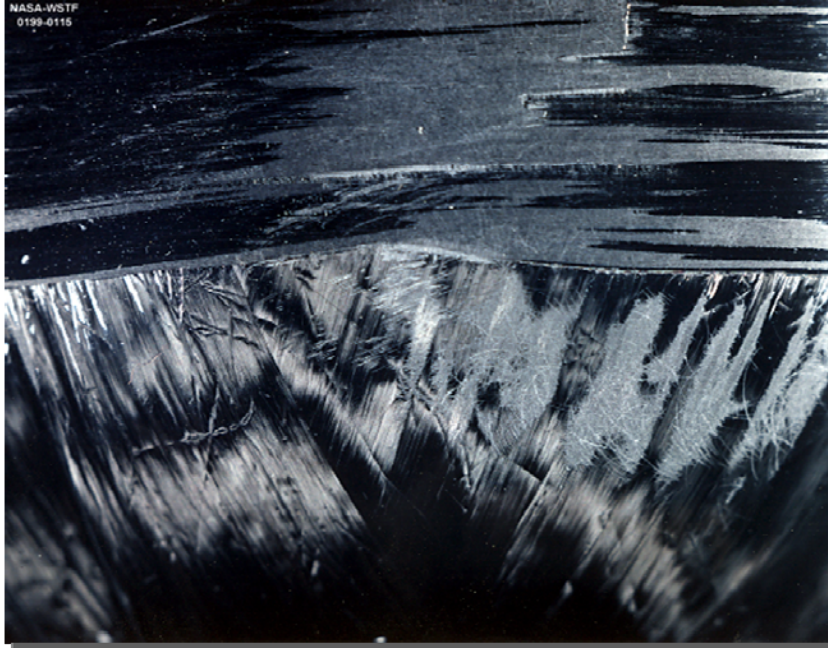
4.6 x 10 in. cylinder, abrasion

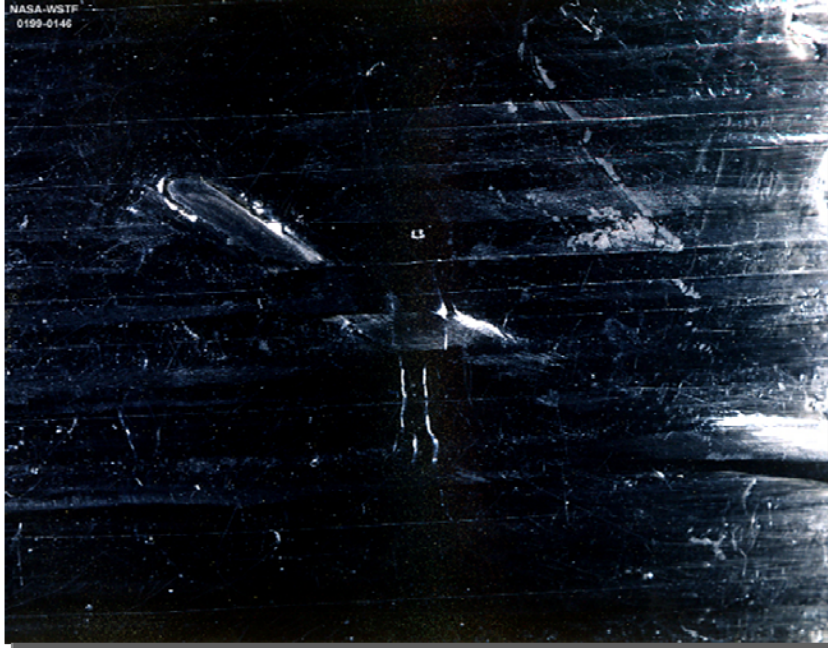
4.6 x 10 in. cylinder, significant abrasion

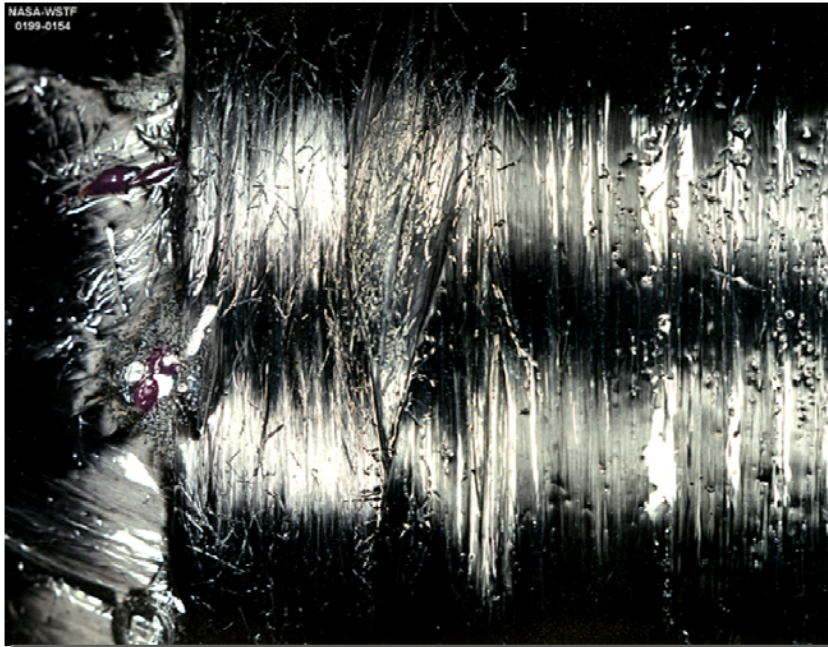
Small sphere, abnormal tie-off

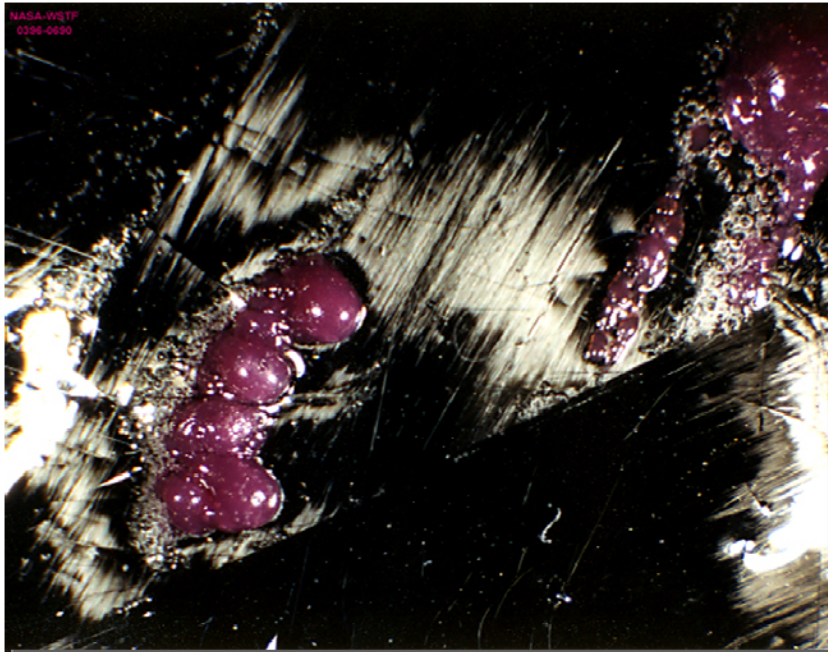
4 x 9 in. cylinder, excess bonding agent

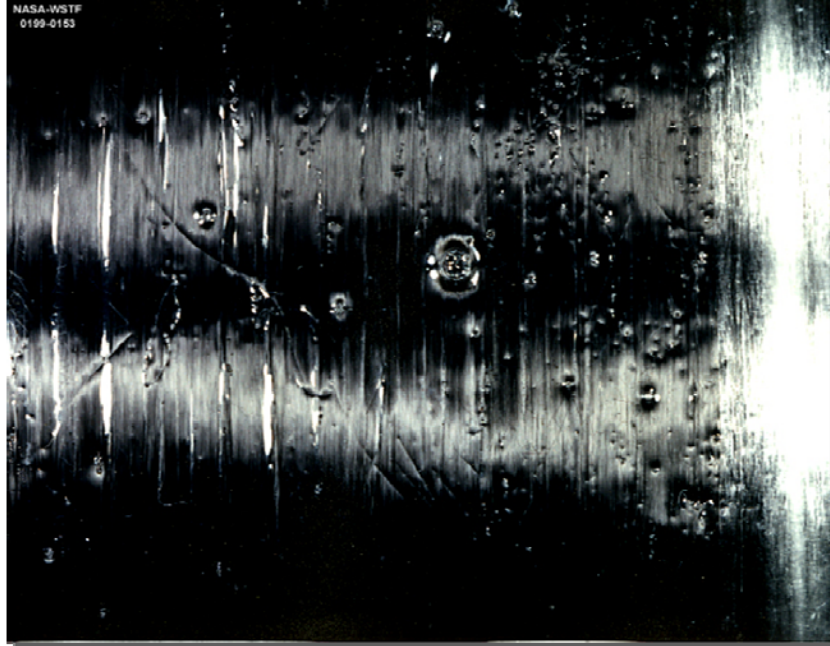
4 x 9 in. cylinder, excess bonding agent, magnified view

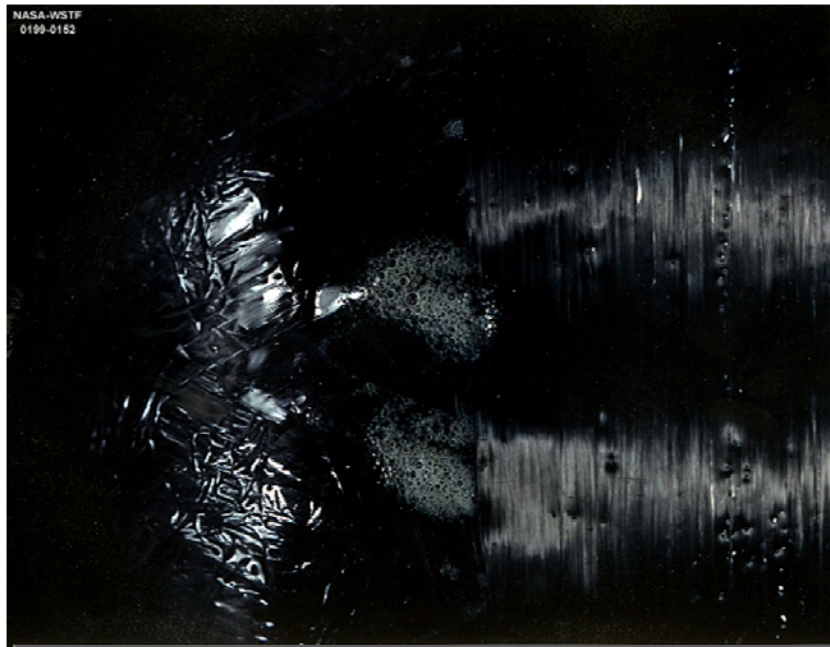
4 x 9 in. cylinder, surface resin indications

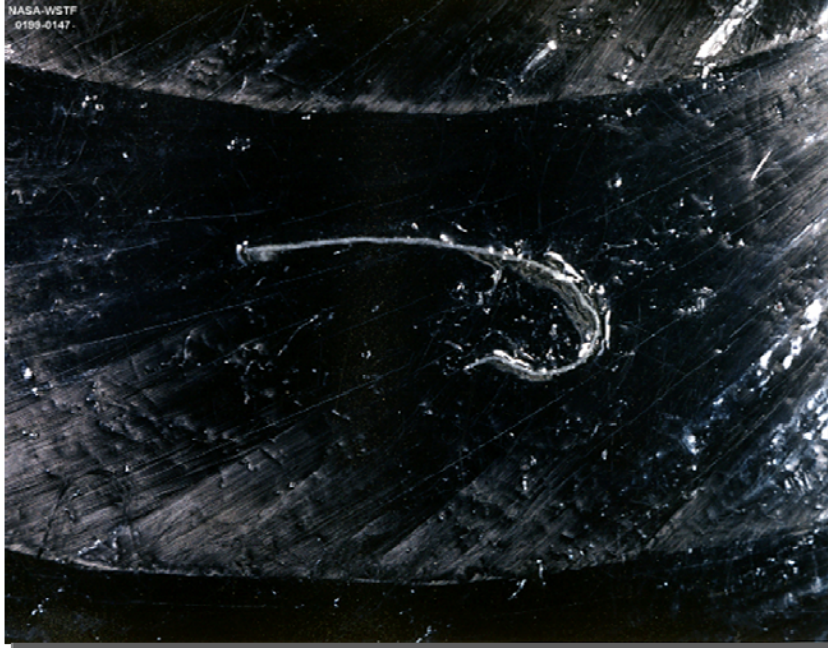
4 x 9 in. cylinder, surface resin porosity

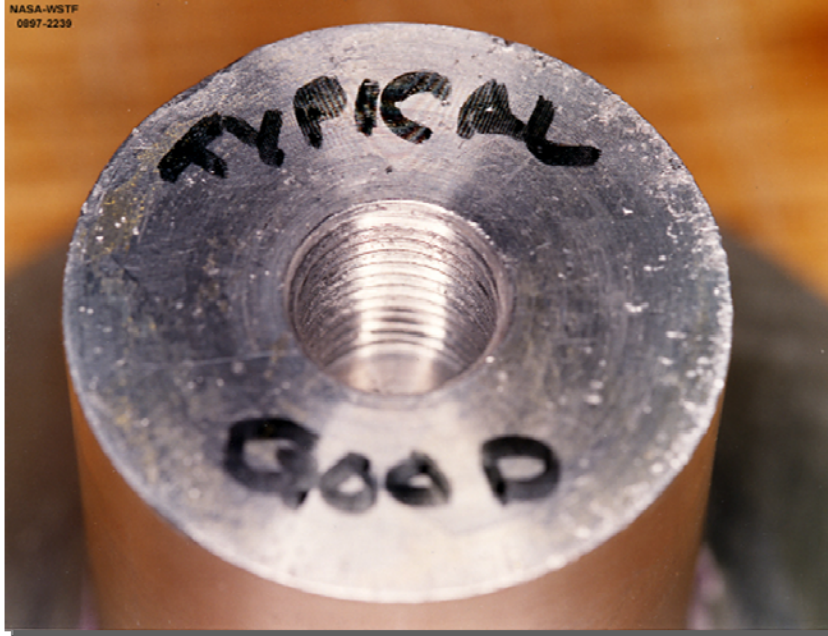
4 x 9 in. cylinder, entrained fiber
