# BURST PRESSURE FAILURE OF TITANIUM TANKS DAMAGED BY SECONDARY PLUMES FROM HYPERVELOCITY IMPACTS ON ALUMINUM SHIELDS

*American Physical Society  
Shock Compression of Condensed Matter  
June 26-July 1, 2011  
Chicago, IL*

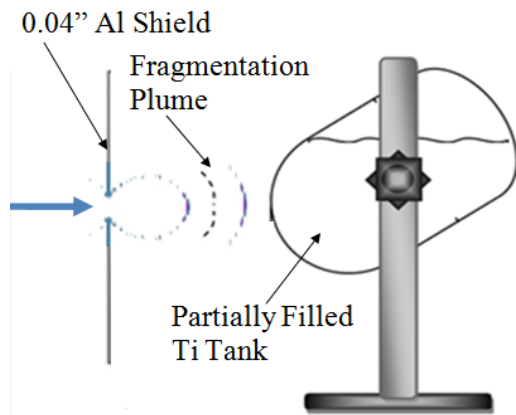
**Figure 1.** Schematic of the hypervelocity impact on the titanium tanks partially filled with water.

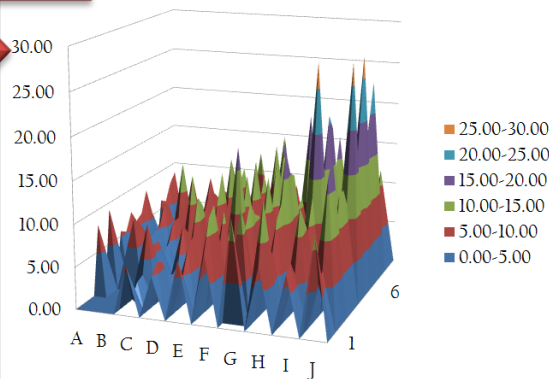
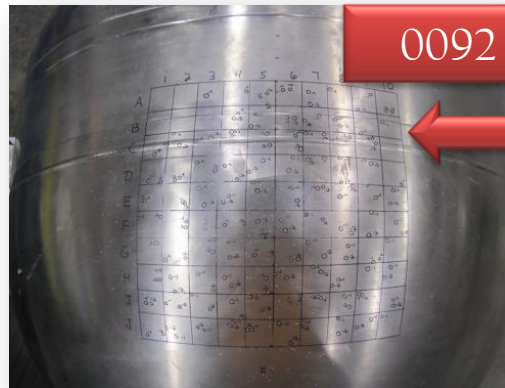
0092 Tank

Penetration Depth Distribution of Measured Craters

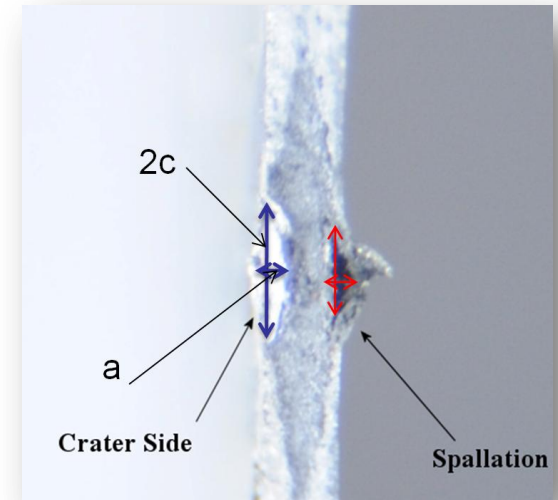
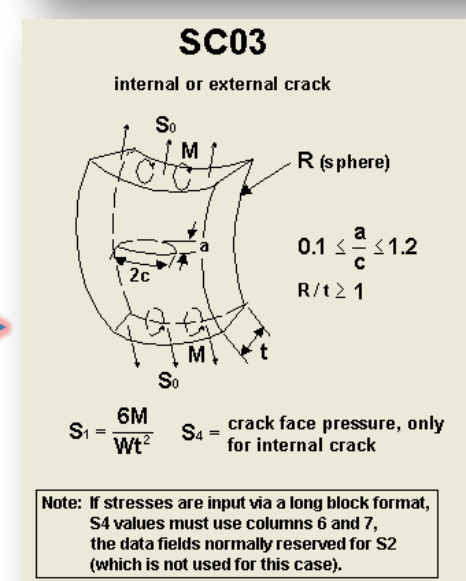
- Determination of the failure mode of the tank under burst pressure
  - Failure caused by loss of strength
  - Failure cause by dynamic crack propagation
- Perform a fracture analysis and compare toughness of Titanium with the predicted stress intensity factors
  - On the inside surface where a spall has been observed
    - $a = 0.0082''$ ,  $2c = 0.05''$ ,
    - $c = 0.025''$
    - $a/c = 0.33$
  - Used NASGRO to compute the stress intensity factor and compared with the Titanium toughness

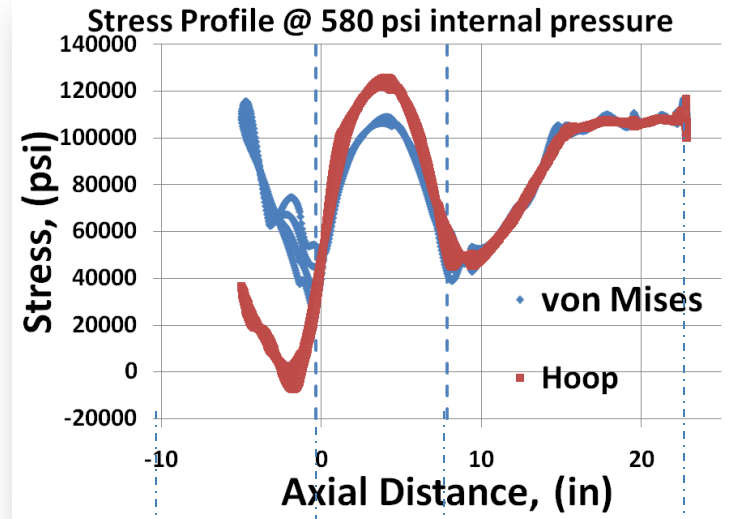
- A plastic-elastic axi-symmetric finite element analysis was performed on the tank with a x-y coordinates provided from the thickness profile
- Pressure in tank assumed at 580 psi
- Yield strength at 125 ksi
- Ultimate strength at 145 ksi

- Results show that at 580 psi, the hoop and Von Mises stresses are below the ultimate the yield strength of Ti 6Al4V
- This corroborates the findings that failure at 580 psi was caused by a crack propagation and was not driven by strength exceedence

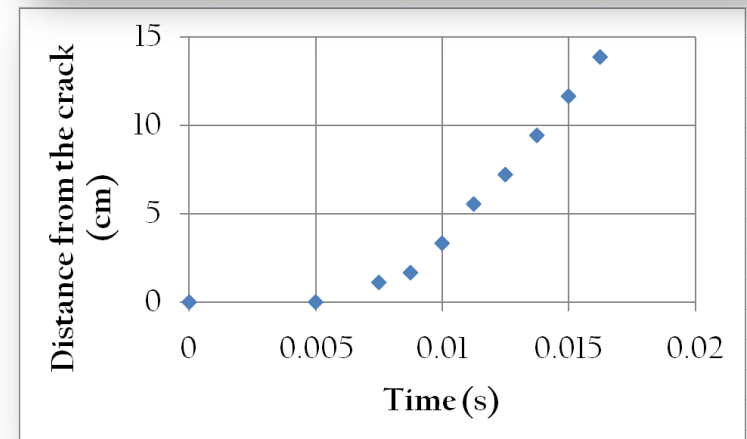
- Concerning is the *quick* dispersion of highly reactive propellant, contact with other nearby hardware and the resulting consequences of such a contact
