# Degradation of Multi-Layer Insulation (MLI) Retrieved from the Hubble Space Telescope

2011 Contamination, Coatings, &  
Materials Workshop

Jelila S. Mohammed  
Materials Engineering Branch  
NASA Goddard Space Flight Center

Kim K. de Groh  
Space Environment & Experiments Branch  
NASA Glenn Research Center

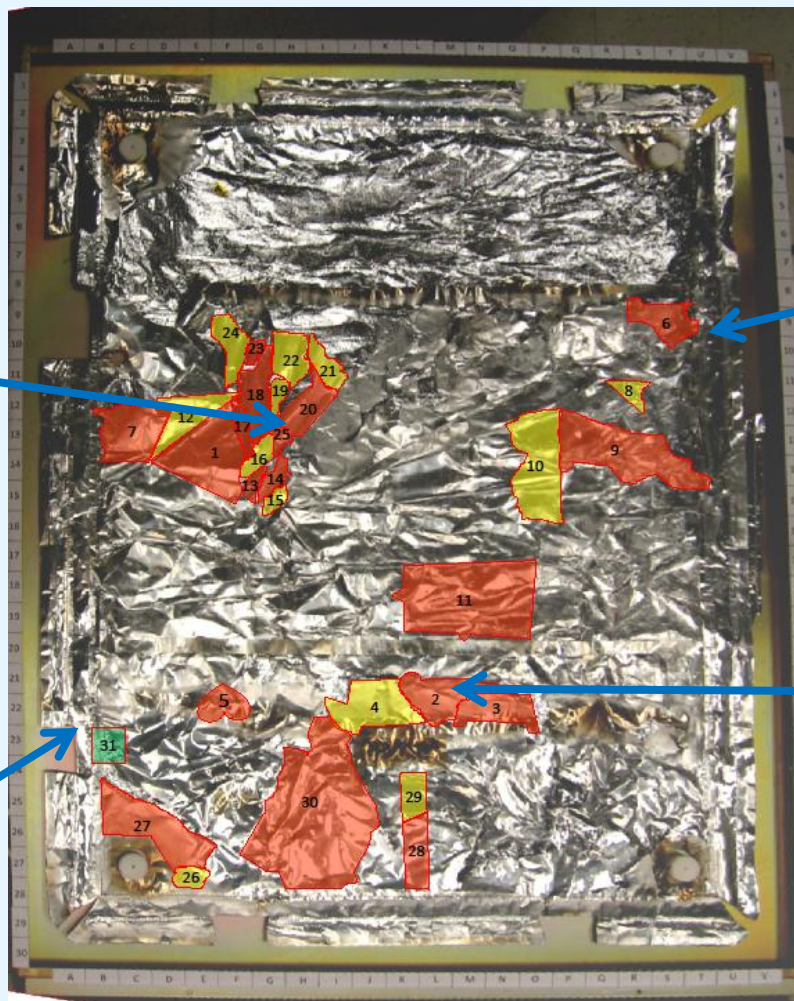
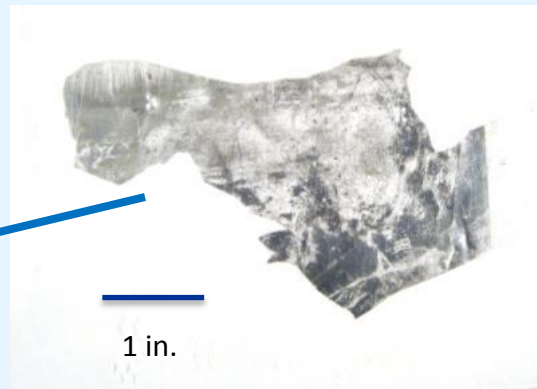
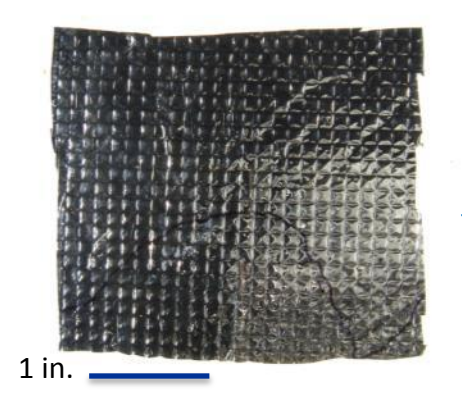
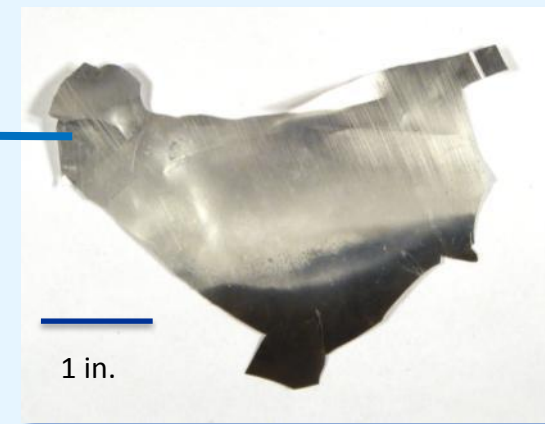
Bay 8 MLI in the lab for sectioning

The blankets had received a wide range of environmental exposure levels on orbit, based on alignment with the sun and whether or not the material was patched.

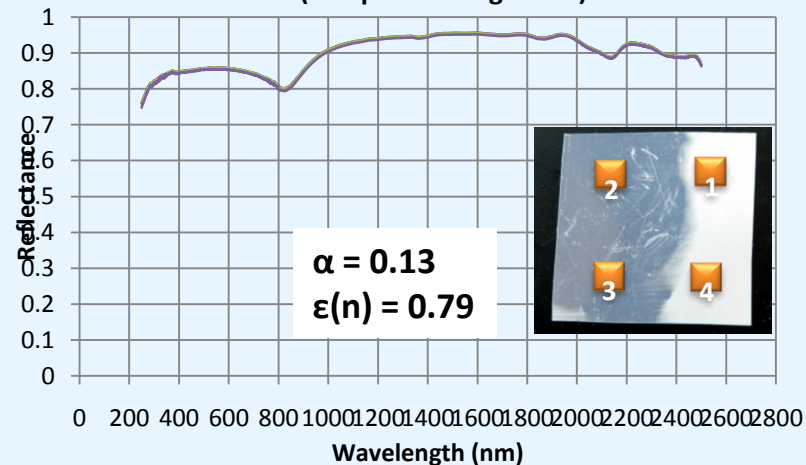
(Sample 50B Region 20)

**Pristine**

Reflectance Graphs showing thermal property calculations
