Shuttle Liquid Hydrogen (LH2) Engine Cut-Off (ECO) System Anomaly

Michael D Stirling

NASA Electrical Systems

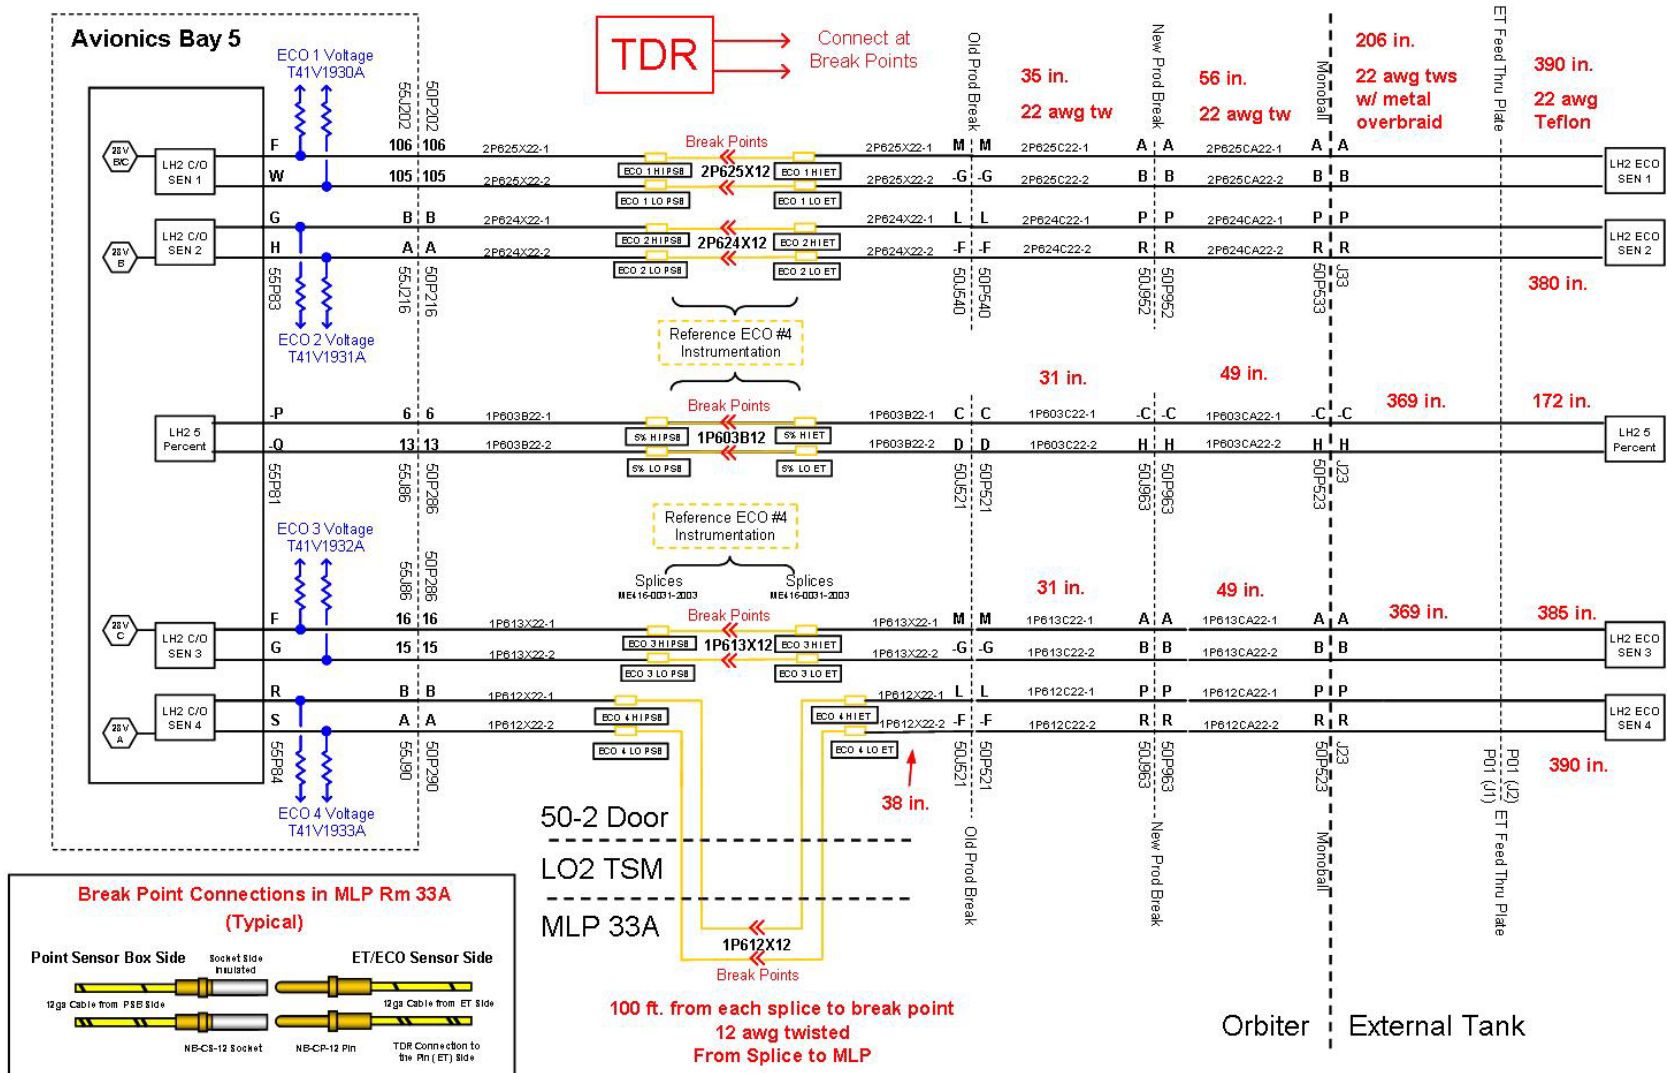
LH2 ECO System Wiring Diagram

- A tanking, or fueling, test at Kennedy on Dec. 18, 2007, revealed that open circuits in the external tank's external electrical feed through connector were the most likely cause of false readings in the ECO sensor system during launch attempts on Dec. 6 and Dec. 9. NASA formed a combined troubleshooting team involving multiple NASA centers to find the root cause and develop plans to fix the system. A parallel team also was established to develop a forward plan of action to support the earliest possible launches STS-122 and STS-123.

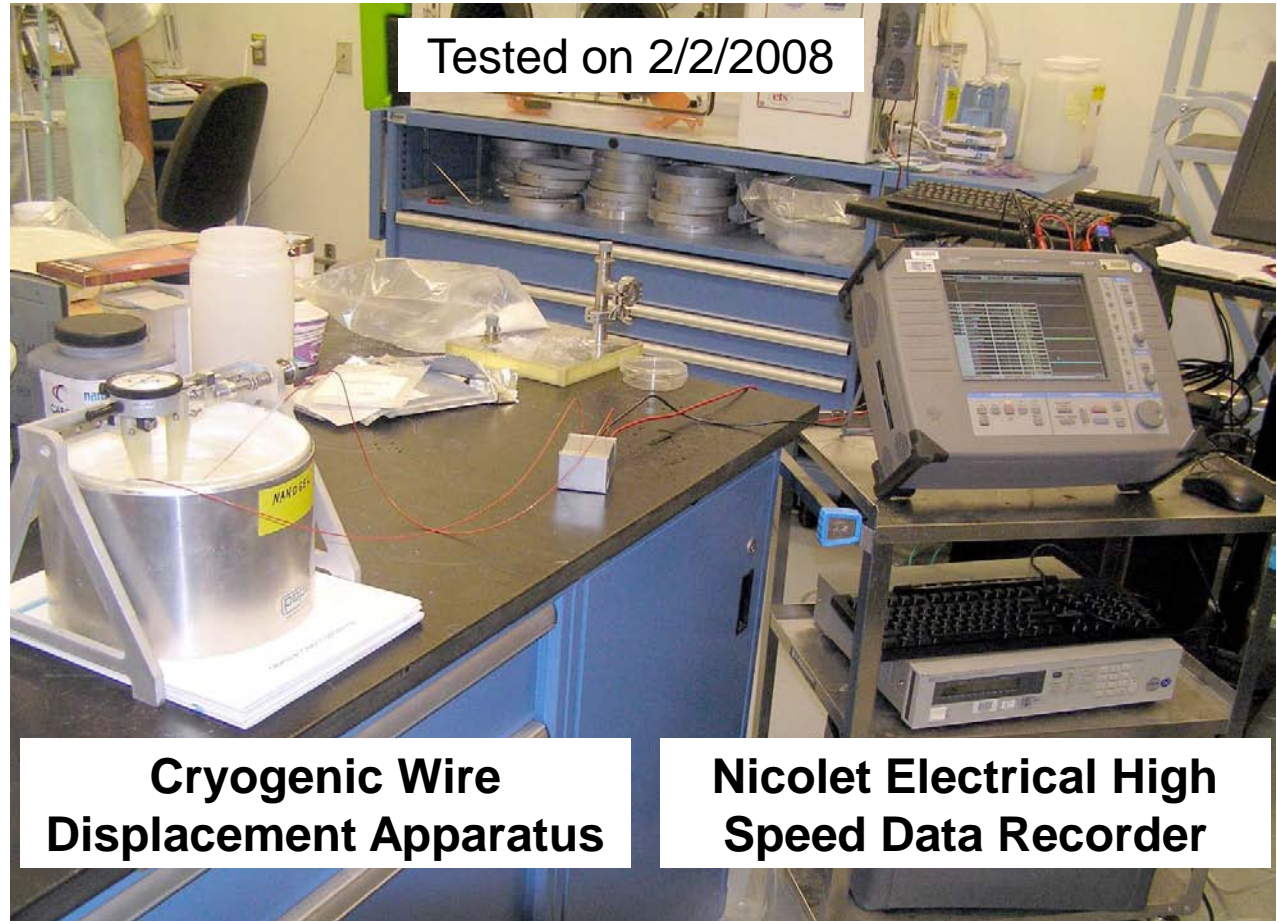
Anomalous electrical behavior and opens are noted with respect to displacement and contaminant condition (i.e. Krytox®, water, frost, Krytox®/water, or baseline/clean).

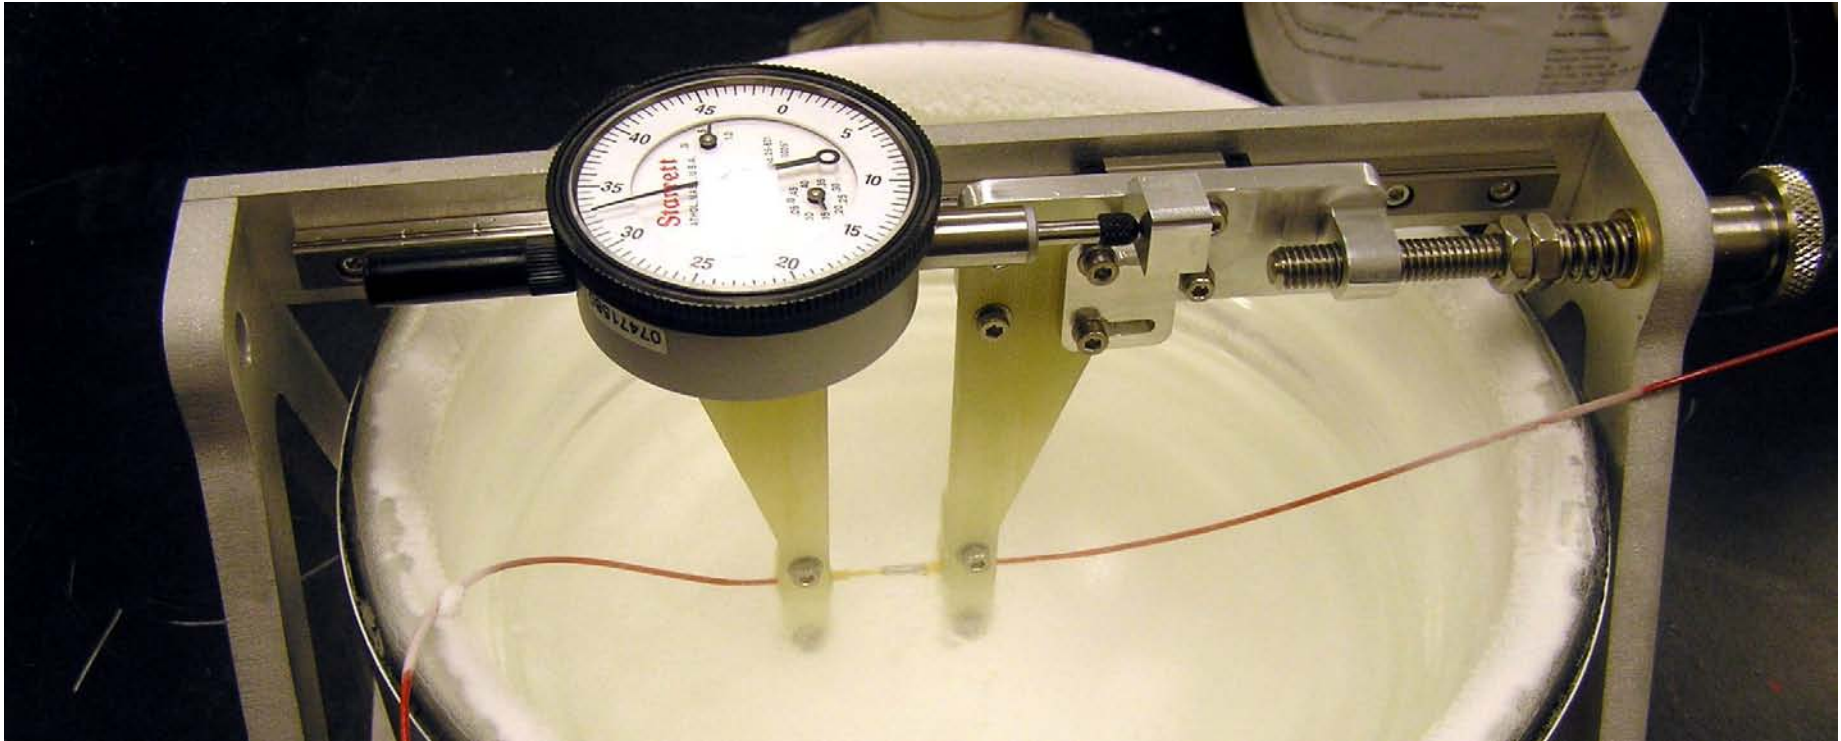
Krytox®/water contamination is achieved by cooling engaged pin/socket in LN2 for 3 minutes then removing from LN2 and allowing frost/condensate to form engaged or disengaged or a combination thereof. Pin/socket is engaged 160 mils then placed back into LN2 for at least 3 minutes before displacement.
