SHUTTLE PROPULSION SYSTEM MAJOR EVENTS AND THE FINAL 22 FLIGHTS

James W. Owen, NASA, Marshall Space Flight Center

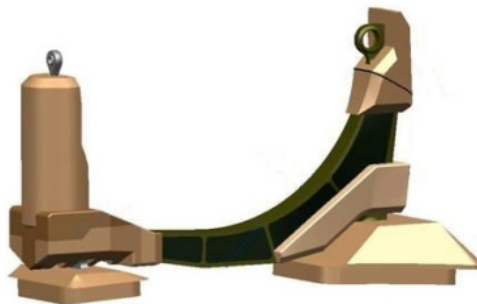
Figure 12. Liquid Oxygen Feedline Titanium Bracket

Redesign of the Liquid Oxygen Feed-line Bracket: A significant change implemented during the final 22 flights was the redesign of the feedline support brackets (from aluminum to titanium) greatly reducing the risk from ice debris, and eliminating a failure mode discovered at the bracket to feedline interface. The material change greatly simplified the foam closeout on the bracket, and dramatically reduced ice formation on the bracket. The initial redesign included a gap at the bracket to feed-line interface, susceptible to ice formation. Ice growth at these interfaces could bridge the gaps between the bracket and feedline, and subsequent articulation of the joints could cause the foam to crack. This could have resulted in ice and foam debris. Flight video data from STS-118 revealed the potential debris risk (from an aluminum bracket with a similar gap), and a slip joint was successfully added to the redesign, eliminating the gap (and ice). This design was extremely successful, flying on twelve of the final twenty-two flights.

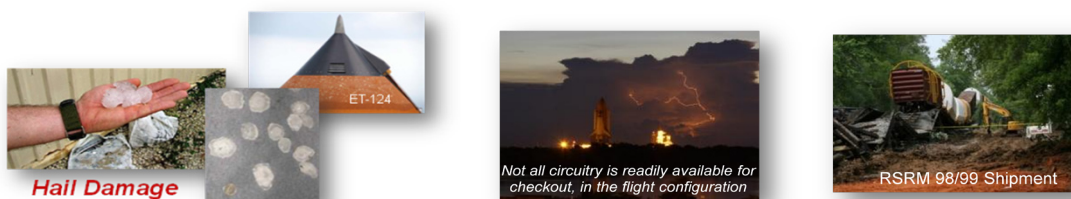
Figure 17. Unexpected Events

Unexpected Events can dramatically affect Programmatic: Unexpected events can affect the program in numerous ways. On the launch pad wind and lightning events can result in the need to reassess hardware configuration. A hail storm badly damaged an external tank prior to STS-117, requiring repair resulting in schedule delays. Launch delays in turn lead to longer exposure to the natural environment. In a very unexpected event, a train wreck including a trestle collapse occurred during shipment of solid rocket motor segments requiring urgent attention. And hurricanes including Katrina and Frances damaged critical manufacturing and assembly facilities. Unusual events require unique responses and diligence in implementing a recovery process.
