NASA WG3 MMOD Protection Summary

Interagency Space Debris Coordination Committee (IADC)

May 2012

Summary of MMOD Protection Activities

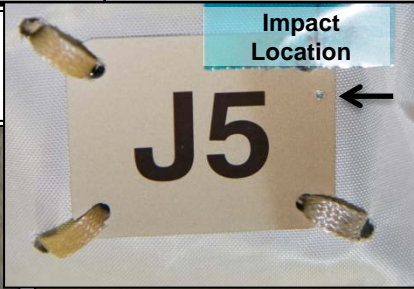
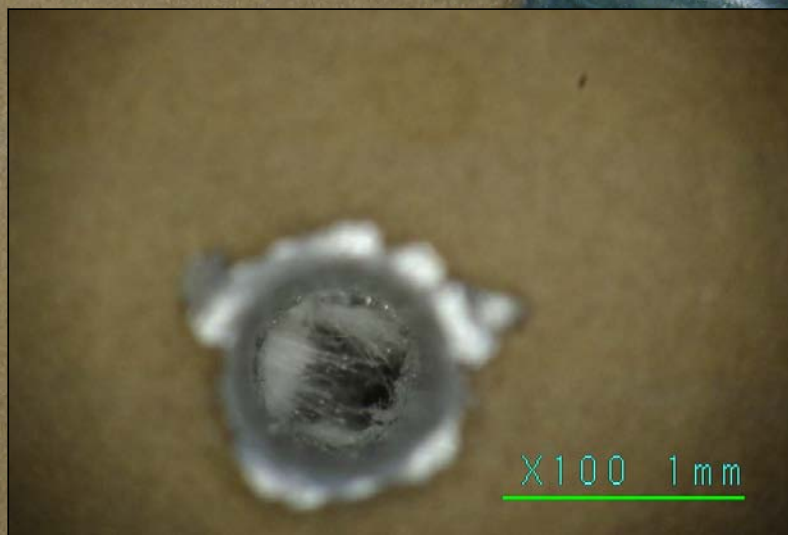
MPLM grapple fixture coating spall dia. = 0.6 mm

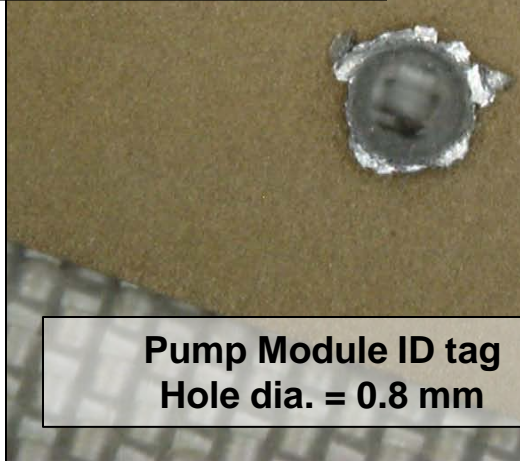
**Pump Module ID tag
Hole dia. = 0.8 mm**

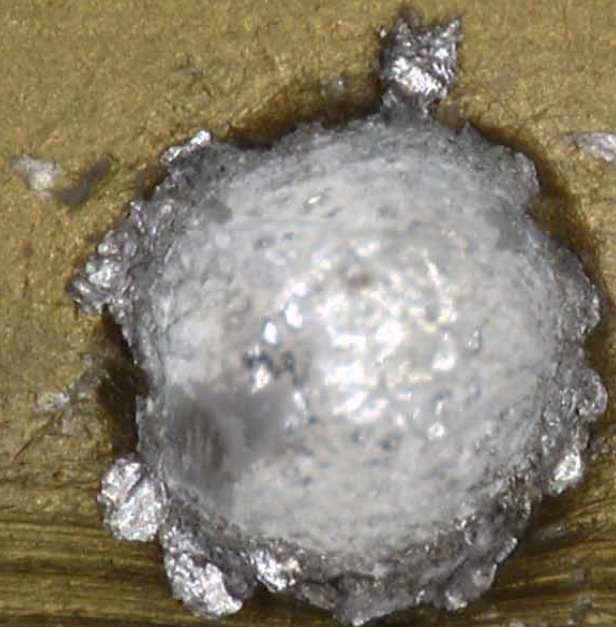
1.8 mm diameter
crater in handrail ZNC7

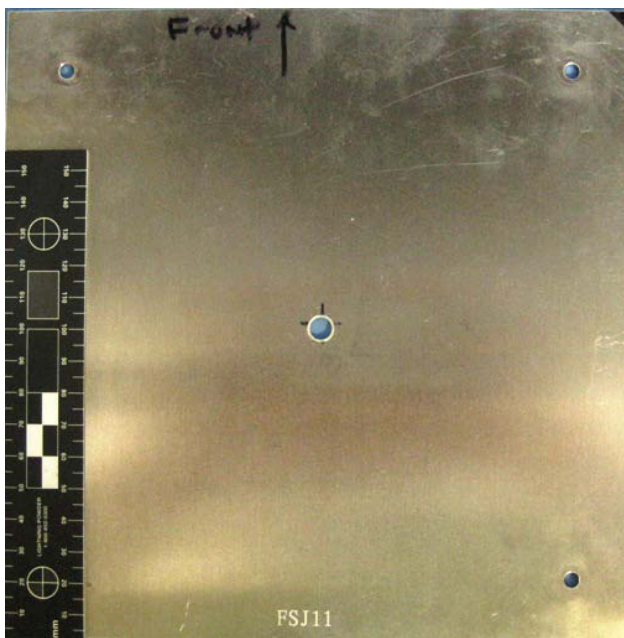
Front

- HITF-11146, 3.2mm AL 2027 projectile, 0.04779g, 5.77km/s, 0deg
 - **1st layer:** through-hole 6.8 mm inside diameter, 8.0 mm outside diameter (including crater lips)

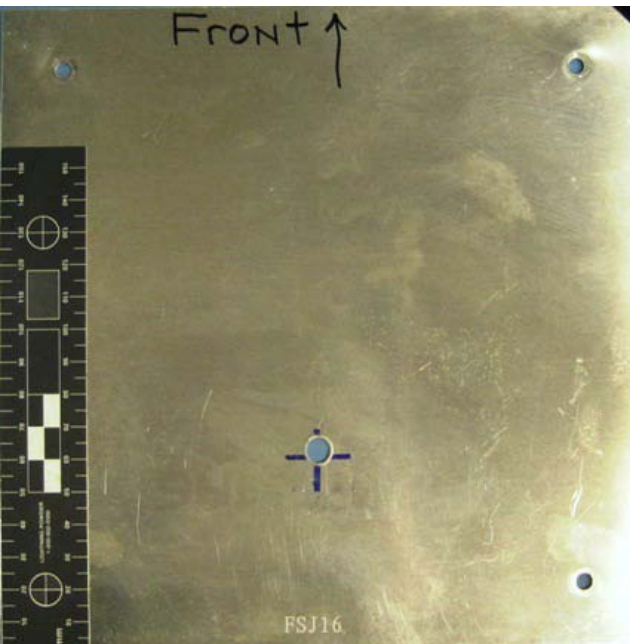
Front

- HITF-11147, 3.2mm AL 2027 projectile, 0.04788g, 5.30km/s, 30deg
 - **1st layer:** through-hole 7.5 x 6.9 mm inside diameter, 9.2 x 8.4 mm outside diameter (including crater lips)

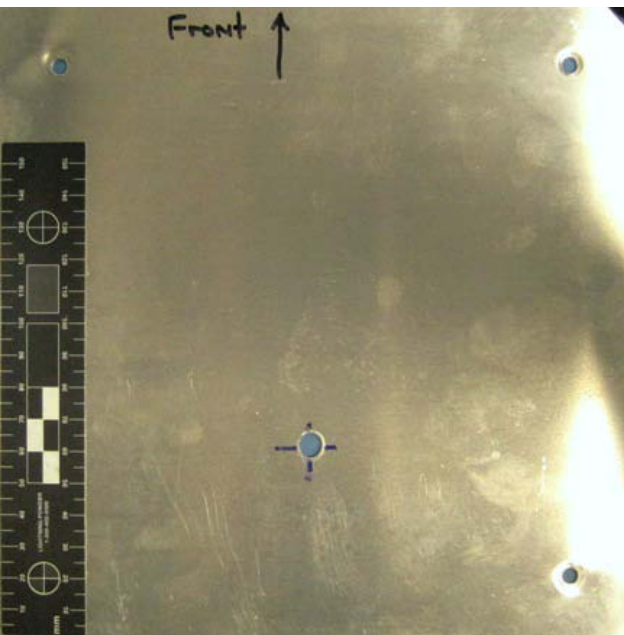
Front

- HITF-12092, 3.2mm AL 2027 projectile, 0.04767g, 5.01km/s, 30deg
 - **1st layer:** through-hole 7.4 x 6.8 mm inside diameter, 9.0 x 8.2 mm outside diameter (including crater lips)
