Boiling eXperiment Facility (BXF)

Fluid Toxicity Technical Interchange Meeting (TIM) with the Payload Safety Review Panel (PSRP)

June 14, 2012

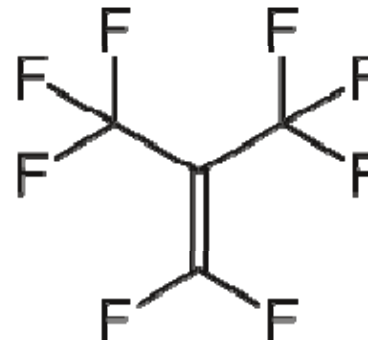
- Plan Change: Fluid Sampling & Analysis added
 - Rationale: Stronger evidence of an overheat condition, increasing concern that PFIB was produced.
- Two samples taken of BXF Fluid, 1 sample analyzed for PFIB
- **CONFIRMED!!!** 90 ppm of PFIB detected in BXF Fluid; Acceptable Exposure Level (AEL) is 10 ppb TWA
- CV reassembled to reestablish 3 levels of containment
- PFA Activities halted to determine how to proceed

Generation of PFIB in the fluid is indicative that the BXF Fluid (PFNH) was exposed to excessive temperatures long enough to cause molecular decomposition.
14 June 2012

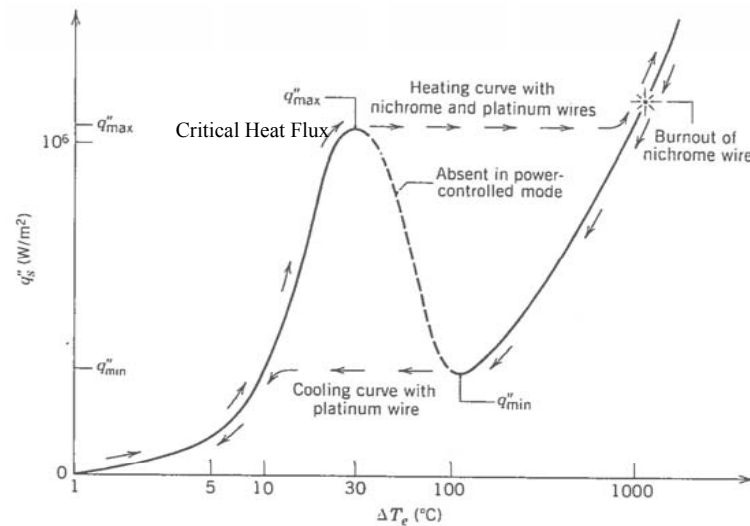
Figure 10.3 Nukiyama's boiling curve for saturated water.

- Heater Operating Conditions
 - 60 W @ 24 VDC, 1/8" DIA x 6" LG, 1/4" No Heat Zone
 - Heat Flux $\approx 4 \text{ W/cm}^2$
 - $\sim 0.04 \text{ L/min}$. flow over each heater at time of anomaly
- Fluid manufacturer 3M recommends heat flux of no more than 6-10 W/cm²
 - If exceed, “boiling is no longer stable, a vapor blanket forms on the wire, and the wire temperature skyrockets.”
 - This is called exceeding the “critical heat flux,” and it leads to burnout of heating element.

Typical boiling curve with onset to “burnout point” or “boiling crisis”
