Space Mishaps

Apollo 1, Apollo 13, Challenger, and Columbia

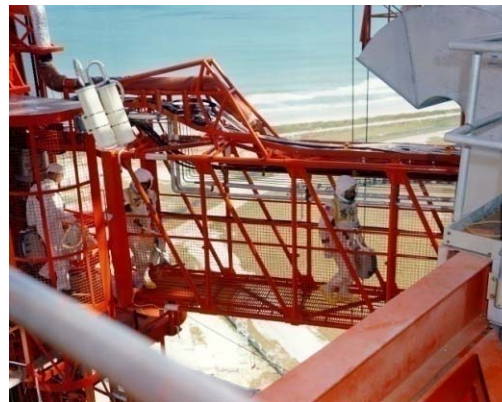
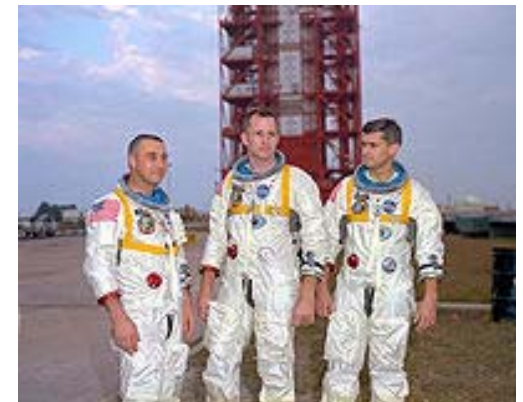
On January 27, 1967, tragedy struck the Apollo program when a flash fire occurred in command module 012 during a launch pad test of the Apollo/Saturn space vehicle being prepared for the first piloted flight, the AS-204 mission.

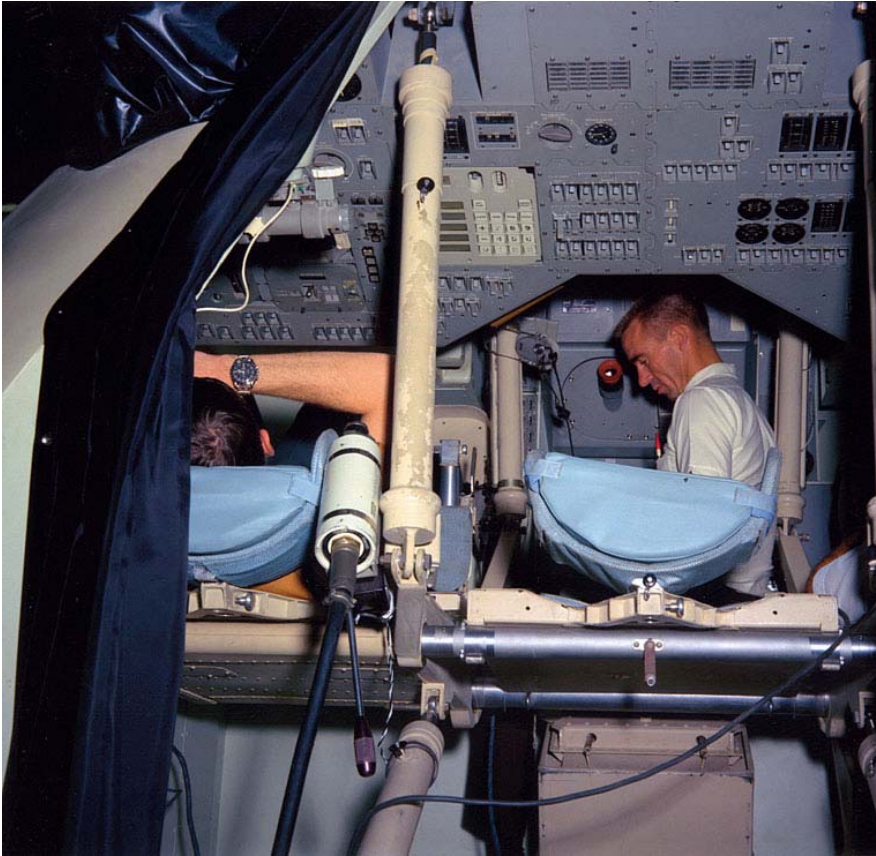
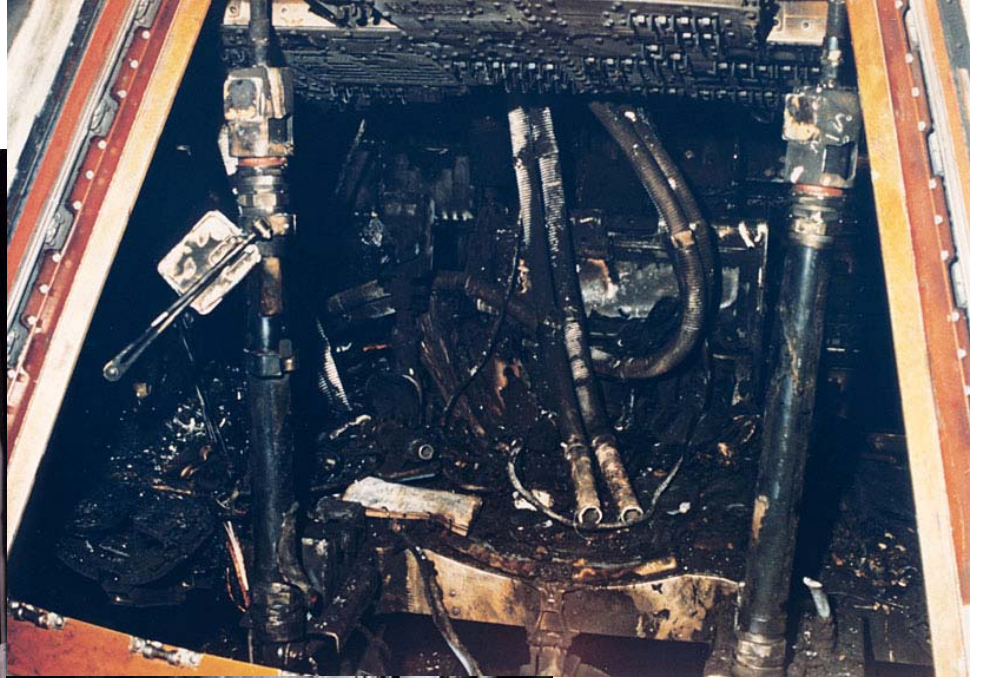
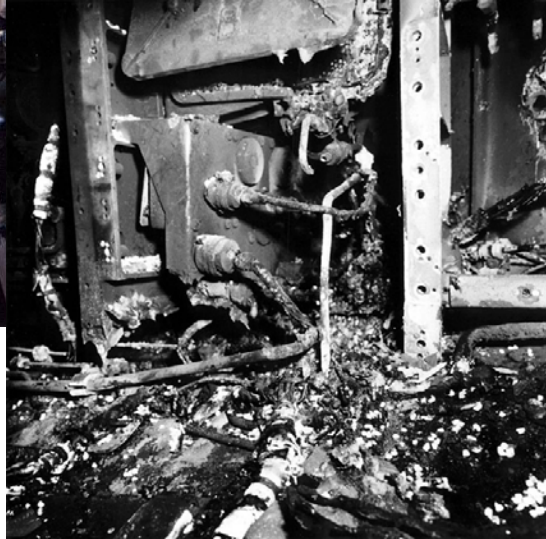
Apollo 1

- The test **cabin pressure was over 16 psi**, almost 2 psi above the ambient sea level pressure and near the upper limits of measuring devices in the spacecraft. Following a worldwide survey of artificial oxygen-rich environments, it was found that rarely if ever had a 100% oxygen environment been created and maintained at such a high pressure. **Note: A bar of aluminum can burn like wood in this environment.**

- 34 square feet (3.2 m²) of Velcro was installed throughout the spacecraft and **Velcro was later found to be explosive in a high-pressure, 100% oxygen environment.**

- Up to 70 lbs of other non-metallic, flammable materials had also been incorporated into the design.
- **Substandard wiring and plumbing was found along with a misplaced socket wrench.**

- **Sloppy workmanship, poor inspection, and inadequate safety design** led to the accident.
 - A silver-plated copper wire was running through an environmental control unit near the Command Module pilot's couch which had become stripped of its Teflon insulation and abraded by repeated opening and closing of a small access door. This weak point in the wiring also ran near a junction in an ethylene glycol/water cooling line which was known to be prone to leaks. The electrolysis of ethylene glycol solution with the silver anode was a notable hazard which could cause a violent exothermic reaction, igniting the ethylene glycol mixture in the CM's corrosive test atmosphere of pure, high-pressure oxygen.

- Flammable materials in the cabin were replaced with self-extinguishing versions.
- Plumbing and wiring were covered with protective insulation. 1,407 wiring problems were corrected.

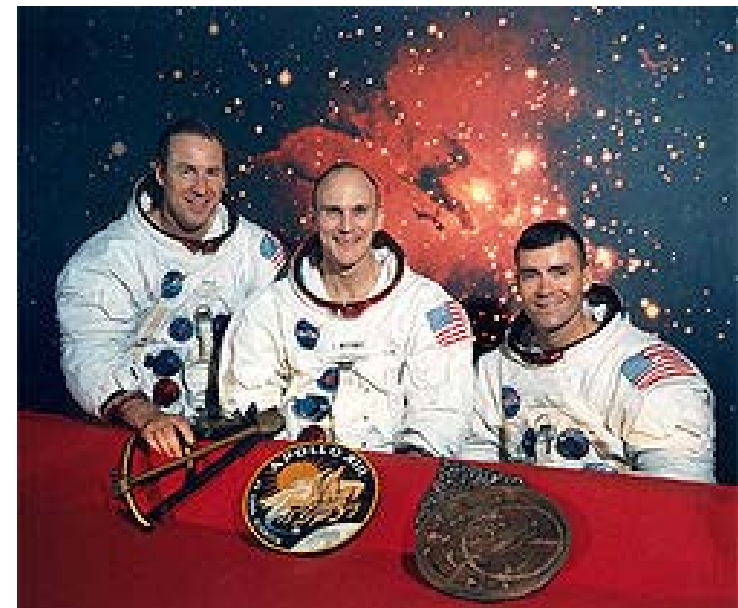
- The number two oxygen tank, one of two in the Service Module (SM), exploded.
- The resulting fire rapidly increased pressure beyond its nominal 1,000 PSI (7 MPa) limit and either the tank or the tank dome failed.
- All three astronauts survived.
 - James A. Lovell, Jr.
 - John L. Swigert, Jr.
 - Fred W. Haise, Jr.

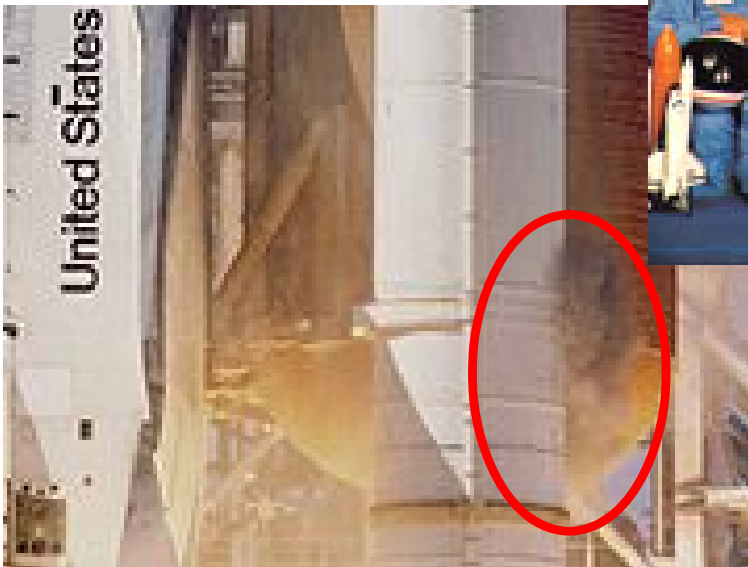
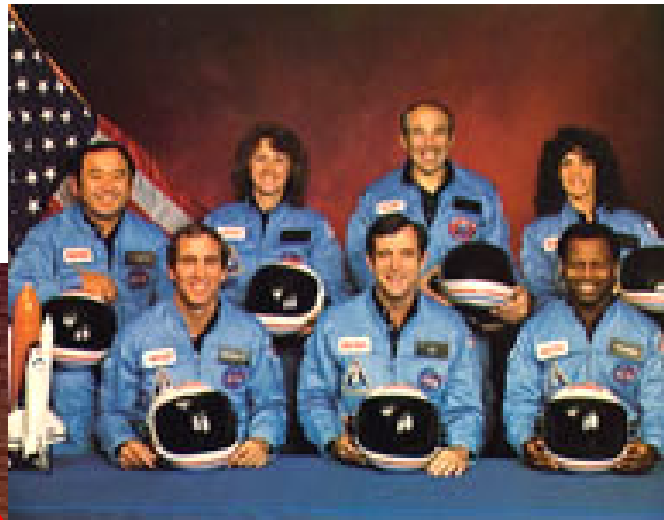
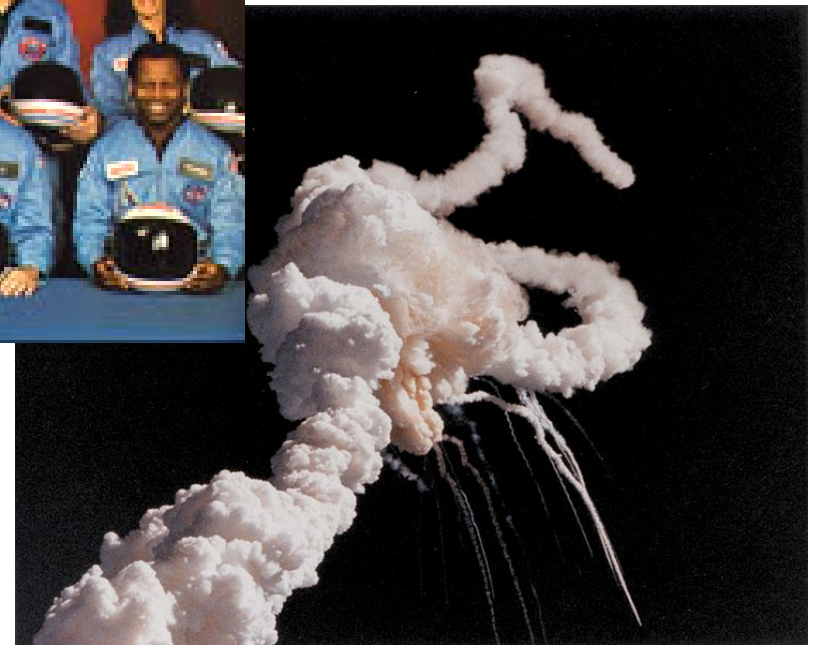
On January 28, 1986, Space Shuttle Challenger broke apart 73 seconds into flight due to a poor joint seal in the Right Solid Rocket Booster.

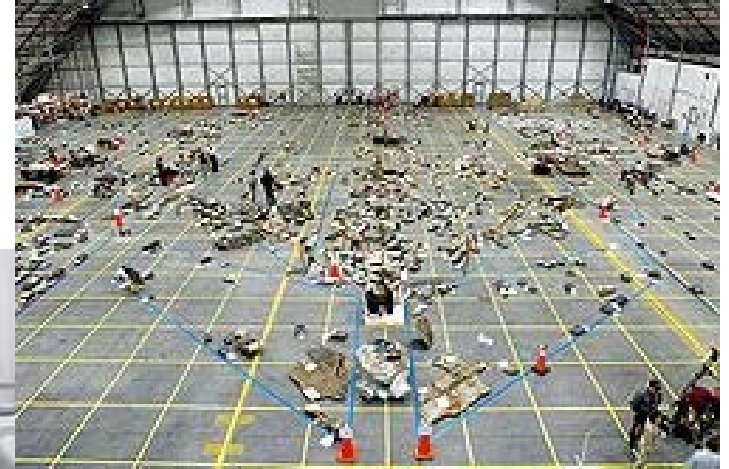
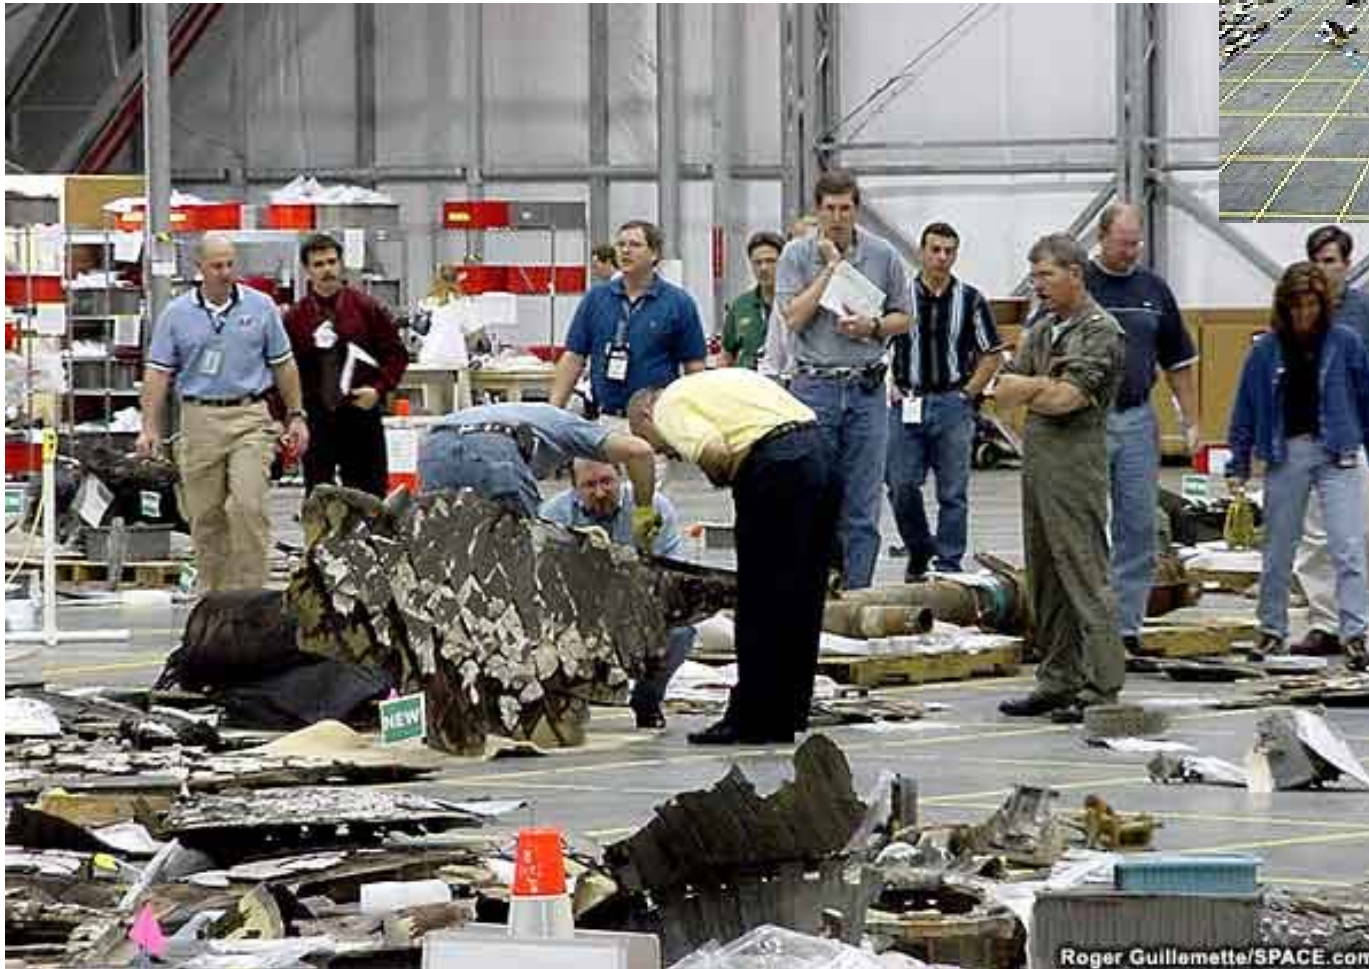
"In four simple words, the foam did it."
- Scott Hubbard, Deputy Director for Research at
NASA Ames Research Center

- "The root cause of TPS foam debris shedding has been attributed to internal defects (voids) within the foam structure. Entrapped gas or liquid nitrogen/liquid air within the defect (void) expands during ascent due to the reduced ambient pressure and aerodynamic heating. Depending on the size, depth and geometry of the defect, the resultant pressure differential may cause failure of the surrounding foam. This type of failure mode has been identified as "cohesive" failure and results in chunks of foam being shed from the tank." – NASA ESC
