# Stress Analysis and Testing at the Marshall Space Flight Center to Study Cause and Corrective Action of Space Shuttle External Tank Stringer Failures

After the launch scrub of Space Shuttle mission STS-133 on November 5, 2010, large cracks were discovered in two of the External Tank intertank stringers. The NASA Marshall Space Flight Center, as managing center for the External Tank Project, coordinated the ensuing failure investigation and repair activities with several organizations, including the manufacturer, Lockheed Martin. To support the investigation, the Marshall Space Flight Center formed an ad-hoc stress analysis team to complement the efforts of Lockheed Martin. The team undertook six major efforts to analyze or test the structural behavior of the stringers. Extensive finite element modeling was performed to characterize the local stresses in the stringers near the region of failure. Data from a full-scale tanking test and from several subcomponent static load tests were used to confirm the analytical conclusions. The analysis and test activities of the team are summarized. The root cause of the stringer failures and the flight readiness rationale for the repairs that

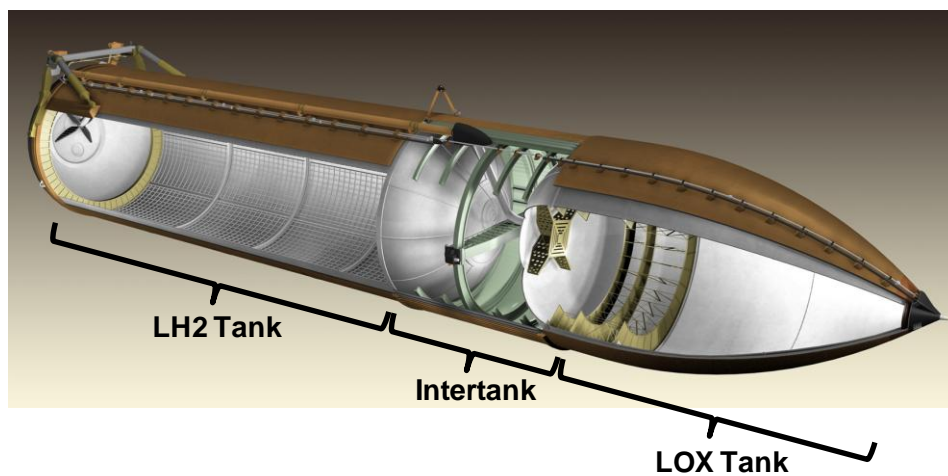
Removal of the damaged foam revealed that an underlying aluminum hat-section stringer had cracked approximately 9 inches along each side, just inboard of the fasteners that attached the stringer “feet” to the intertank forward flange chord (Figure 2). The crack in the foam was solely a result of the stringer failure. An adjacent stringer was also found to be similarly cracked on each side for about 3 inches along its forward end, although the SOFI directly over it had appeared undamaged.

**Figure 2. Stringer cracks discovered after STS-133 launch scrub. ET-137 stringer S7-2 shown. (Bottom left inset: stringer S7-2 after removal from ET-137 and foam residue cleaned off.)**

The two stringers were repaired in-situ at the launch pad by removing several inches of the forward end of each damaged stringer and splicing on an equivalent length taken from new stringers. Aluminum sheet stock doublers formed into a shape resembling the letter 'Z' were overlaid and fastened on the splice location to mechanically tie each portion of new stringer to the remaining portion of original stringer. The SOFI was then manually re-applied, allowed to cure, and trimmed to meet flight requirements. The remnants of the two stringers containing the cracks were shipped first to the MAF and later to the MSFC for forensic engineering.

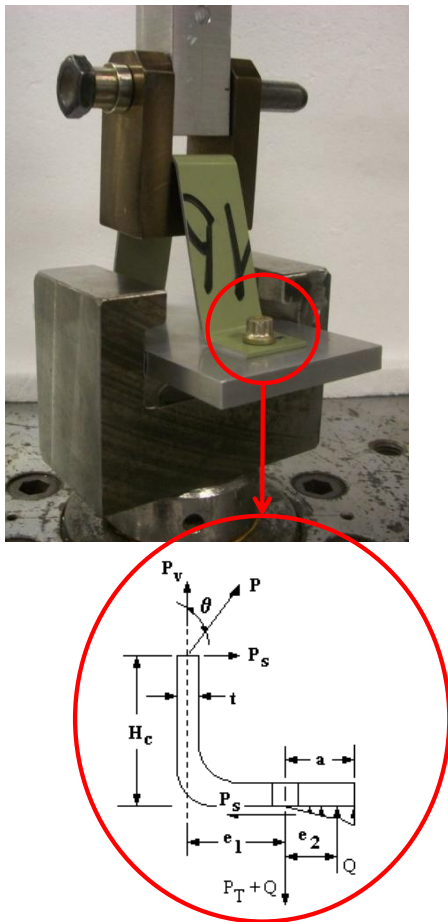
To check the validity of using the heritage analysis methodology for this application, Lockheed Martin conducted simple tension tests on cross sections of spare stringers obtained from the production inventory (Figure 9). Referred to as “clip tests,” the test articles were essentially one-inch lengths of the stringer hat section with one fastener through each of the two stringer feet anchoring the clip to a rigid base. A load frame was used to pull the clips away from the base, simulating the local loading condition created when radial contraction of the forward end of the intertank causes the stringers to bend. The initial clip tests confirmed that the analysis method was conservative in that the test articles demonstrated higher capability than predicted by analysis.

Figure 9. Lockheed Martin stringer “clip test.”

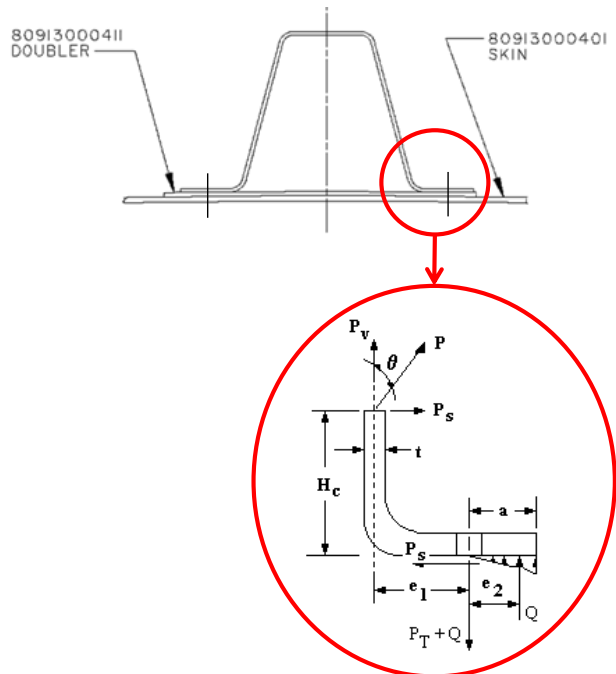
One of the early reviews Lockheed Martin performed of the structural capability of the stringer feet used an existing methodology for the analysis of classic aircraft details. As can be seen in Figure 8, it was noted that the free body diagram of the cross section of a stringer foot was similar to that of an aircraft structural detail commonly known as a “tension clip” or “tee.” A modified version of the heritage Lockheed stress memo, “Flange Bending Strength of Angles,” provided a standard analysis procedure for tension clips based on empirically-derived allowable tension loads for sheet metal angles [3]. Using stringer sidewall forces derived from expected thermal deflections and nominal stringer geometry and properties, the tension clip analysis indicated that the stringers should have had adequate structural capability. The analysis did not explain the failures.

Figure 8. Stringer foot free-body diagram similarity to aircraft “tension clip.”

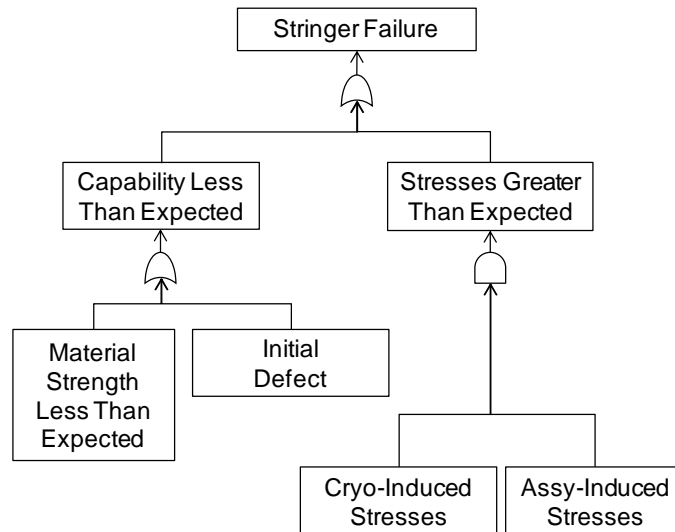
The investigation into the cause of the structural failure of the stringers can be summarized as having pursued the scenario that either the stringer capability was less than expected or that the stresses were greater than expected. Each of these two possible causes was further developed into their potential sub-causes (Figure 10). Within the effort at the MSFC, these two main branches were the focus of an ad-hoc Material Failure Analysis Team (FAT) and an ad-hoc Stress Analysis Team, respectively.

**Figure 10. Simplified stringer failure fault tree.**

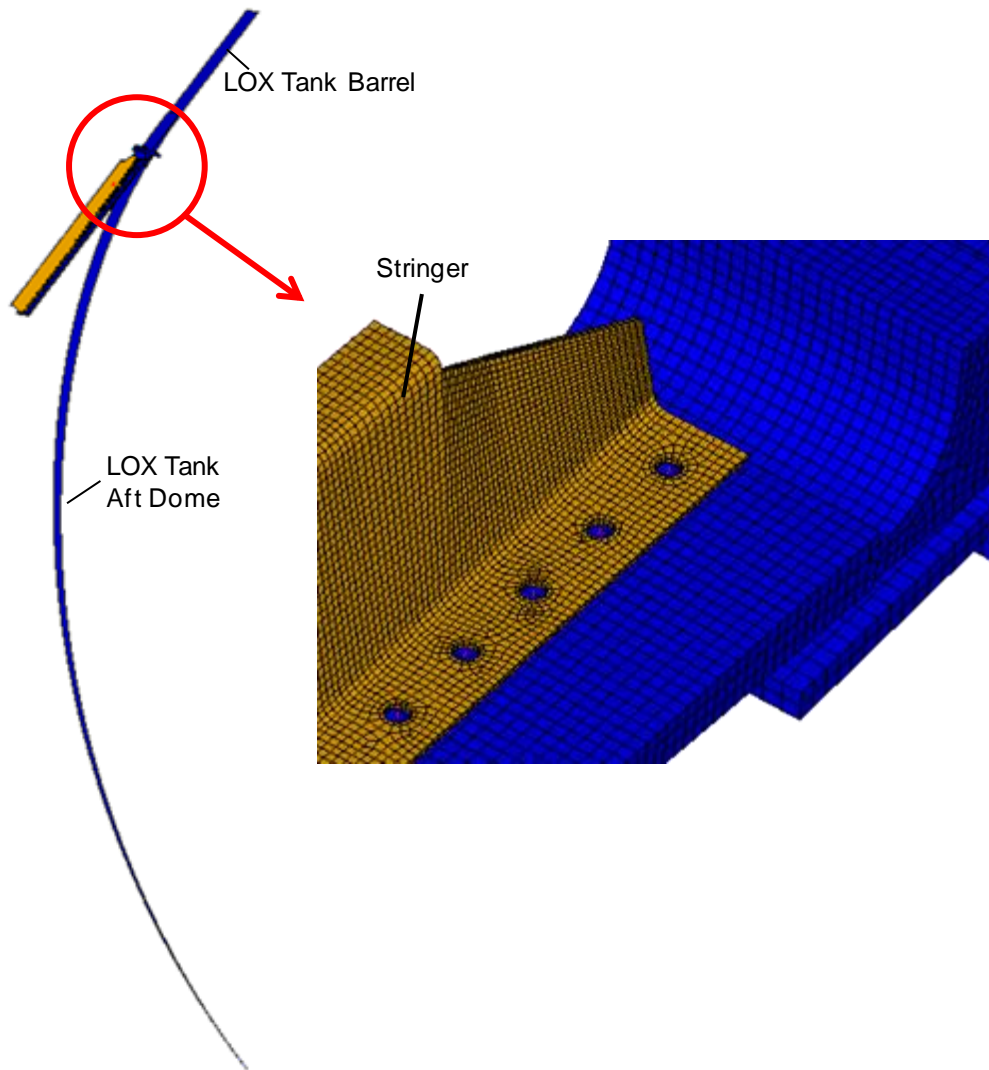
modeled (Figure 11). Different models were created to replicate the different configurations of stringer and underlying skin that existed circumferentially around the intertank. Portions of the adjacent LOX tank ring, barrel, and aft dome were modeled to provide appropriate boundary conditions. Runs were made with simplified representations of the fasteners and with the fasteners explicitly modeled with solid elements. Different profiles of stringer temperature as a function of distance from the LOX tank interface (representing snapshots in time of the transient thermal conditions) were mapped onto the mesh to study resulting stringer deflections and stresses. The stringer model with the steady state temperature profile achieved while filling the LOX tank was further augmented with compressive loads to study stresses in the feet of the stringer under the influence of ascent flight loads [6]. Linear elastic material properties were used. Additionally, it was acknowledged that the magnitude of the peak stresses from the analysis could not be stated with sufficient accuracy to calculate a meaningful factor of safety or failure margin because it was just a linear analysis, and it was unclear what material allowable should be used. Rather, the results were used for qualitative comparisons of stringer response to different thermal profiles, flight loads, and underlying skin configuration.

**Figure 11. FE model of stringer and adjacent LOX tank structure.**

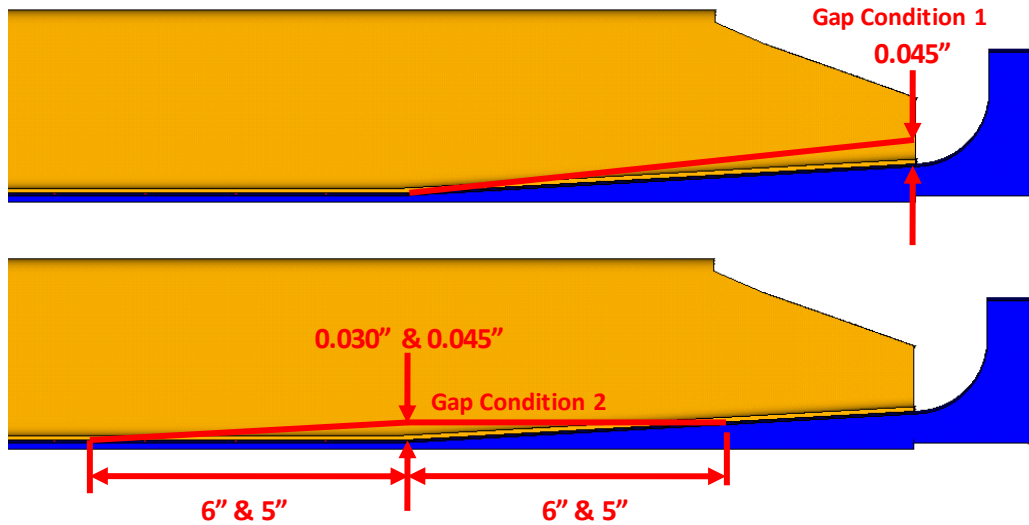
These same FE models were modified as necessary to study stresses resulting from possible assembly fit-up conditions. The design drawings of the stringer panels specified that shims were to be used when attaching a stringer to a skin panel if a gap greater than 0.030 inches existed between the stringer foot and skin. One theory for unexpected stresses was that gap conditions existed during assembly that required shimming, but that the shims had been inadvertently omitted, inducing high residual stresses in the stringer feet during fastener installation. This theory was studied with the FE model by including excessive (but credible) gaps under several fasteners at the end of the stringer, and then simulating preloading of the fasteners, followed by application of thermal deflections (Figure 13). The anomalous gap conditions hypothesized in these analyses did not introduce significant additional stresses above the baseline as-designed conditions, so it was considered unlikely that these particular conditions contributed to the failure.

down” condition) as seen in Figure 14. An initial toe down geometric condition would cause bending in the stringer foot during fastener installation, resulting in stresses in the foot that would be additive to stresses caused by the prelaunch thermal transient. This condition was studied analytically by giving the FE model an initial toe down condition, and sequential installation (preloading) of the forward fasteners was simulated to obtain stringer internal forces and stresses. The results indicated that it was possible to induce assembly stresses that would be additive to subsequent cryogenic deflection-induced stresses.

Figure 13. FE simulations of possible assembly stress scenarios.

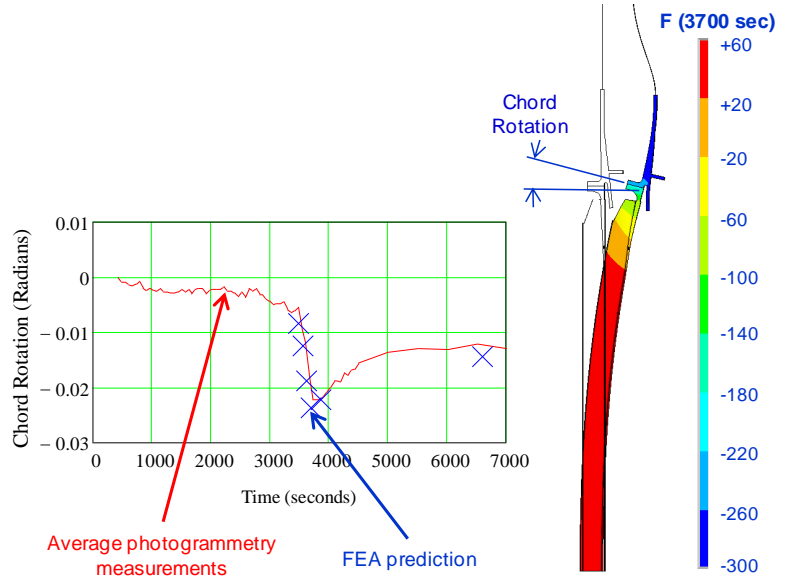
bending of the stringers was quantified and compared to ANSYS FE predictions from the effort previously mentioned. The FE analysis had shown that the stresses in the stringer feet were particularly sensitive to how much the forward chord rotated during the thermal-induced deflections, but the accuracy with which the FE model predicted the chord rotations had been the subject of some debate as it did not agree with other analyses. However, as shown in Figure 16, the photogrammetry data indicated that the ANSYS model very accurately predicted the average radial deflection and rotation of the intertank forward chord [10].

**Figure 16. Intertank forward chord rotation due to thermal transient.**

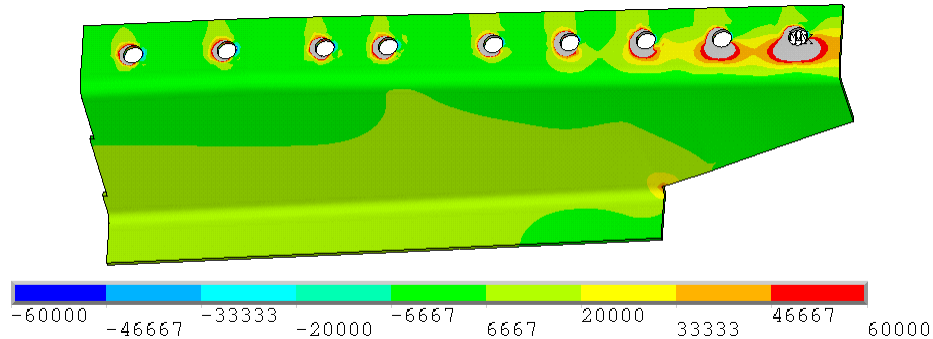
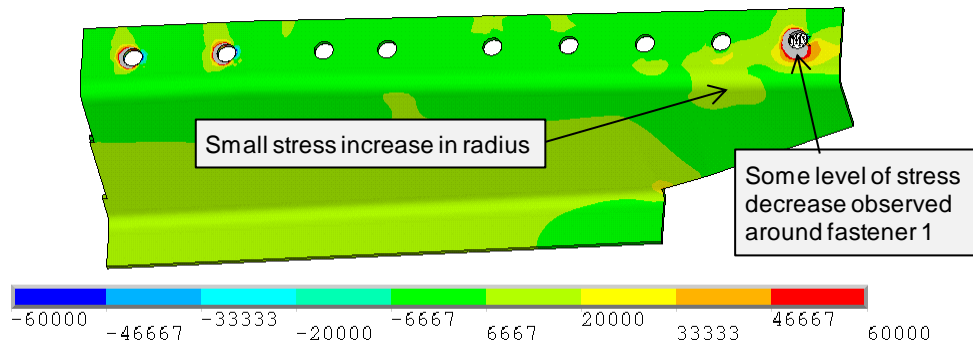
include any features to simulate possible sources of assembly stress. By running critical load cases of the model with and without a radius block, and plotting the principle stress patterns on the underside of the stringer foot, it was possible to study whether the addition of the radius block changed the shape or magnitudes of the stress contour and to qualitatively determine radius block effectiveness (Figure 20). The findings of this assessment were:

- The addition of the radius block did not add new high stress regions;
- The stress in the foot of the stringer in the region near the first five fasteners during the critical thermal transient was significantly reduced with addition of the radius block;
- The stress in the foot of the stringer in the region near the fasteners at the aft end of the radius block saw only moderate increases with the addition of radius blocks for the steady state thermal condition with ascent compressive loads, but the stress remained low relative to the magnitude of the stresses near the forward fasteners.

**Figure 20. Example FE results comparison of stringer foot (with single doubler) 1<sup>st</sup> principal stress (psi) on the bottom of the foot at the 3700 sec thermal transient with and without radius block reinforcement.**

Lockheed Martin proposed the corrective action of retro-fitting the feet on every Al-2090 stringer with structural reinforcement in the region of the first several attachment fasteners at the forward end of the intertank. These reinforcements, known as “radius blocks” because they fit into the radius between the stringer sidewall and foot, were 0.190-inch thick strips of aluminum alloy Al-2024 and were mechanically fastened to the outside of the stringer feet (Figure 19). Similar reinforcements were already in use by design on stringers near cutouts in the intertank. The repair required the removal and replacement of several of the forward stringer attachment fasteners. However, due to the risk of possible collateral damage to the LOX tank dome in removing the forward-most fastener, this fastener was untouched, and the radius blocks did not cover the stringer feet at the forward fastener.

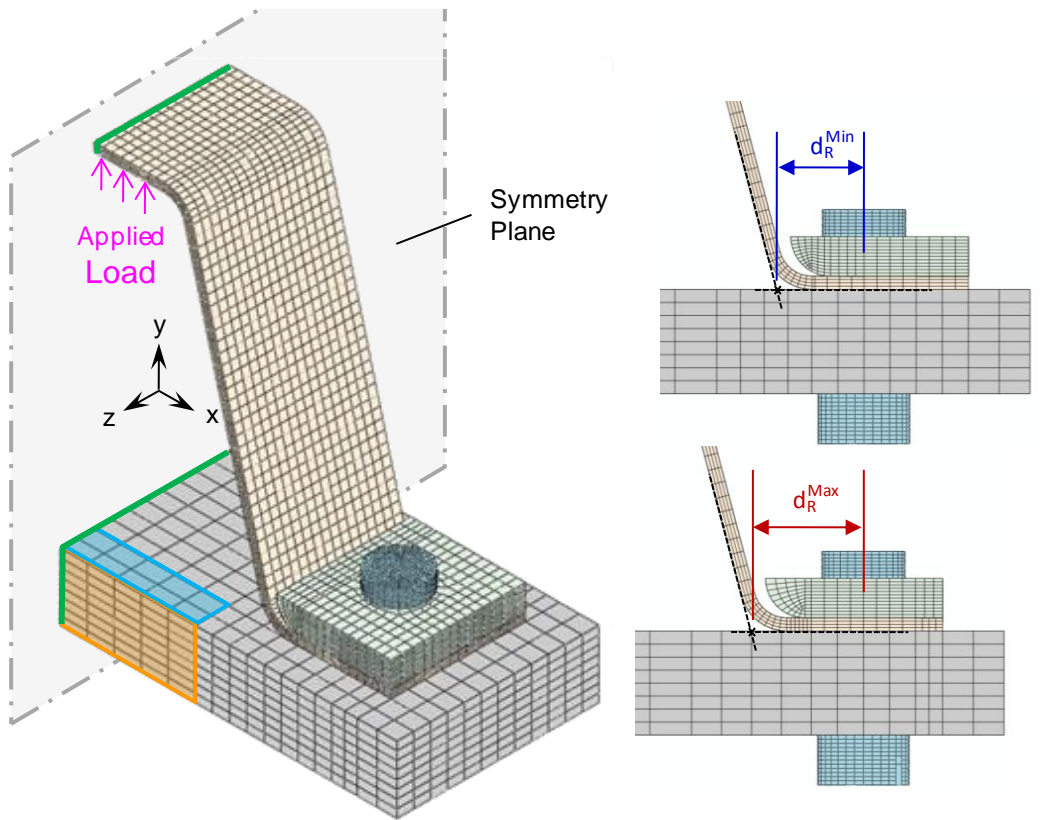
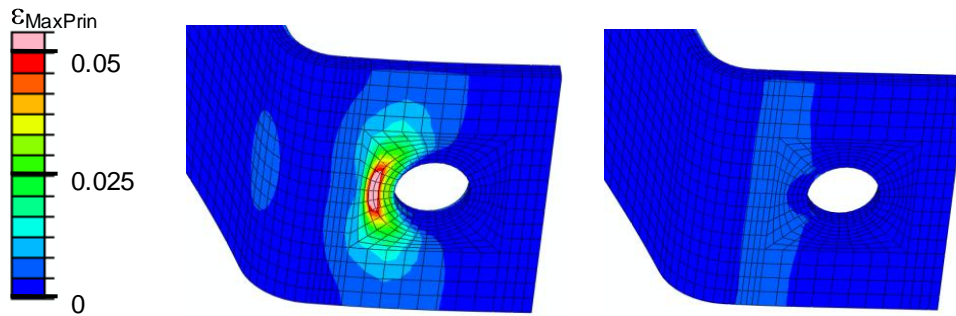
Parametric analyses were conducted to study radius block performance in the presence of allowable dimensional tolerance stack-up conditions between the stringer foot and radius block. The parametric analyses used a FE model of the Lockheed Martin clip test geometry. The purpose was not to compare analytical predictions to test results, but rather to use the simple sub-component test article geometry as an analytical test bed for understanding the sensitivity of stringer foot stresses and strains to dimensional variation. These analyses were conducted using the ABAQUS<sup>§</sup> commercial FE code. Three-dimensional brick elements were used to model the geometry of the clip tests. The sensitivity of stringer foot stresses and strains to tolerance conditions was studied by parametrically varying the model geometry for conditions such as fastener location relative to the sidewall of the hat stringer, both with and without radius blocks (Figure 21). The results showed that the radius blocks significantly mitigated strains induced by some credible tolerance conditions.

Figure 21. Parametric analyses of clip test specimens with and without radius blocks.

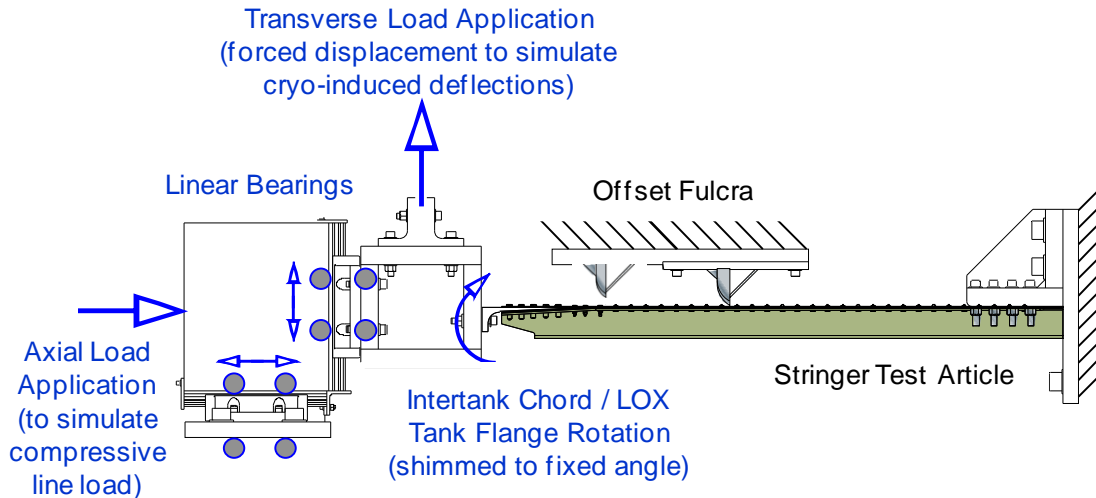
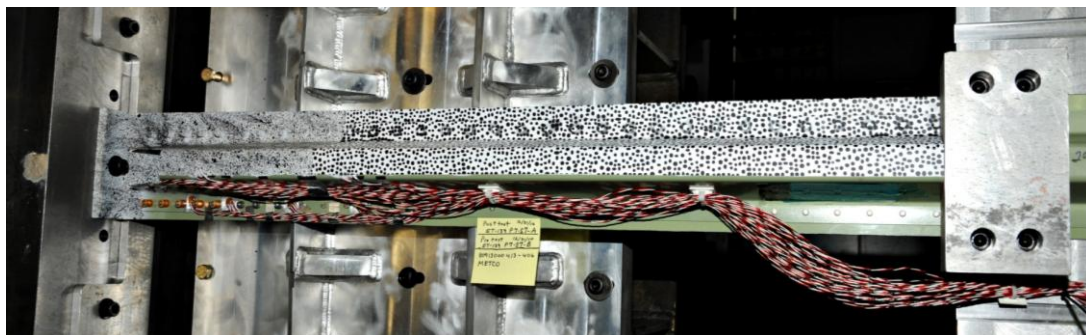
The test apparatus for what would eventually become colloquially known as “single stringer bending tests” was assembled at the MSFC Materials Environment Test Complex (METCO) facility. The test configuration is shown in Figure 22. Each stringer test article was approximately 40 inches long and consisted of the forward end of a single stringer attached via actual flight fasteners to an approximately 5-inch wide cross-section of skin, extruded shim, and chord. The stringer test article was anchored to the test fixture at the aft end. At the forward end, the article was attached to load blocks with a single bolt through the chord simulating the local attachment of the intertank chord to the LOX tank ring frame. The load blocks were mounted on linear bearings to allow for axial and transverse stringer displacement but prevent free rotation of the chord. A wedge-shaped shim, installed between the chord and load block, was used to fix the chord angle (relative to the load block) to the worst case value predicted by the ANSYS FE analysis and validated with the tanking test photogrammetry data. A hydraulic jack was used to apply a transverse load, bending the stringer over two fixed, offset fulcra to simulate the cryogenically-induced displacements. The location and offset of the fulcra were determined from basic thermal deflection calculations to induce a flight-like deformed shape into the stringer and to create maximum stresses in the feet of the stringer in the vicinity of the first few fasteners as predicted by the prelaunch analyses.

**Figure 22. Single stringer bending test setup.**

Initially, it had been envisioned by the stress analysts that the focus of testing would be to collect load, strain, and deflection data to validate the FE modeling approach used to study prelaunch and flight. On the very first test runs it was seen that when stringers fabricated from suspect material were tested to failure in this apparatus, the crack failures experienced on ET-137 could be accurately reproduced; i.e., a sudden brittle fracture of the feet of the stringer just inboard of the fasteners (Figure 23). The primary focus of the tests soon changed to become a study of

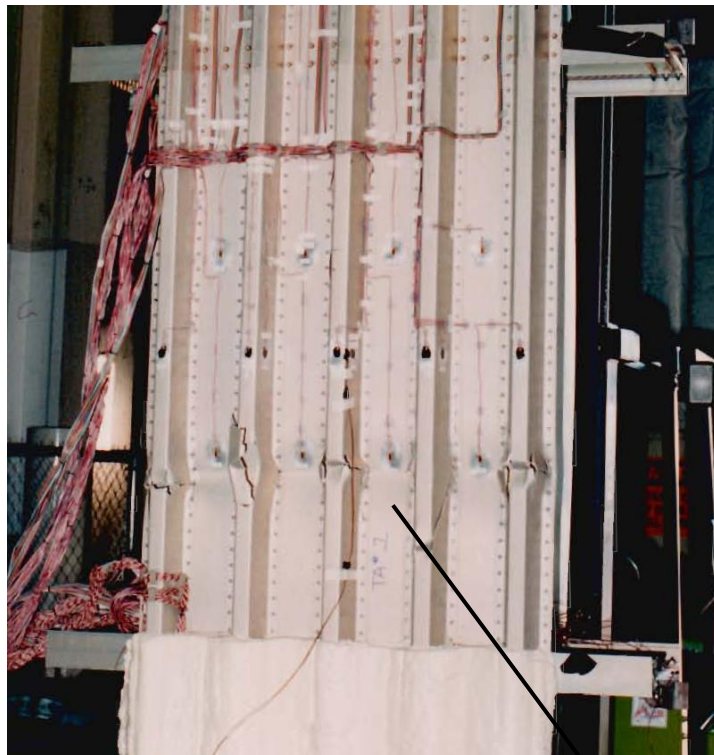
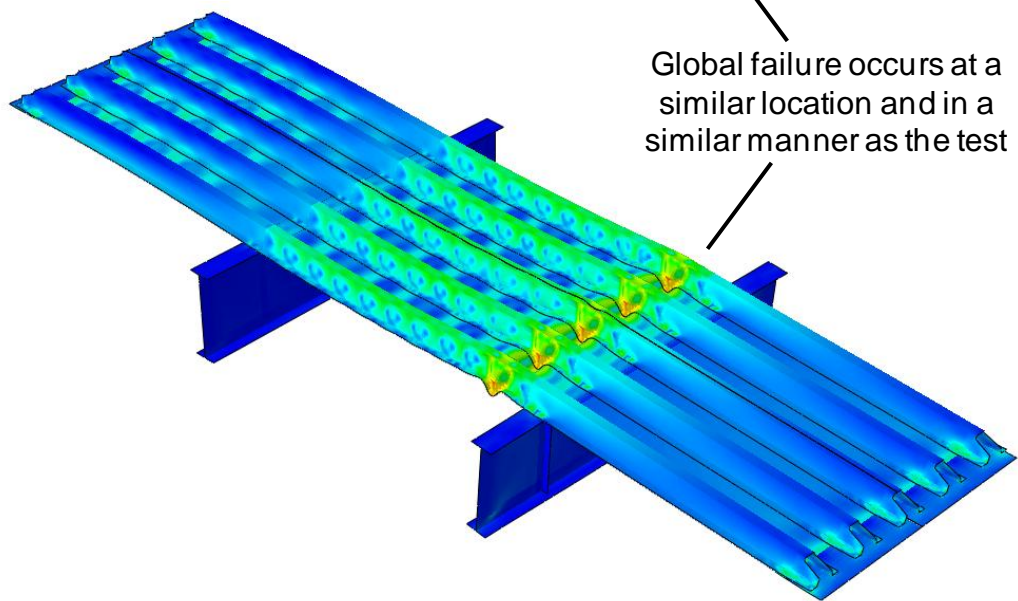
The model of the “as-tested” panel configuration correlated well with the measured test data retrieved from archive: the global stability failure mode and location matched photographic records of the original test, and FE-predicted stresses correlated well to those derived from strain gage measurements (Figure 25). The FE model over-predicted the compressive load at panel failure by almost 20%, but it was decided to address this unconservatism in subsequent iterations of the model through the use of a knockdown factor.

Global failure occurs at a similar location and in a similar manner as the test

**Figure 25. Stringer panel compression test photograph compared to FE prediction of global stability failure (von Mises stress and deformation exaggerated 3X).**

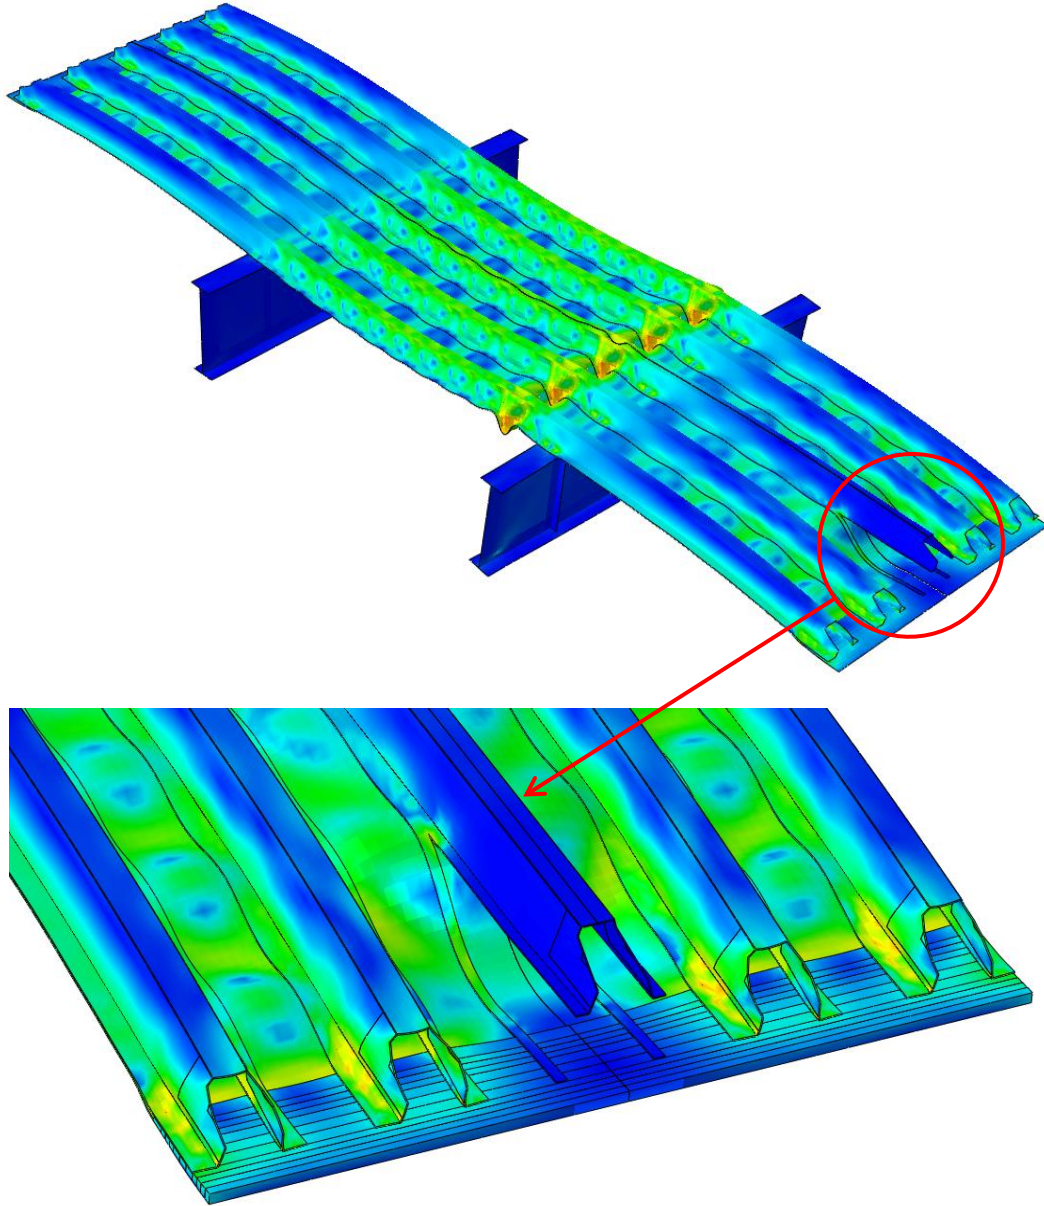
With analysis of the as-tested panel configuration completed, the FE model was modified, first to better match the current flight configuration of the intertank skin/stringer panels, and then to simulate cracks in the feet of the stringers representative of those found on ET-137. The changes to the panel configuration included adjustments to the skin thicknesses, increasing the thermal deflection to current estimates, and modifying the stringer material properties to match those of the suspect stringer lots (based on data from the FAT). Various crack lengths and numbers of cracked stringers were analyzed to study the tolerance of intertank stability to damaged stringers. It was concluded that cracks in only one stringer did not significantly affect the buckling capability of a panel, and multiple cracks in both feet of three adjacent stringers maintained a positive fail-safe margin of safety for stability (Figure 26). However, all scenarios with cracked stringers exhibited significant local skin buckling immediately under the stringers, which was identified as a concern for increasing the risk of foam debris due to potential SOFI debonding.

**Figure 26. Example fail-safe analysis of single stringer with long cracks in both feet (von Mises stress and deformation exaggerated 5X). Note the global failure occurs at a similar location and in a similar manner as the baseline FE model with no cracked stringers.**
