Stringer Bending Test Helps Diagnose and Prevent Cracks in the Space Shuttle's External Tank

Joseph B. Saxon¹, Gregory R. Swanson², William P. Ondocsin³, and Robert J. Wingate⁴
NASA Marshall Space Flight Center, Huntsville, AL

Extended Abstract of Proposed Paper for the 53rd AIAA/ASME/ASCE/AHS/ASC Structures, Structural Dynamics, and Materials Conference, April 23-26, 2012, Honolulu, Hawaii

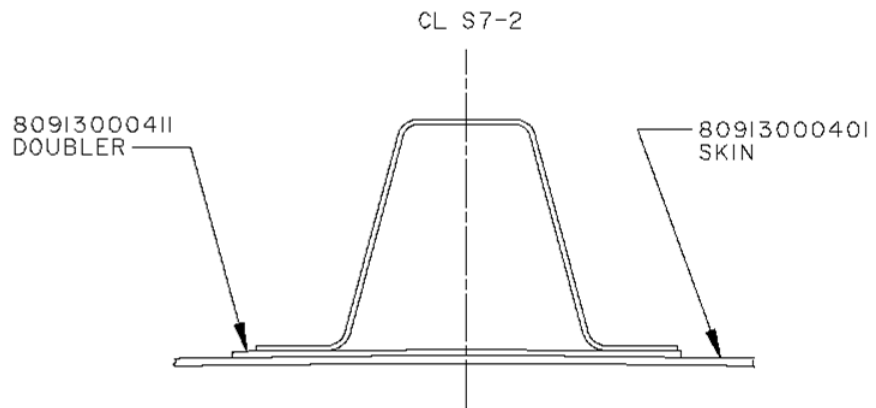
Figure 2. Typical Intertank skin and stringer cross section.

When the propellants are loaded, both ends of the Intertank approach cryogenic temperature and contract inward. The center of the Intertank remains at warmer temperature and resists contraction, causing considerable bending of the stringers, especially at the ends. Figure 3 shows cracks on the LOX end of a stringer that are consistent with this loading scenario, appearing as if the stringer end pulled away from the skin, fracturing the stringer foot along the fastener line. Fractography analysis indicated the ET-137 fractures were static, initiating on the bottom of the stringer foot (the tensile side of bending) between the 2nd and 3rd fasteners from the end. The video footage of the launch attempt indicated that the fracture occurred precisely when the LOX level should have reached the Intertank/LOX tank interface. No cracks were detected at the LH2 end of the ET-137 Intertank.

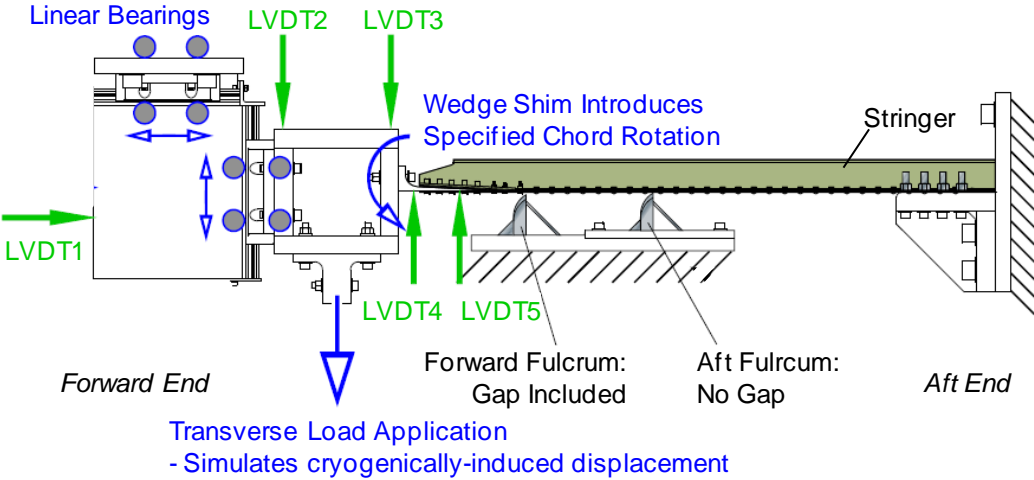
Figure 4. MSFC single stringer bending test configuration.

On December 31, 2011, MSFC tested its first flight-like stringer. There were two defining characteristics of this bending test: (1) the stringer was from a suspect heat lot, and (2) it marked the first use of the double-fulcra configuration shown in Figure 4. The double-fulcra was intended to drive more load into the forward fasteners than achieved in the pathfinder tests. The test reached an estimated nominal deflection without incident, but with a small and slow increase in load, the stringer failed suddenly with a fracture pattern that perfectly matched that seen on ET-137. This was a watershed moment since no previous testing at MSFC or MAF had clearly replicated the failures seen on ET-137.
