VIIRS on-orbit optical anomaly – lessons learned

Glenn Iona^a, James Butler^a, Bruce Guenther^b,
Larissa Graziani^c, Eric Johnson^d, Brian Kennedy^e, Craig Kent^b, Robert Lambeck^f,
Eugene Waluschka^{a,} Xiaoxiong Xiong^a

SPIE Earth Observing Systems XVII 12-16 August 2012, San Diego, USA

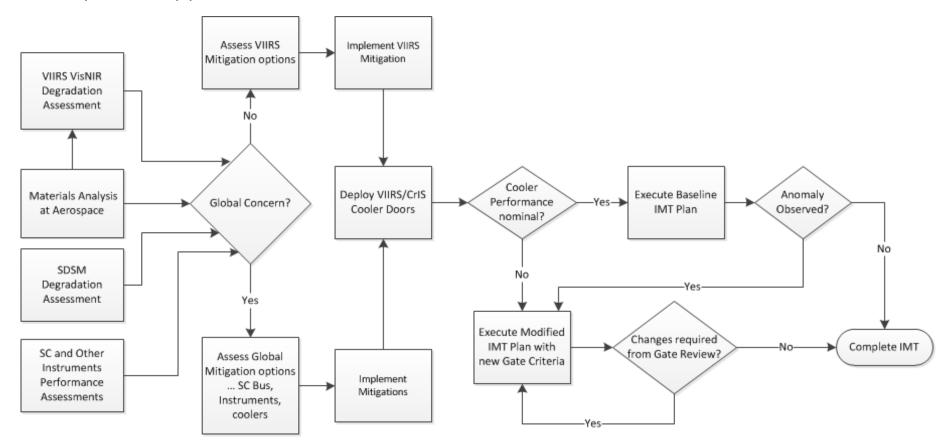
Anomaly Investigation(4) VIIRS Events and Special Tests (ST)

• The Raytheon anomaly team outlined four VIIRS special tests to discriminate between the VisNIR/DNB and SDSM optical path degradation. The timeline, data and results are shown in the next few charts.

Test Activities	Objective	Conclusions / Findings
VIIRS Special Tests #1 – RTA and SDSM stowed 3 days (12/9 – 12/12) • Evaluate rate of degradation for VIIRS/SDSM (RTA stowed eliminating optics UV exposure)		 VIIRS NIR degradation returned to slower decay SDSM NIR degradation continued at same rate
VIIRS Special Tests #2 - RTA stowed in daylight, Night Obs with Solar Cals (12/15 – 12/19) • Minimize light on VIIRS optics to discriminate between solar and other contamination effects while providing trend data		 VIIRS NIR degradation returned to slower decay SDSM NIR degradation continued at same rate Active contamination source unlikely to be the cause
 VIIRS Special Tests #3 – Long stow of RTA/SDSM ~ 1 week (12/21 – 12/28) Confirm SDSM degradation rates are relatively insensitive to solar exposure Stow 12/21 – 12/28, 1-day OP_D/OP_N mode to measure rate of decay 		 VIIRS NIR degradation returned to slower decay SDSM NIR degradation confirmed not to be UV related as it continued to decay at the same rate

VIIRS Special Tests #4 - Short stow of RTA/SDSM not operating ~ 4 days (12/29 – 1/2)	Stow 12/29 – 1/2 to halt degradation while we awaited the Aerospace witness sample results	 VIIRS NIR degradation returned to slower decay SDSM NIR degradation continued at same rate
