CLEANING STUDY OF GENESIS SAMPLE 60487. K. R. Kuhlman¹, M. C. Rodriguez², C. P. Gonzalez², J. H. Allton², D. S. Burnett³; ¹Planetary Science Institute, 1700 East Fort Lowell, Suite 106, Tucson, AZ 85719; kim@psi.edu, ²NASA/Johnson Space Center, Houston, TX 77058; ³California Institute of Technology, Pasadena, CA.

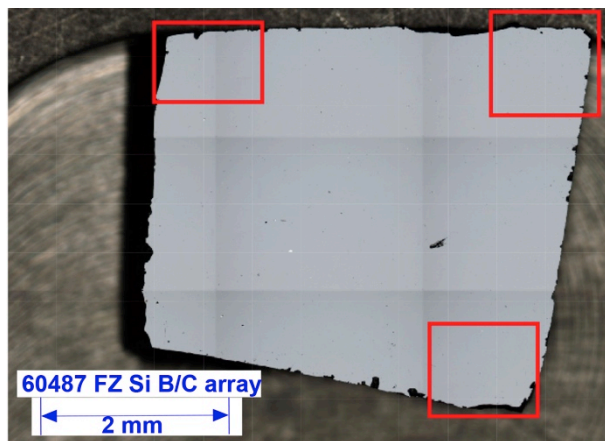
Figure 1. 5X Optical image of Genesis sample 60487 with regions scanned at higher resolution indicated. The region analyzed in this study is at Position 1, the upper left hand corner of the sample.
