# International Space Station Crew Quarters On-Orbit Performance and Sustaining

The International Space Station (ISS) Crew Quarters (CQ) is a permanent personal space for crew members to sleep, perform personal recreation and communication, as well as provide on-orbit stowage of personal belongings. The CQs provide visual, light, and acoustic isolation for the crew member. Over a 2-year period, four CQs were launched to the ISS and currently reside in Node 2. Since their deployment, all CQs have been occupied and continue to be utilized. This paper will review failures that have occurred after 4 years on-orbit, and the investigations that have resulted in successful on-orbit operations. This paper documents the on-orbit performance and sustaining activities that have been performed to maintain the integrity and utilization of the CQs.

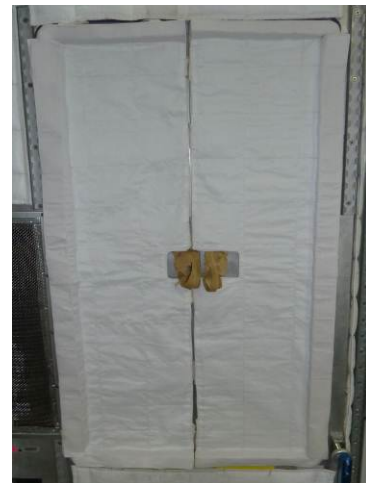
**Figure 8. Cover installed on CQ exterior doors.**

In early 2011, a blanket replacement plan was recommended by the CQ project and approved by the ISS Program. A crew contact assessment was performed to investigate the possible contact on each blanket. This led to the identification of “low contact” and “high contact” areas. The replacement plan recommended replacing low frequency crew contact blankets approximately every 5 years and covering high frequency crew contact blankets with covers (Fig. 8) approximately every 3-1/2 years. The covers would be attached on top of the existing blankets to protect the blankets from spills and wear. The covers do not contain any acoustic mitigation material. They consist of one layer of Nomex® and one layer of Gore-Tex®, identical to the outer layers of the acoustic blankets. In addition, the covers use and provide the same crew attachment points, such as grommets and Velcro®, as the current blankets. By developing lighter-weight covers instead of replacing the high frequency crew contact blankets, 16 kg and 0.16 m<sup>3</sup> of upmass and volume could be saved for the four CQs. One set of spare blankets and covers was manufactured in 2011 and early 2012. In July 2012, H-II Transfer Vehicle 3 delivered the first set of blanket covers to the ISS. The remaining covers are currently in stowage until required on-orbit.

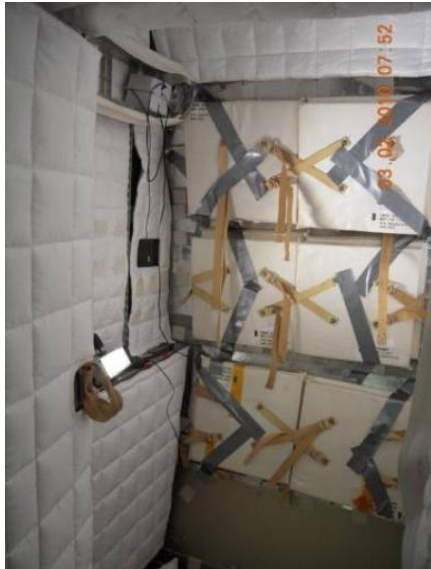
**Figure 11. Six TeSS bricks installed on CQ back wall.**

the best use of the material and there is a clear benefit to integrating the additional radiation protection inside the CQ. Deploying six TeSS bricks on the back wall of each of the CQs can achieve approximately 16% of additional radiation reduction in nominal conditions. Furthermore, if the bricks are placed in other configurations that were analyzed, additional radiation reduction in nominal conditions can range from approximately 4% to 16%.

The integration assessment evaluated five different configurations of six flat brick assemblies inside the CQ volume. The CQ trainer that is located at JSC was used for the evaluation. The five different configurations included permutations of attaching the bricks to the CQ back wall (Fig. 11), back wall and floor, and sleep wall and floor. Additionally, the evaluation considered whether the radiation bricks could be deployed on the CQ back wall underneath the CQ blankets. Installing the bricks in this manner would keep the integrity of the crew attachment points (Velcro®) for personal items on the back wall, as well as eliminate the abrasion points from the TeSS brick pins.
