# Testing and Analysis Validation of a Metallic Repair Applied to a PRSEUS Tension Panel

**A design and analysis of a repair concept applicable to a stiffened composite panel based on the Pultruded Rod Stitched Efficient Unitized Structure was recently completed. The damage scenario considered was a midbay-to-midbay saw-cut with a severed stiffener, flange and skin. Advanced modeling techniques such as mesh-independent definition of compliant fasteners and elastic-plastic material properties for metal parts were utilized in the finite element analysis supporting the design effort. A bolted metallic repair was selected so that it could be easily applied in the operational environment. The present work describes results obtained from a tension panel test conducted to validate both the repair concept and finite element analysis techniques used in the design effort. The test proved that the proposed repair concept is capable of sustaining load levels that are higher than those resulting from the current working stress allowables. This conclusion enables upward revision of the stress allowables that had been kept at an overly-conservative level due to concerns associated with repairabi

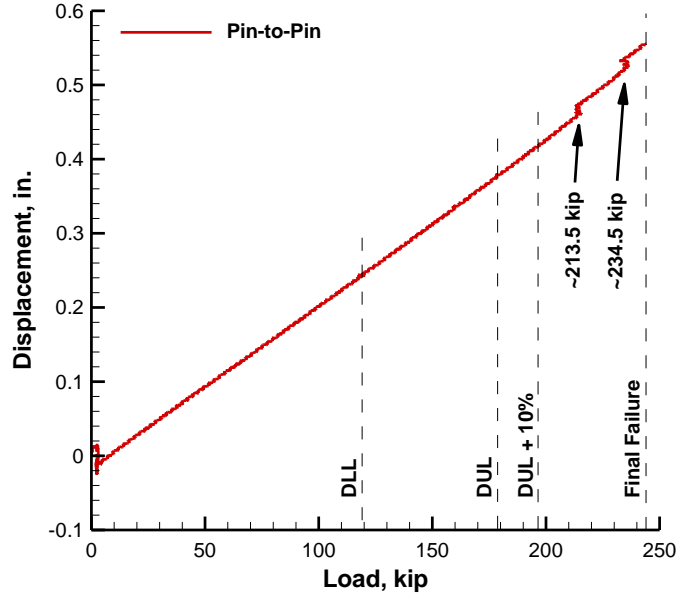
The final panel failure occurred at the loading of 243,992 lb. Failure mode is illustrated in Figure 9. The failure occurred away from the center section of the panel, i.e., away from the initial saw-cut damage, generally in the vicinity of the top foam-filled frame. While pin-to-pin elongation of the panel presented in Figure 10 shows linear global behavior up to approximately 213.5 kip load level, i.e., greater than DUL+10%, subsequent sections detail several localized effects not identifiable in the global displacement plot. Some of these local events did not significantly influence the final failure, but nevertheless it is worthwhile to trace the damage progression, as it helps in understanding the mechanics of the structure. Identification of test behavior before embarking on FE predictions assessment is also helpful in the process as the adopted modeling assumptions and analysis fidelity can be placed in the context of the actual article behavior.

Figure 10. Pin-to-pin displacement versus loading.

The final failure was preceded by two noticeable load reductions, as illustrated in Figure 10, occurring around 213.5 kip and 234.5 kip. More detailed examination of the two load reductions in Figure 10 (not shown for brevity) revealed that each were comprised of two separate but closely spaced events. A summary of the loads and locations of these events is shown in Table 2.

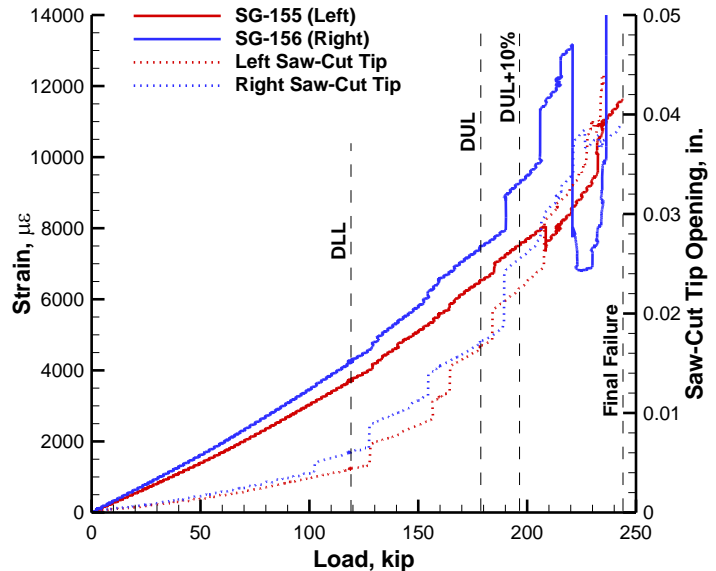
The first identifiable local failure was initiated in the region of the right-hand-side saw-cut tip (when looking at the panel from its stiffened side) at a load of 102.5 kip or 86.1% of DLL and is shown in Figure 11. The tip of the saw-cut is highlighted with a yellow dashed line in Figure 11 and the speckling visible inside the saw-cut area is on the smooth side doubler. The surface fiber splitting is not easily visible in Figure 11, however, the extent of the splitting was 0.15 in. and was determined based on displacement contours from the high-resolution VIC-3D acquisition. Both left- and right-hand-side saw-cut tip openings and surface splitting lengths were traced using the high-resolution VIC-3D acquisition throughout the entire loading sequence. For brevity, only the surface openings are presented in Figure 12 along with strain readings from the two closest strain gages, SG-155 and -156, located one inch to the side of the left- and right-hand side saw-cut tips, respectively. It is seen in Figure 12 that the initial saw-cut tip event at 102.5 kip was so minor that it did not result in a noticeable strain reading disruption in the two aforementioned strain gages. It is therefore concluded that this local event did not significantly affect the behavior of the panel away from the saw-cut for load less than DLL.

Figure 12. Saw-cut tip openings and strains in its vicinity.

Increasing tip opening and surface splitting lengths were also noticed near the saw-cut and, contrary to previous observation at load less than DLL, the surface splitting development was observed at both left- and right-side saw-cut tips. As this form of damage progressed, its effects became noticeable further away from the saw-cut tips, as strain gage SG-155 and -156 recorded some perturbations visible in Figure 12. Though the surface splitting length growth is not plotted for brevity, a gradual increase in saw-cut tip opening that did not correspond to the surface splitting length growth was observed. On the other hand, each discontinuity in a saw-cut tip opening shown in Figure 12 corresponded to an instantaneous increase in the length of the surface splitting. It was, therefore, concluded that gradual increases in saw-cut tip openings were associated with potential energy increasing at the saw-cut tip. The energy was released in an abrupt fashion when the length of surface splitting increased. Again, note that none of the events occurring at loads less than DUL lead to identifiable events in the global behavior, i.e., the pin-to-pin elongation versus load curve, as shown in Figure 10.

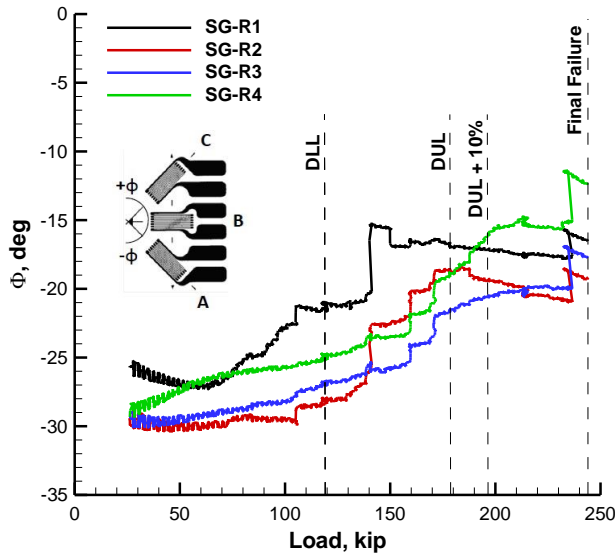
The only other minor event at load less than DLL was identified based on the strain gage data from the rosettes affixed to the severed stringer under the repair angles. Specifically, a slight discontinuity was first noticed in the strain principal direction shown in Figure 13 at 106.0 kip in rosettes SG-R1 and -R2. Note that these two rosettes are affixed to the tapered section of the stringer, where the pultruded rod has only a partial overwrap, a configuration that can potentially be prone to delamination. It is therefore concluded that a minor delamination in the tapered section between the pultruded rod and the partial overwrap might have occurred at this instance. Note that the event is so minor that the maximum principal strain values shown in Figure 14 are virtually unaffected.

Figure 13. Principal strain direction from severed stringer strain gage rosettes.

As the load was increased above the DLL, additional damage developed in the panel. Based on previously introduced principal direction and maximum principal strain plots (Figure 13 and Figure 14, respectively) it is likely that the suspected delamination of the pultruded rod in the severed stringer progressed in an abrupt fashion around 141.3 kip load. This event was more pronounced when compared to the previously noted event of similar nature at 106.0 kip, as evidenced not only by a more substantial principal direction change in Figure 13 but also by a strain level reduction in Figure 14. Note though, that the behavior was still limited to SG-R1 and -R2 affixed within the tapered section of the severed stringer. Several less pronounced events occurred between 141.3 kip and DUL. While these discontinuities in principal strain direction and magnitude were considerably smaller, their significance stems from the fact that they involved a larger span of the severed stringer. This conclusion is based on discontinuities identified also for rosettes SG-R3 and -R4 affixed beyond the tapered section of the stringer.

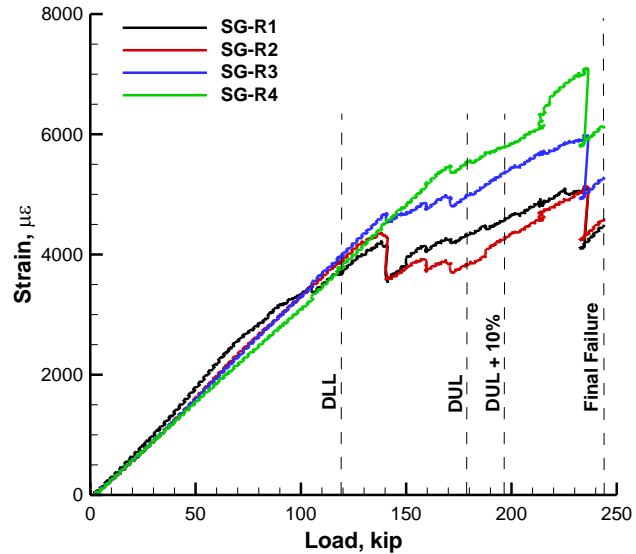
Figure 14. Maximum principal strain from severed stringer strain gage rosettes.

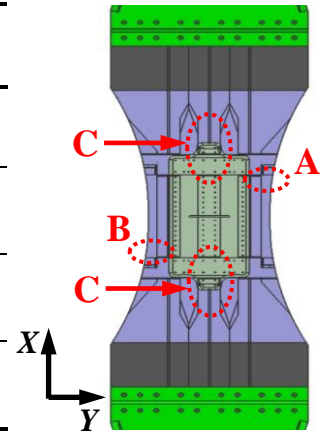
**Table 2. Summary of events associated with the two load reductions.**

Event	Load, kip		Description
	Before	After	
1 (1 <sup>st</sup> event in the 1 <sup>st</sup> load reduction)	214.5	212.7	Cracks developed in area A
2 (2 <sup>nd</sup> event in the 1 <sup>st</sup> load reduction)	214.2	212.9	Cracks developed in area B
3 (1 <sup>st</sup> event in the 2 <sup>nd</sup> load reduction)	234.5	234.5 <sup>(*)</sup>	Additional cracks developed in area A
4 (2 <sup>nd</sup> event in the 2 <sup>nd</sup> load reduction)	235.6	233.1	Event suspected in the center stringer in area C

<sup>(\*)</sup> Loads associated with the VIC-3D data acquisition shown above are sampled at 1 second rate. Loads associated with the strain gage data sampled at 0.1 second rate confirmed initial load increase and subsequent reduction.

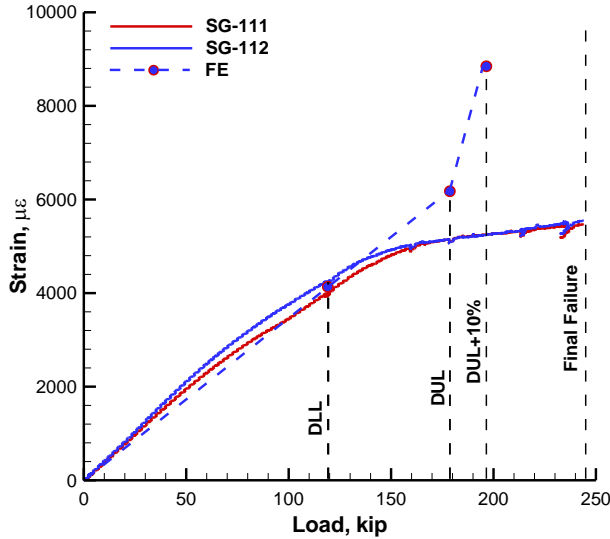
The strain level comparison at the flange section of the stiffened side repair, presented in Figure 26, shows a good comparison only up to the load of approximately 140 kip, which is greater than DLL but less than DUL. Even though the comparison for load less than 140 kip is considered good, a slight departure from the linear characteristic is noted in the test results, but absent in the FE analysis results. For load levels greater than approximately 140 kip the test strain values tend to asymptote and reach only approximately 5,500  $\mu\epsilon$  level at the failure load. The FE analysis results for loads greater than 140 kip, however, first show a linear strain characteristic up to approximately the DUL of 178.7 kip, followed by a softening characteristic due to the yielding stress being exceeded and the plastic response regime being introduced in the mid-span repair section.<sup>11</sup> To assist in analysis of this discrepancy the strains acquired in the web sections of the repair angles are presented in Figure 27, where a less-pronounced but similar softening response for the load greater than DUL can also be noticed and is accurately captured by the FE analysis.<sup>11</sup> Since the locations corresponding to the results in Figure 26 and Figure 27 are only approximately 1.175 in. apart, the difference in strain characteristics may appear surprising at first. Since the flange section of the stiffened side repair is bolted to the panel but its web section is not bolted to the panel, the discrepancy between the measured and predicted strains can be assumed to be related to the manner in which the load is transferred from the damaged center stringer of the panel into the repair assembly. However, strains on the smooth side of the panel must be considered to develop a more complete picture of the test versus analysis comparison.

Figure 26. Mid-span strain vs. load at the flange section of the repair.

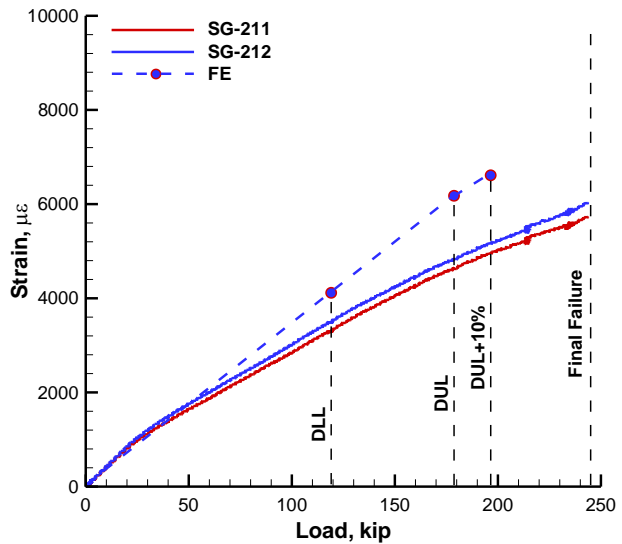
Results for strain gages which are back-to-back relative to those of Figure 24 are shown in Figure 28. The quality of strain comparison on the smooth side of the panel presented in Figure 28 is very good and matches the quality of comparisons achieved in Figure 24 and Figure 25. Strains measured at the mid-span of the smooth side doubler are presented in Figure 29 and match the FE analysis results well only up to approximately 70 kip, i.e., half of the load level up to which a good comparison was obtained on the flange section of the stiffened side repair, as presented in Figure 26. Furthermore, the first noticeable departure from the linear behavior occurred at a very low load level of approximately 30 kip, which might be indicative of fastener joints slipping, especially given that the doubler had countersinks. The second even less pronounced bend in the strain curves occurred around 150 kip, a level comparable to a similar behavior observed in Figure 26. In this context, note that locations of strain gages SG-111 and -112 in Figure 26 are back-to-back relative to strain gages SG-211 and -212, respectively, in Figure 29. Also note that, per Figure 4(a), 36 fasteners installed in the center stringer flange are double shear fasteners that attach both smooth side doubler and stiffened side repair components to the severed stringer.

Figure 29. Mid-span strain vs. load on the smooth side repair doubler.

Given the FE modeling techniques employed in the present FE analysis and outlined in section III, it is reasonable to expect that the behavior of the repair panel was more reliably predicted in its general far-field sections rather than in the vicinity of the fastener joints. Recall that modeling of fastener joints was considerably simplified as the fastener holes were not explicitly modeled and fasteners themselves were represented by connector elements. With such reduced level of fidelity, fasteners and their associated bearing surfaces in the fastener holes were not sufficiently represented to permit calculation of the bearing and bypass stresses within the FE analysis. Furthermore, while material properties of the composite panel can be assumed to be elastic in the entire regime prior to failure, metallic repair components yield before failure. Despite the fact that the elastic-plastic material properties were prescribed for the metallic repair assembly, yielding in the vicinity of the fastener joints could not be accurately predicted by the model. Hand calculations performed using fastener forces obtained from the FE analysis for loads greater than DLL, however, confirmed that a subset of the center flange fasteners would produce bearing stress levels exceeding the yielding stress on both stiffened side angles and smooth side doubler. Elongations of some fastener holes noted after the test and described in section V.D substantiate this result.
