Kržan, M. Bosiljkov, V., Gostič, S., Zupančič, P. 2012. Influence of Ageing and Deterioration of Masonry on Load Bearing Capacity of Historical Building In: 15th World Conference on Earthquake Engineering: 24 to 28 september 2012, Lisbon, Portugal. Lisbon : Sociedade Portuguesa do Engenharia Sísmica : International Association for Earthquake Engineering: p. 1-10.

Influence of Ageing and Deterioration of Masonry on Load Bearing Capacity of Historical Building

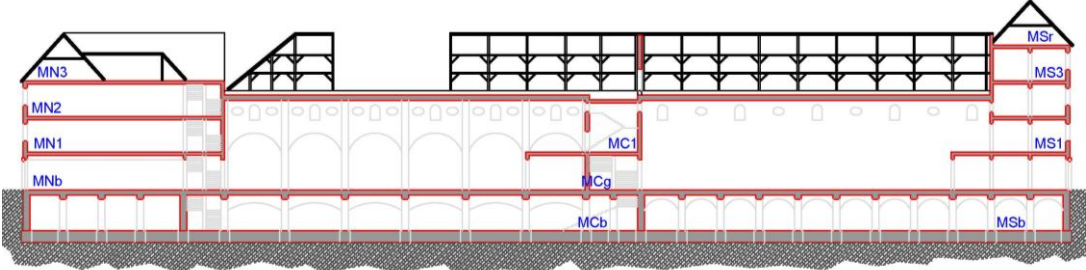
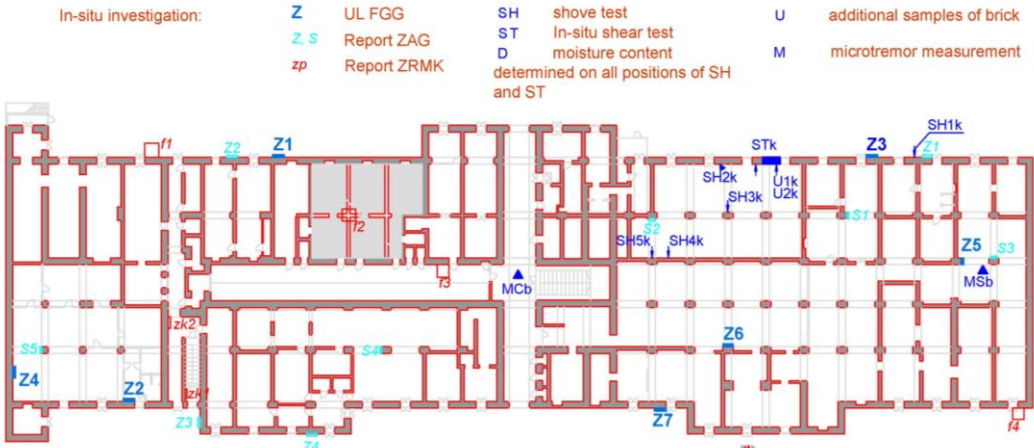
Figure 3. Map of in-situ tests and specimen samplings.

a) cross-section of Kolizej Palace and position of microtremor measurements

b) layout of the basement, testing positions and positions of masonry constituents sampling

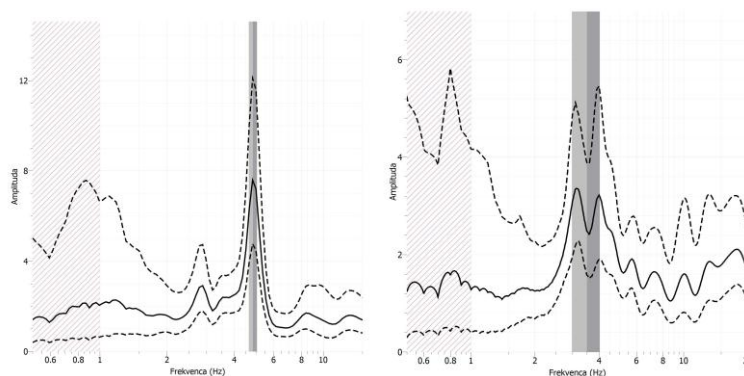
expected due to geometrical characteristics of the building (irregular plan) and the effect of torsion. Floor spectral ratio (FSR) showed two peaks for NS and three for EW. In the South tower, two (NS) and one (EW) peaks were obtained and one in both directions in the north part of the building (Table 3.1 and Fig.7).

Figure 7. Microtremor measurements (FSR - 1st floor to basement) a) N-S direction, b) E-W direction

Soil frequency measured nearby in previous free-field measurements was 3.3 Hz. Compared with the building's fundamental frequencies; the soil-structure resonance in transversal direction is not excluded.

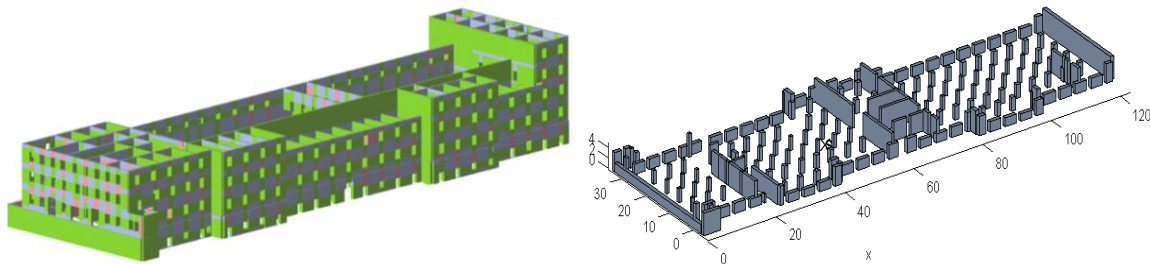
For both approaches 3D model of the building was prepared (Fig.8). Main difference for two approaches is that 3Muri allows global mechanisms response of the whole structure while SREMB consider only critical storey mechanisms response. For 3Muri the floors were modelled as they were in reality; over the basement masonry vaults and over the upper storeys wooden floors. Presumed eccentricity was 0.5%. In analysis two possible lateral load patterns were considered, modal and mass. SREMB model allows only the capacity of one (critical) storey to be calculated separately (mass lateral load pattern). In our case we considered the basement floor. Floor was considered to be a stiff diaphragm.

Figure 8. 3-D model in 3Muri and critical storey model in Sremb
