NASA/TM-2017-219497

Mission Success of U.S. Launch Vehicle Flights from a Propulsion Stage-based Perspective: 1980-2015

April 2017

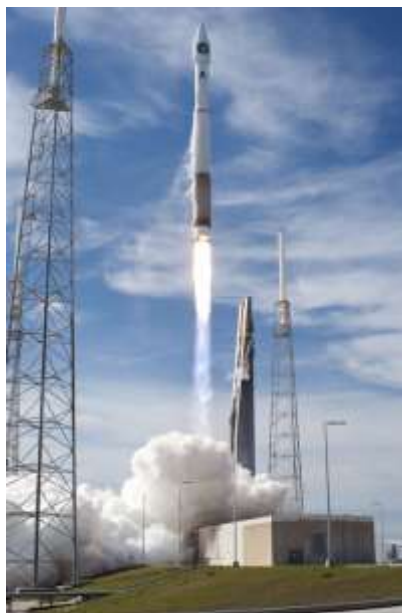
Figure C-4. An Atlas V rocket lifts off from Launch Complex 41. Credit: NASA

The Centaur upper stage shut down four seconds earlier than planned due to a fuel leak in the engine system cryogenic liquid hydrogen valve. The leak continued during the nearly one hour coast phase between the two Centaur main engine burns. Some real-time indications of an anomaly occurred during the mission. Several parameters suggested that the temperature was off-nominal, but the effects of the difference on the performance of the engine were unknown until the premature shutdown due to fuel depletion. Although the payload was placed in a lower orbit than planned, a proper orbit was eventually achieved using the spacecraft's on-board propulsion system.

The failed LH2 fuel valve in the RL10 was a new design used in only a half-dozen previous flights (the manufacturer was phasing the old valve out of their product line). Future Atlas 5 and Delta 4 rocket launches -- both rocket families use versions of RL10 engines to power their upper stages -- planned to revert the previous fuel inlet valve design that officials fully trusted. Subsequent testing during the investigation showed that the heritage valve design had larger closing force margins. This mission also experienced a longer than average first burn, which increased valve exposure to cryogenic hydrogen and elevated valve friction. As a result, the valve did not close completely and leaked fuel during the coast phase [40].

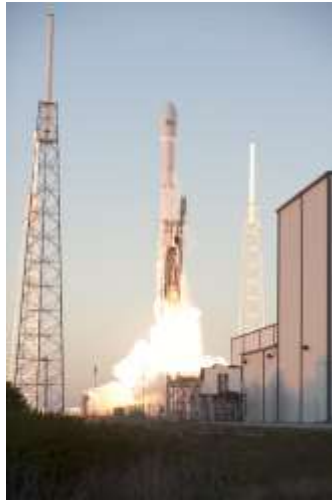
Figure C-7. A Falcon 9 launch vehicle lifts off from Cape Canaveral. Credit: NASA

The first stage of the launch vehicle operated nominally until T+139s when an overpressure event occurred in the upper stage LOX tank. The first stage of the vehicle continued to power through the overpressure event for several seconds before it disintegrated. The Dragon

spacecraft on board the launch vehicle survived and continued to communicate until it fell below the horizon. The time from first indication of trouble to loss of all data was 0.893 seconds. A steel strut holding a high-pressure helium tank was later discovered to have snapped during ascent under the combination of g-forces and cryogenic temperatures, ultimately leading to helium tank rupture within the LOX tank or impact with, and puncture of, the LOX tank wall. In either case, the LOX tank experienced an overpressure event and ruptured catastrophically. The helium tank is located inside the cryogenic oxygen tank for temperature regulation [51].
