Experimental behaviour of a steel structure under natural fire

This paper reports on the results of a collaborative research project (Tensile membrane action and robustness of structural steel joints under natural fire, European Community FP5 project HPRI—CV 5535) involving the following institutions: Czech Technical University (Czech Republic), University of Coimbra (Portugal), Slovak Technical University (Slovak Republic) and Building Research Establishment (United Kingdom). It consists of an experimental programme to investigate the global structural behaviour of a compartment on the 8-storey steel–concrete composite frame building at the Cardington laboratory during a BRE large-scale fire test, aimed at the examination of the temperature development within the various structural elements, the corresponding (dynamic) distribution of internal forces and the behaviour of the composite slab, beams, columns and connections.

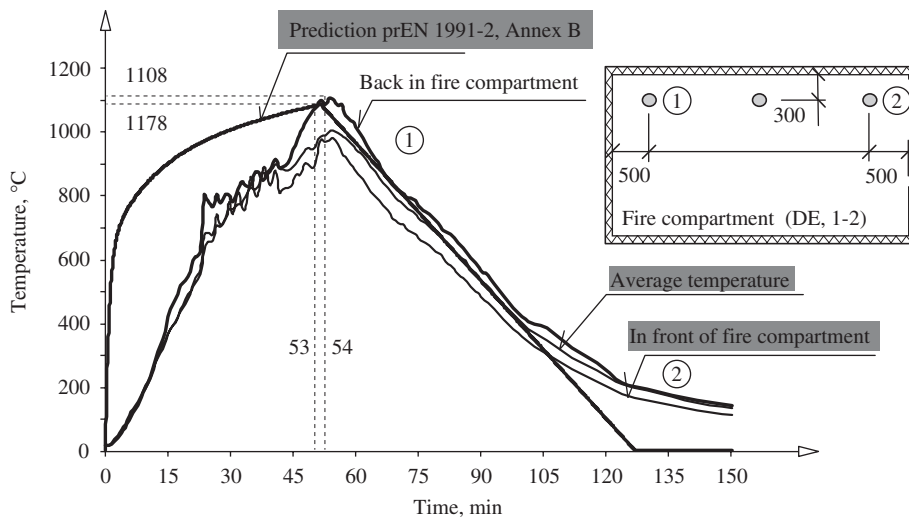
Fig. 10. Compartment temperature.

During the test the predicted local collapse of the structure was not reached, see Fig. 9. Fig. 10 compares

the temperatures recorded in the compartment with the parametric curve presented in Eurocode 1, Annex A [19]. The quantity of thermal load and the dimensions of the opening on the facade wall were designed to achieve a representative fire in the office building. The maximum recorded compartment temperature near the wall (2 250 mm from D2) was 1107.8 °C after 54 min,

while the predicted temperature was 1078 °C in 53 min, see [16].

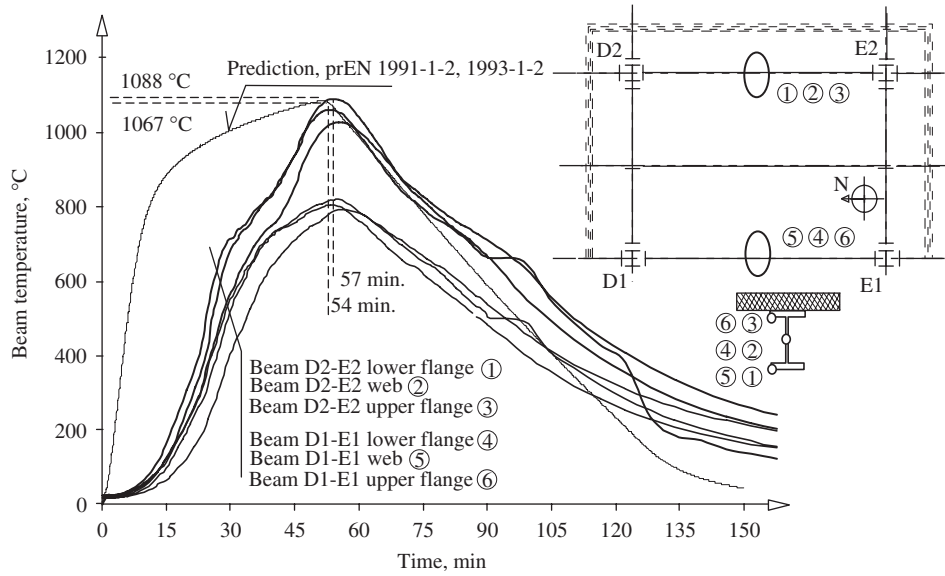
Fig. 11. Differential relative temperature variation within the beams D1–E1; D2–E2.

Measurements of the temperature in the mid-span beams were taken on the bottom flange, on the web and on the upper flange. A summary of the temperatures recorded in the beams is presented in Fig. 11. The maximum recorded steel temperature of 1087.5 °C occurred after 57 min of fire, on the bottom flange of beam DE2 in the middle of the section. By calculation, using a step by step procedure for

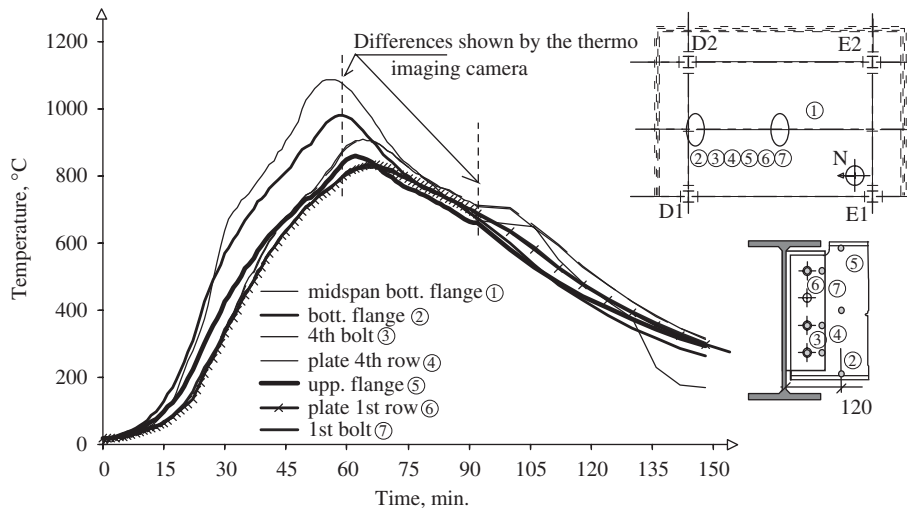
Fig. 12. Differential relative temperature variation within the beam-to-beam fin plate connection D1/2–E1/2.

Measurements of the temperature in the connections were taken on the beam adjacent to the connection, in the plate and in the bolts. A summary of the temperatures recorded in the connections is presented in Figs. 12–14.

In the heating phase, the joint temperature is significantly lower than the remote bottom flange, which is usually the critical element that defines the limiting temperature of the beam; in contrast, the cooling down

in the joints was slower. Using the thermal cameras it was possible to observe this effect, see Fig. 15.

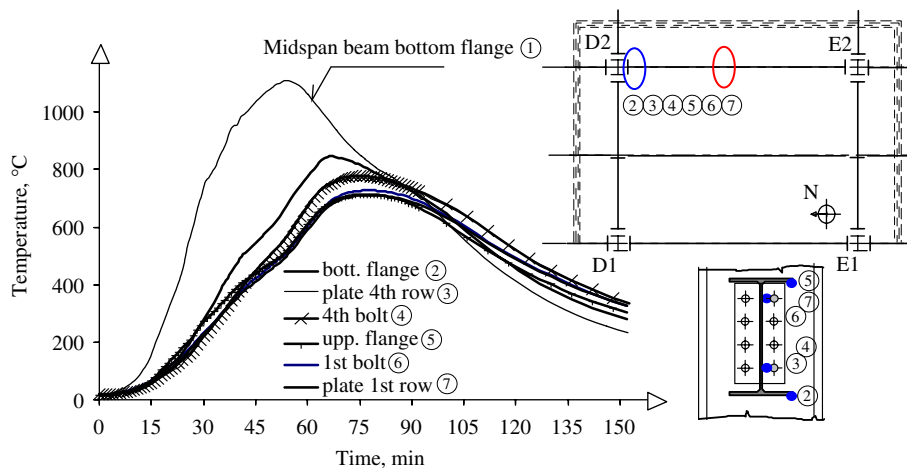
Fig. 13. Differential relative temperature variation within the beam-to-column minor axes end plate connection D2–E2.

column. The end-plate was hotter than the bolts at the same level due to the ratio of the bolt diameter to the end-plate thickness (20 mm).

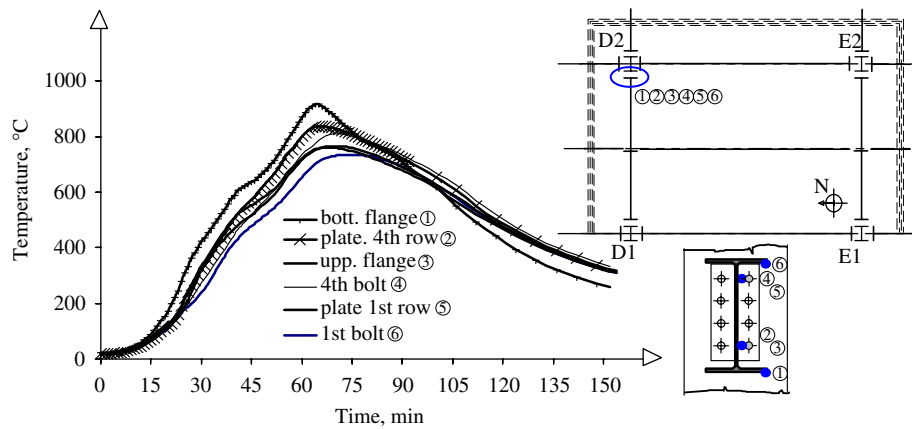
Fig. 14. Differential relative temperature variation within the beam-to-column major axes end plate connection D2–D1.

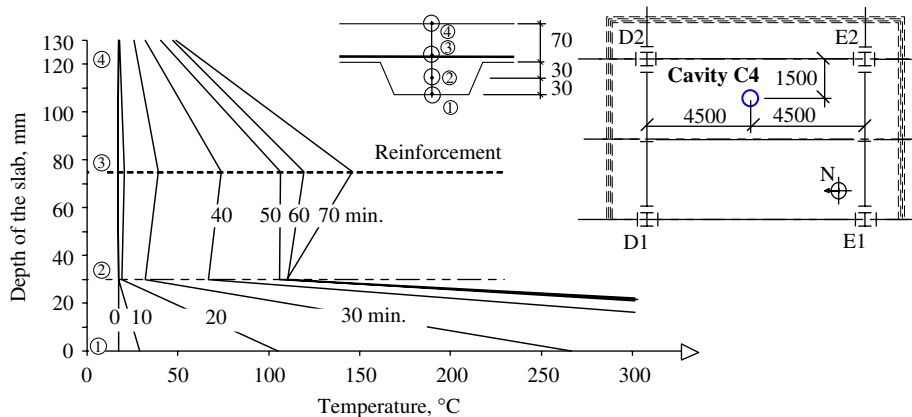
Fig. 16. Differential relative temperature variation within slab over the rib, cavity C4.

A summary of the temperatures recorded in the slab is presented in Fig. 16 for temperatures in the reinforcement over the rib.

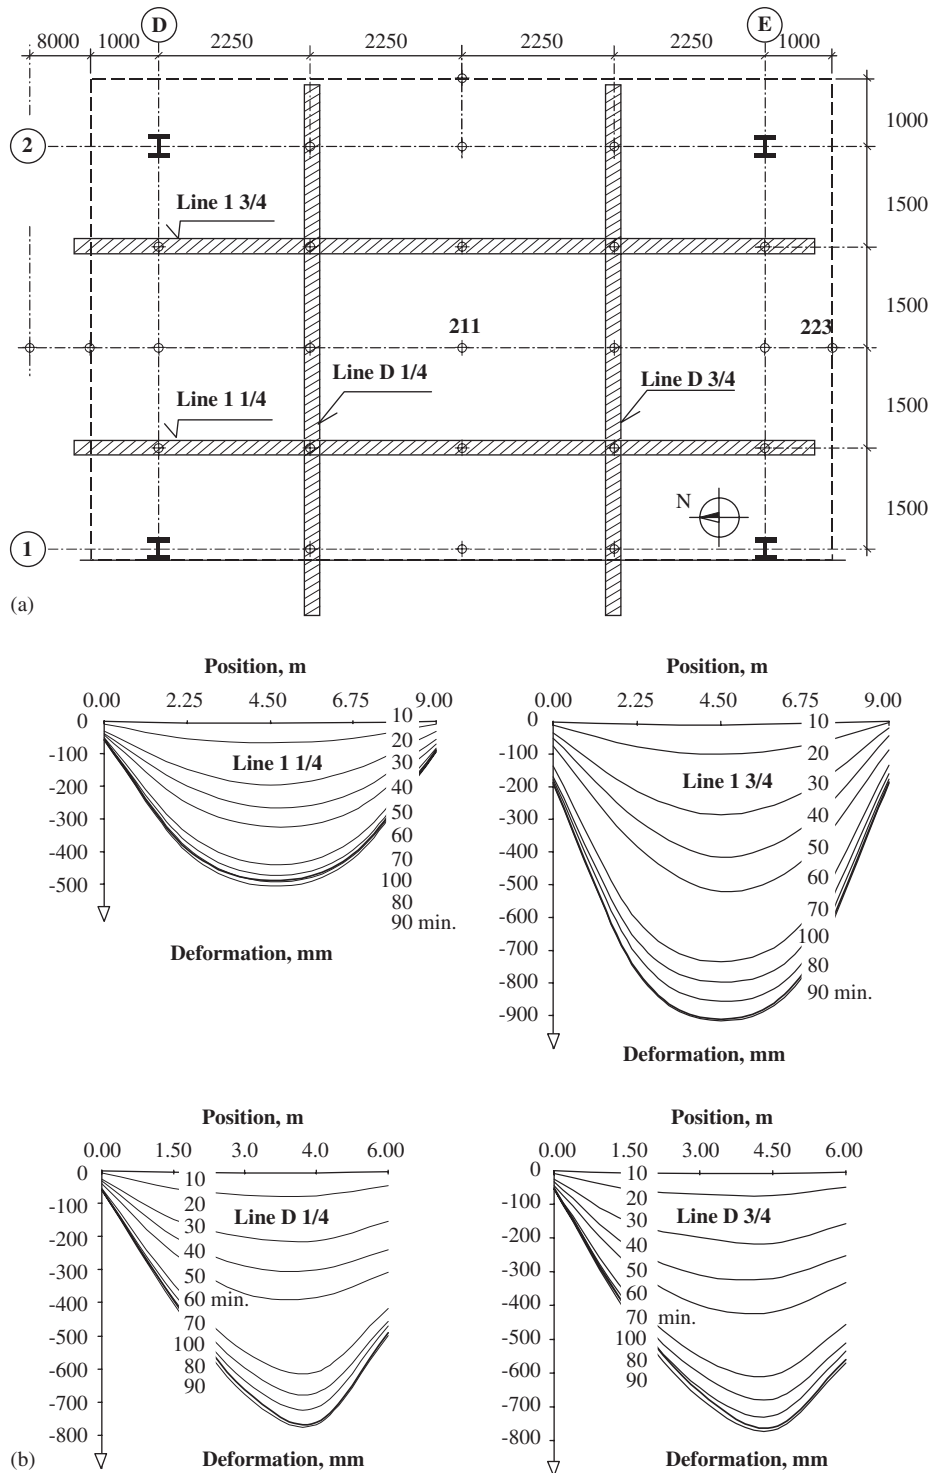
Fig. 17. Vertical deformations; (a) measured points, (b) reached values at drawn lines, * deflection more than 900 mm may be affected by the limited record in transducers.

The maximum deflections were not recorded by the displacement transducers because its range was limited to 1000 mm minus the initial offset. From the video cameras on the 5th floor it is possible to recalculate a maximum vertical displacement of about 1200 mm. Fig. 17 shows the vertical displacement recorded in beams D1–E1, D1/2–E1/2, D2–E2. Comparing the different secondary beams, it is observed that during the heating phase, the beam with a lower displacement is the beam near the window, because of lower temperatures, while the beam near the internal wall shows the biggest displacement. In the cooling phase, both these beams partially recovered.
