# The restoration of San Paolo Church in Pisa: geotechnical aspects

Nunziante Squeglia,\* Stefano Stacul,\* Elena Diddi\*\*

## Summary

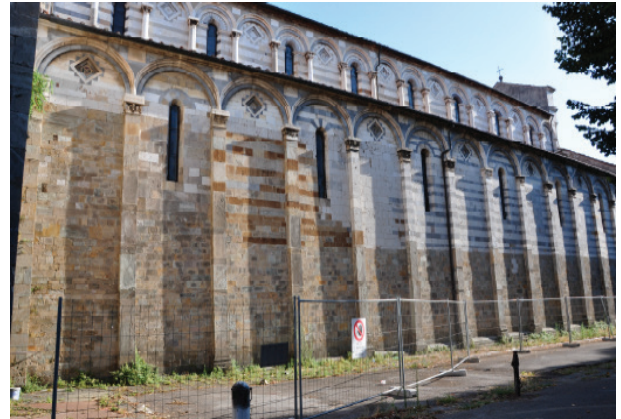
Fig. 3 – North side of the Church.

thern wall (Fig. 3) is different from the southern one (Fig. 4) thanks to the monastery that bordered the Church. The layout of the foundations was also influenced by the different phases of construction; as a matter of fact, the different portions of the Church have a different geometry of foundation. It is well known that the southern wall is weaker than the northern one and poorly arranged not only in the reconstructed portion, but also in the original one.

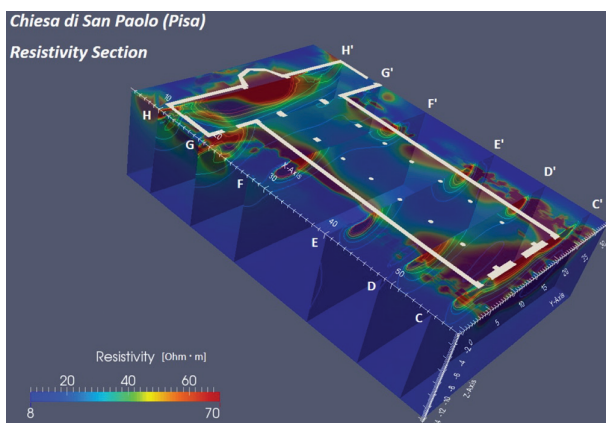
Fig. 15 – Results of electrical tomography.  
Fig. 15 – Vista d'insieme dei risultati delle tomografie elettriche.

whole foundation system of the Church with the installation of more than 100 electrodes, in order to investigate the whole plan of the Church up to 14 m depth. A partial view of the results is reported in figure 15, whereas figure 16 shows a vertical section with details concerning the geometry of the foundations.

sent case an increment of resistivity has been associated to the occurrence of masonry; in figure 16 the foundation seems 2.5 m deep and some meters wide. As reported in figure 15, information about foundation of columns is not available. Such lack of information is due to presence of a metallic grid below internal pavement, discovered after ERT execution.

An accurate analysis of electric tomography and a comparison with direct inspection (say excavation) revealed that the information deduced by means of ERT is not reliable. The reasons of such unreliability are probably connected to the small difference in resistivity between the foundation walls and the ground, rather than the presence of the metallic grid. In fact, similar results have been obtained at the Baptistry in Piazza dei Miracoli, in which the metallic grid below the internal pavement is not present, while the material of foundation masonry is similar (Fig. 17). Further investigation revealed that the foundation were deeper than 2.5 m and the ERT tests have been discarded since the technique was evidently unable to discriminate the masonry from the ground.

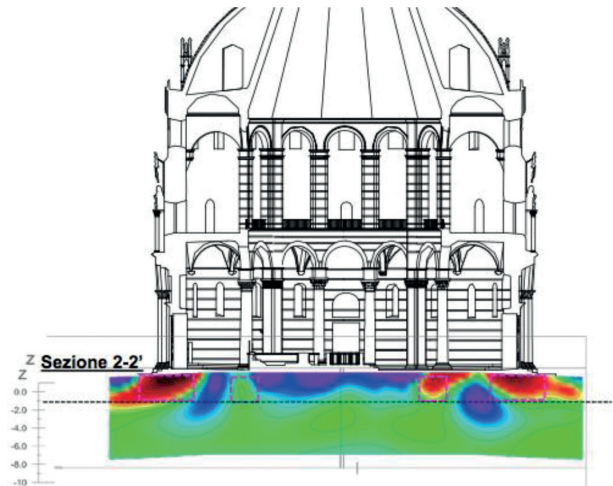
Fig. 17 – Results of ERT for Baptistry.  
Fig. 17 – Risultati delle tomografie elettriche sul Battistero di Piazza Duomo. Si noti la “presenza” della fondazione anche sul lato esterno.
