NASA/TM—2018-219400

Advanced Stirling Radioisotope Generator Engineering Unit 2 Anomaly Investigation

Edward J. Lewandowski
Glenn Research Center, Cleveland, Ohio

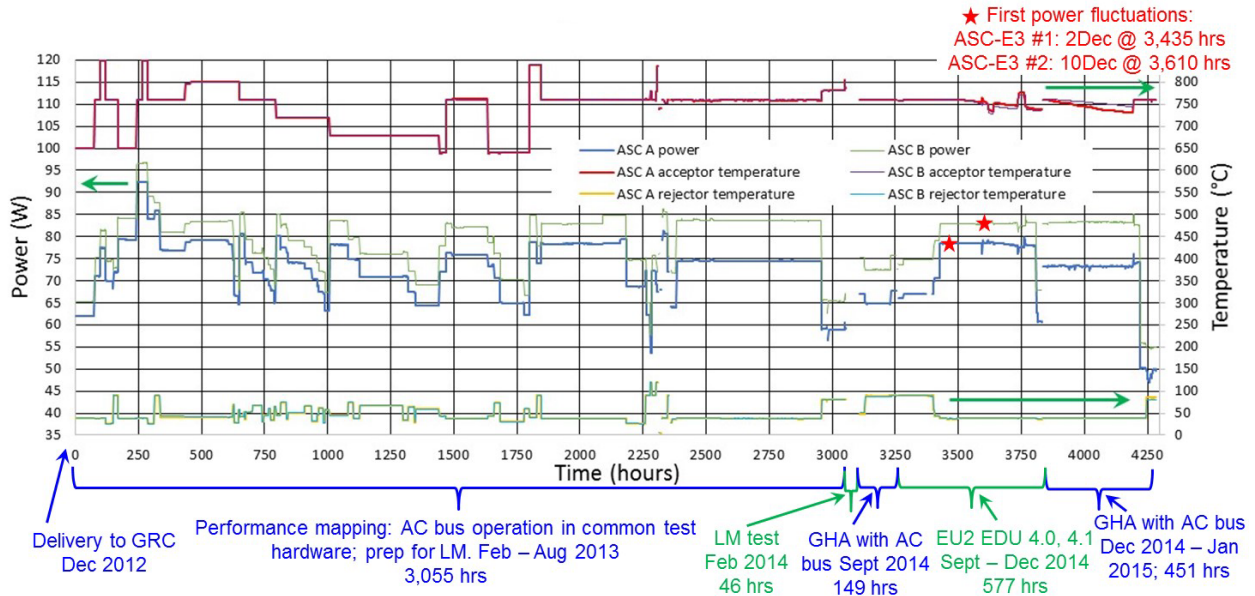
Figure 3.—ASC-E3 #1 and #2 operating history.

Test engineers first noticed small power fluctuations on ASC-E3 #1 as the first indication of a problem with the EU2. After just 179 hr of EU2 generator operation, the first power fluctuation occurred on ASC-E3 #1 (0.4 W drop) on December 2, 2014. This corresponded to 3,435 total hr of operation for ASC-E3 #1 since delivery, 328 hr of operation in the GHA under either AC bus or ACU control, and 225 hr of operation under ACU control (Figure 3). Then 175 hr later, the first power fluctuation occurred on ASC-E3 #2 (0.2 W drop). Figure 4 shows the power fluctuations observed on ASC-E3 #1 and #2 during EU2 operation, which appear as short-duration decreases in power. Some power fluctuations were as small as 0.2 to 0.4 W and lasted less than 2 sec. Over time they became more frequent and greater in magnitude, with some power fluctuations becoming as large as 9 W and lasting for many minutes, if not hours.

The fourth observation was a slow downward drift in hot-end temperature and upward piston amplitude over many hours. The drift began about when the EU2 began operation under fixed heat input at 3,495 hr of ASC operation. Previously, the hot-end temperature was fixed, and the test system adjusted heat input to maintain temperature. In Figure 6, the downward drift in hot-end temperature and upward drift in piston amplitude is clearly seen, superimposed on step changes in hot-end temperature and amplitude when the operating point was adjusted. This drift occurred under both ACU control and AC bus control, which began at 3,833 hr. The ASRG was designed to maintain hot-end temperature and piston amplitude open loop by controlling the ASC voltage setpoint, and this amount of drift was abnormal. This drift can also be seen in figures published previously. The downward drift in hot-end temperature is apparent in Figures 7 and 8 in Reference 2 and the upward drift in piston amplitude is seen in Figure 8 in Reference 2.

The fifth observation was an increase in the current required to move the pistons in the convertors. The ASC startup procedure includes applying a DC current to the alternator to move the piston to a certain position. Beginning with the restart under AC bus control (at 3,833 hr in Figure 3), the current to move ASC–E3 #1's piston was as much as five times the nominal value. The current to move ASC–E3 #2's piston was abnormally high as well.
