# Seismic Behavior of Local Soil and Foundations in Bam City During the 2003 Bam Earthquake in Iran

## Abstract

## 2. Ground conditions in Bam city

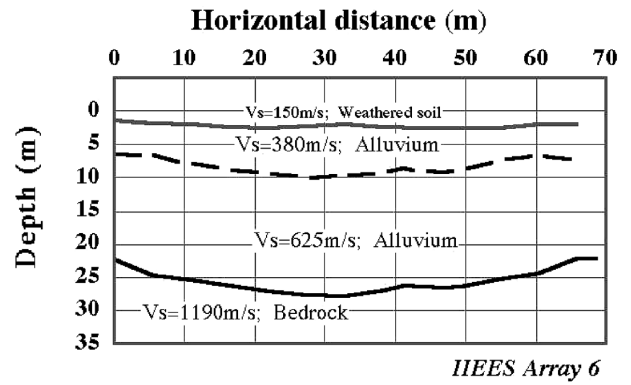
Fig. 4. Example of seismic reflection survey at Array 6 in Bam (study done by IIEES).

The International Institute of Earthquake Engineering and Seismology (IIEES), which is a Tehran-based research institute and was the counterpart of the present investigation, had carried out seismic reflection surveys in and around Bam city prior to the arrival of the authors. The locations of this survey are indicated in Fig. 3. For this study, geophones were installed at intervals of 4 m, and the soil profile obtained has an accuracy of approximately 2 m in the vertical direction. One of the results of this seismic survey is illustrated in Fig. 4, which indicates that the Bam subsoil consists of a surface soil underlain by alluvium and bedrock. The assessed S wave velocities in this figure show that there is not such a soft soil deposit as may be imagined in coastal alluvial or deltaic deposits.

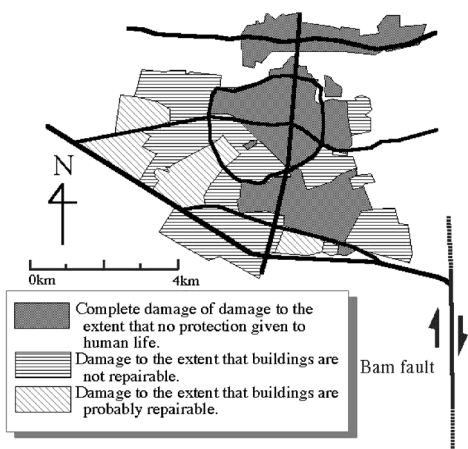
Fig. 2. Variations in damage to houses in different parts of Bam (investigation by Tehran University).

In the earliest phase of the present investigation, it was found that damage was substantial in Bam city, where most houses and buildings were destroyed. In contrast, many buildings and houses, although they suffered slight damage, withstood the earthquake in the southern and western parts of the city (Fig. 2). Thus, it was assumed that subsurface soil conditions might have affected the intensity of tremors and consequently damage. This hypothesis seemed to be supported by the existence of the Posht

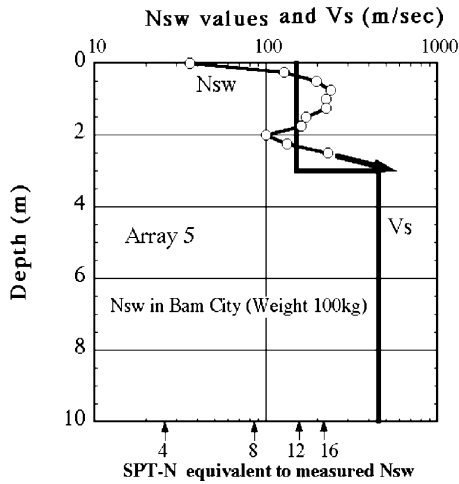
Fig. 6. Comparison of Swedish weight sounding and seismic reflection survey at IIEES array 5.

Figure 6 compares the results of  $N_{sw}$ , the number of half rotations needed for 1-meter penetration, against the average velocity profile obtained by

IIEES. As stated before, Swedish sounding provides detailed soil conditions at a single location, while the seismic profile in contrast provides more global information but less detail on soil conditions. Moreover, the exact surface elevations in these studies are not identical. Despite these issues, there is good consistency between the 2 results; harder soils lie below 3 meters in depth. Note that the soil properties seen in Fig. 6 do not imply soft soil conditions that may cause many seismic problems as often encountered in Japanese alluvial planes.

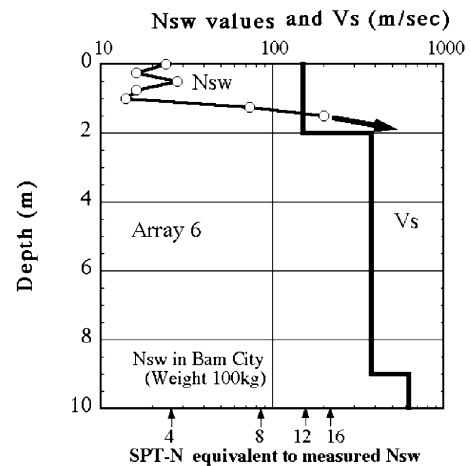
Fig. 7. Comparison of Swedish weight sounding and seismic reflection survey at IIEES array 6.

5). Upon visiting this house, its owner said that it had been built by a local contractor who was renowned for the good quality of construction. Fig. 7 compares

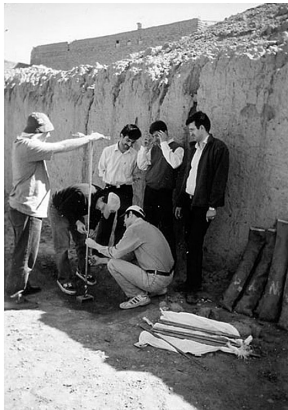
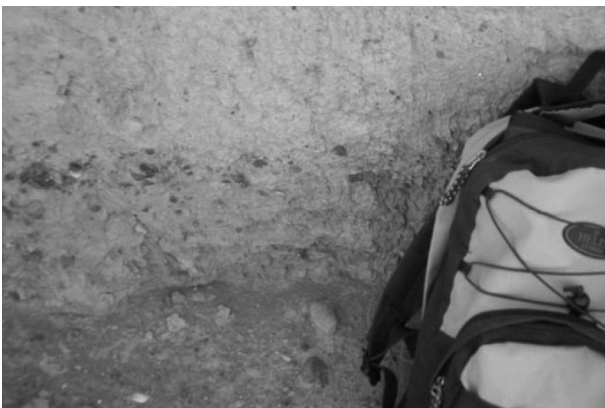
Photo 7. Excavation where Swedish sounding was conducted (array 7 site).

(b) Gravel layer at bottom.

less significant (Photo 6) than in the north and central parts of the city, as demonstrated above. Swedish sounding at this site was conducted in a large excavated pit (Photo 7 a), which was approximately 3 meters deep. It was expected that this decision would save time needed to penetrate the top hard soil and more efficiently study subsoil conditions.

An important feature of this site is the gravel deposit observed at the bottom of the pit (Photo 7 b). For this reason the Swedish sounding device could not penetrate deep into the subsoil. Accordingly, the results of Swedish sounding and IIEES seismic profiling are consistent with each other (see Fig. 8), revealing hard soil conditions at this site.

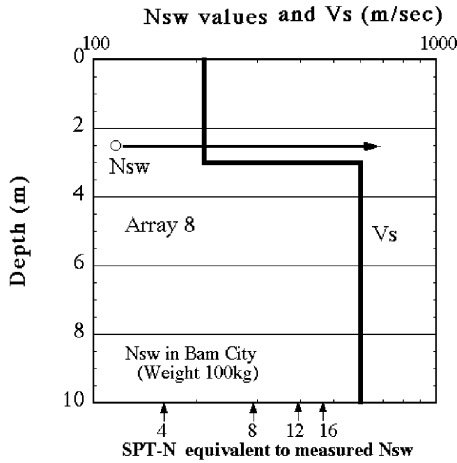
Fig. 9. Comparison of Swedish weight sounding and seismic reflection survey at IIEES array 8.

This site is located to the south of the city, where urbanization has occurred in more recent times, and the density of buildings is not as high as at the city center. Swedish sounding was carried out at the bottom of a shallow excavation (2.5 meters deep) again to save time (Photo 8). Because the bottom soil was also gravel, penetration of the device was terminated immediately. Fig. 9 compares test results to show clearly that soil conditions are hard here.

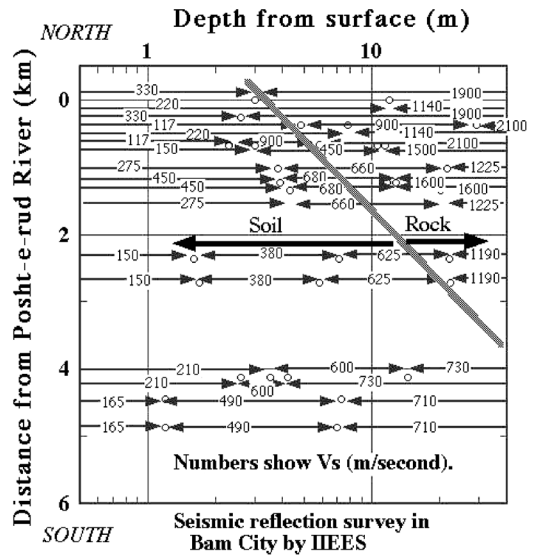
Fig. 10. Assemblage of nine IIEES seismic profiles in Bam city.

for sand (Japan Road Association, 2002). Accordingly, the surface cohesionless soil in Bam has SPT-N values of 20 or more, which means hard soil. Therefore, the soil condition in Bam was not the major cause of building damage.

the city is judged to be reasonable, and is assembled in a single diagram, Fig. 10. The horizontal axis in this figure designates the depth of strata, while the distance from the north edge of the city is plotted on the vertical axis. From this diagram, the following points can be made.

- 1) The elevation of the hardest soil or rock becomes deeper in the southern part of the city. In contrast, the hard material occurs at the ground surface in the northern part of the city as is typically exemplified by the hill of Arg-e-Bam (Photo 1). Therefore, the surface geology is inclined slightly towards the south.
- 2) The angle of base inclination, however, is typically 1%, which is not significant.
- 3) The S-wave velocity (Vs) a few meters below the surface soil ranges from 220 to 900 m/sec. This
