Building Damage around Bam Seismological Observatory Following the Bam, Iran Earthquake of Dec. 26, 2003

Yasushi Sanada^{1)*}, Ali Niousha²⁾, Masaki Maeda³⁾, Toshimi Kabeyasawa¹⁾ and Mohammad Reza Ghayamghamian⁴⁾

Abstract

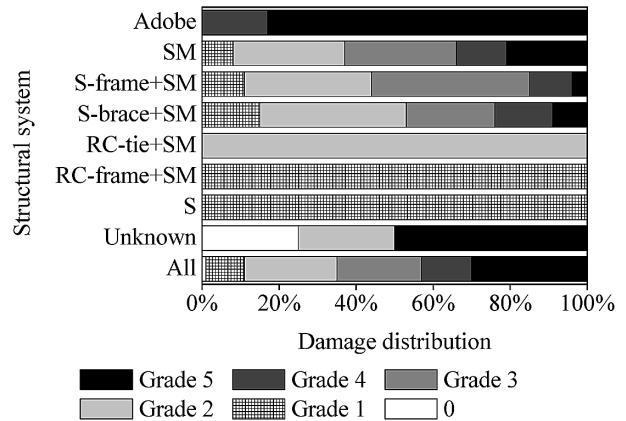
Fig. 5. Damage Distribution of each structural system.

Figure 5 shows the damage distribution of each structural system. All Adobe buildings were classified into Grade 4 and Grade 5. The sum of the ratio of Grade 4 and Grade 5 in SM buildings exceeded 30%, which was much smaller than that of the Adobe buildings. The damage ratios of S-frame+SM and S-brace+SM buildings were expected to be much less than that of the SM buildings, however, there were no major differences among them. This was caused by brittle fractures of poorly welded connections in a few S-frame+SM and S-brace+SM build-

ings. On the other hand, the damage to RC-tie+SM and RC-frame+SM buildings was quite slight because the connections in these buildings were constructed monolithically with other elements. These results, however, were derived from only one case in each system. The damage level of the only S building, which was a gymnasium structure, was Grade 1.

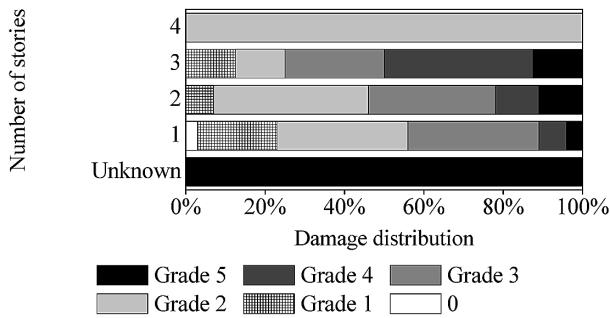
Fig. 6. Effect of number of stories on damage distributions.

location were investigated. Adobe buildings, however, were excluded from the statistical data, because Fig. 5 obviously showed the low seismic performance of these buildings, which were usually single-story residences constructed before 1987. The effect of the number of stories on damage distribution is investigated in Fig. 6. The ratios of Grade 5 and Grade 4 were larger in the case of higher buildings except the only 4-story building. Fig. 7 shows the damage distribution before the establishment of National Standard code No. 2800 in 1987, from 1987 until the revision in 1999, and after 1999. No major differences were observed among these distributions; however, these results were derived from about half of the buildings. This was caused by the technical and social background in Iran. These results reveal that the seismic performance of Iranian buildings

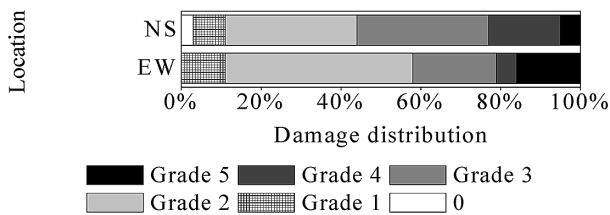
Fig. 8. Damage Distributions along the N-S and E-W streets.

were strongly affected by partial weak points, especially jack arch slab and poorly welded connections, and that the seismic code might have not been diffused to local areas. To investigate the effects of input directivity (EW components > NS components in the records) on building damage, the damage distributions of buildings along the N-S and E-W streets are shown in Fig. 8. The building damage along E-W street is estimated to be larger than that along N-S street, considering the horizontal irregularity due to the arrangement of openings in buildings along the streets, whereas the statistics do not show significant directivity of building damage.

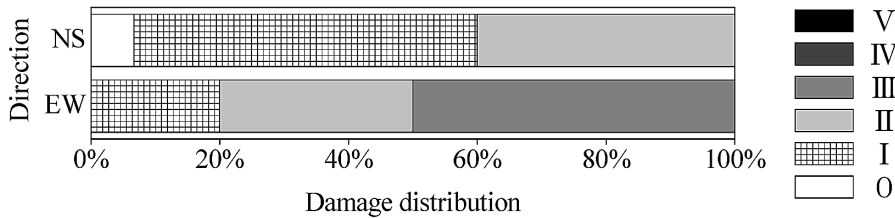
Fig. 12. Distributions of the wall damage level in Bam Tourist Inn.

Grade 2 as estimated from Photo 3, however, the roof of the penthouse collapsed as shown in Photo 4. The wall ratio in the NS direction was 9.4%, which was much larger than that of the Governor's Building, and that in the EW direction was 5.5%. The damage levels of walls except inaccessible ones, which were evaluated from the definition in Table 2, are illustrated in Fig. 11. Fig. 12 shows the distribution of wall damage level in each direction. The average damage level of walls in the NS direction of 1.3 was a little smaller than that in the EW direction of 2.3,

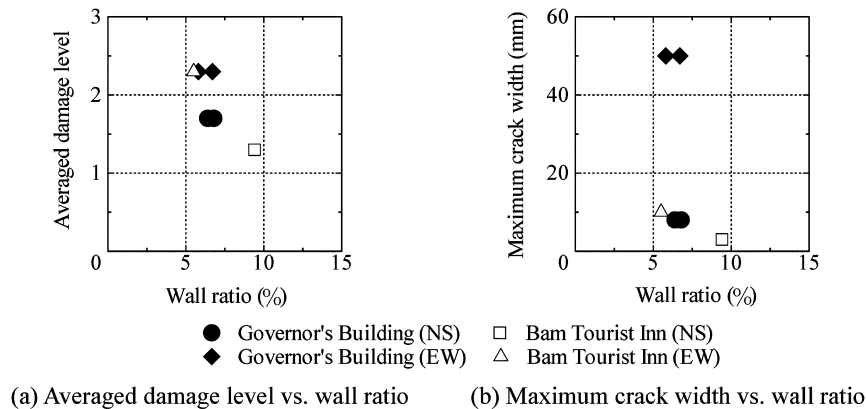
Fig. 13. Relationships between the wall ratio and the wall damage level.

Figure 13 shows the relationships between wall ratio and average damage level, and correlation between the wall ratio and the maximum crack width, respectively. It can be concluded from Fig. 13 (a) that the average damage levels were larger in the case of a smaller wall ratio. The maximum crack widths were also larger in the case of a smaller wall ratio among the NS direction of Governor’s Building and both directions of Bam Tourist Inn, as shown in Fig. 13 (b). However, the maximum crack width in the EW direction of the Governor’s Building was much higher than those in the other cases. This may be caused by torsional responses due to the horizontal irregularity of Governor’s Building, because larger crack widths were observed in the outside walls. The building damage cannot be clarified in detail based only on the wall ratio as mentioned here, however, it can be concluded that the wall ratio is considered to be one of the reliable indexes for evaluating the seismic performance of unreinforced masonry buildings.

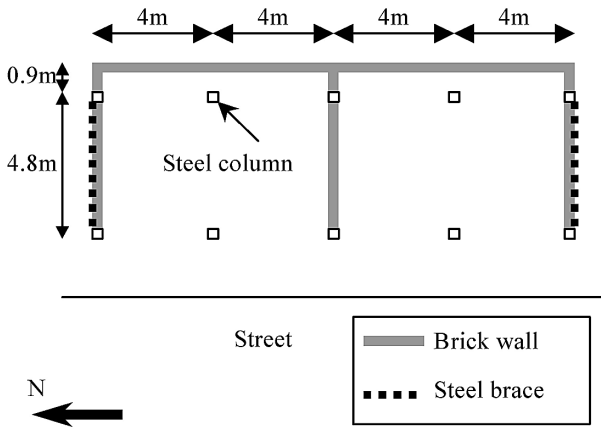
Fig. 15. First floor plan.

in the downtown area. The 3-story steel structure consists of 4 bays in the NS direction along the street and 1 bay in the transverse direction (EW), as shown in Fig. 15. Columns are erected using coupled I-

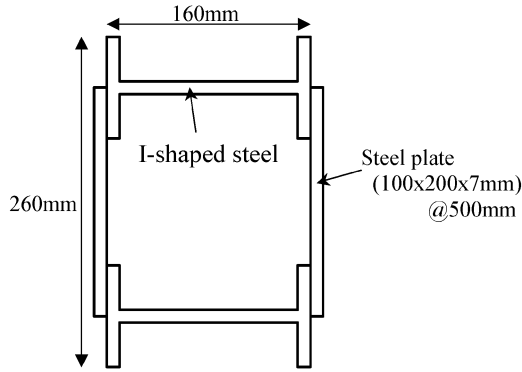
Fig. 16. Section of coupled I-shaped steel column.

shaped steel columns (Fig. 16). Steel braces (I-shape, 70 mm × 140 mm, 7 mm in thickness) are installed in both exterior frames in the EW direction. Brick walls, which are post-installed in the frame without being confined by the surrounding steel frame, are not expected to contribute to carrying the lateral load. I-shaped steel profiles are also used for girders and beams (Photo 7).
