NASA AERONAUTICS BOOK SERIES

Lessons Learned from  
Accidents Involving  
Remotely Piloted and  
Autonomous Aircraft

# Crash Course

Peter W. Merlin

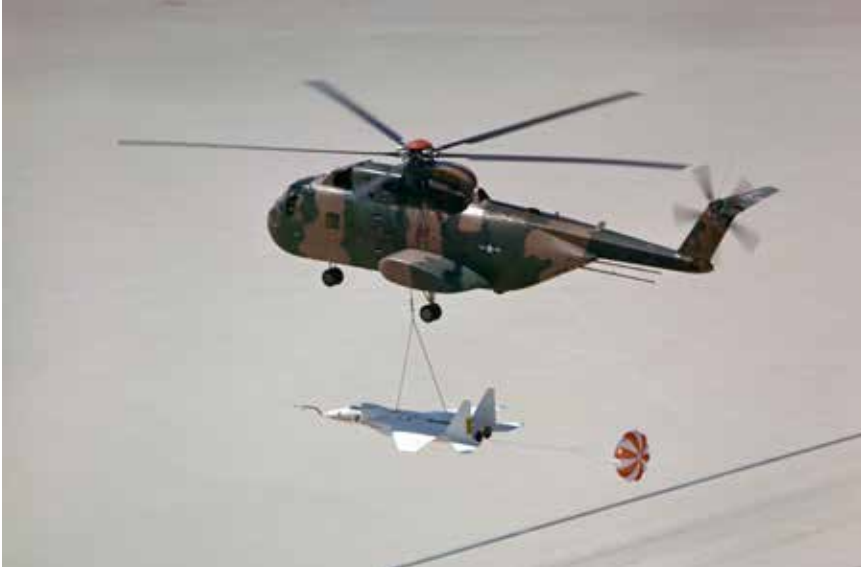
During initial test flights, the crew of a CH-3E helicopter snagged the RPRV in midair and delivered it to a safe landing. NASA

During recovery, the main parachute failed to separate upon engagement with the helicopter's parachute capture system. The hung chute produced a strong drag force on the helicopter and began pulling more load line from the winch drum. The helicopter crew attempted to force main-chute separation by increasing winch brake friction on the line, which finally broke. At no time did the crew attempt to sever the load line using the emergency cable cutter. Fortunately, the CH-3E sustained no damage.

An accident investigation board determined that several factors contributed to the mishap. The primary cause was human error on the part of the F-15 RPRV crew chief that resulted in improper assembly of the parachute release mechanism, as well as failure of an inspector to catch the error prior to flight. There were also several contributing factors, the most serious of which was faulty design by the manufacturer that allowed the release mechanism to be incorrectly installed. Documentation of procedures for installing the device appeared adequate but was inefficiently spread over several separate documents, a situation that prevented critical items from coming to light and required a great deal of cross-checking. Lack of recent practical experience on the part of the mechanic and inspector also played a part, and experienced personnel who had performed the installation on prior flights were not available for consultation. The regular inspector was ill and had been replaced by a backup, and the mechanic most familiar with the parachute system had been transferred to a different project. Investigators also noted that the Air Force MARS crew had

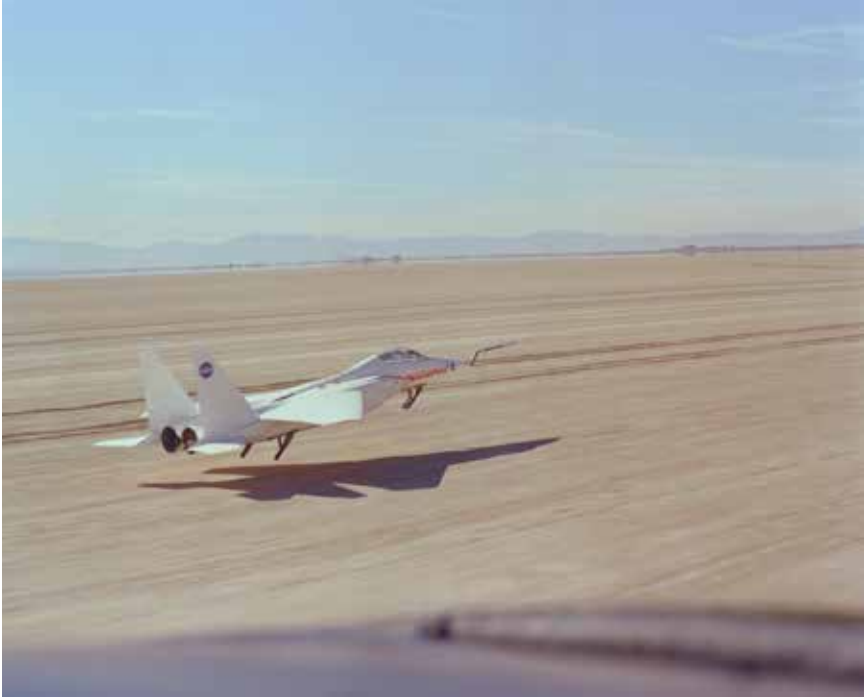
The F-15 RPRV was eventually modified with skids for landings on the dry lakebed at Edwards. NASA

As a result of this successful remotely piloted landing, and considering previous parachute recovery difficulties, further use of MARS was discontinued. The RPRV was modified with landing skids, and all flights thereafter ended with horizontal touchdowns on the lakebed.<sup>24</sup>

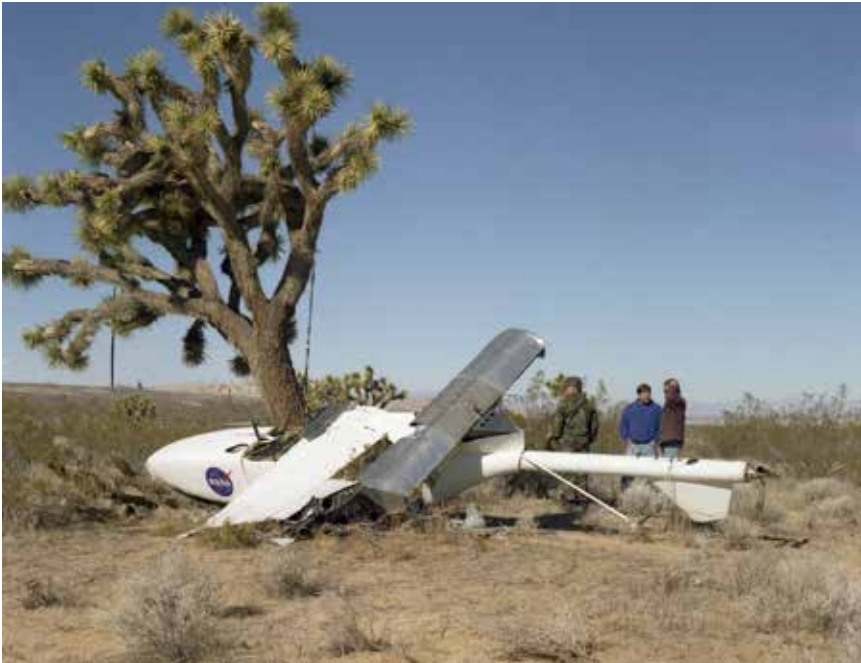
Members of the recovery crew examine the Perseus-A on the Edwards PIRA. NASA

Diverging oscillatory airspeed and vertical acceleration caused the Perseus-A to pitch up with a corresponding mild upward wing bending, followed by a nose-down pitching motion and wing unloading. The left wing dropped due to an accelerated stall, and at one point, the bank angle reached 80 degrees.<sup>8</sup>

The resulting pullout exceeded aircraft load limits, causing the structural failure of the wing assembly center panel. As both wings departed the vehicle,

A joint NASA-Aurora investigation determined that the failure resulted from a malfunctioning pitch gyroscope that fed anomalous attitude signals to the autopilot. The probable cause of the gyro failure was identified as an excessively worn brush assembly in the direct current (DC) spin motor.

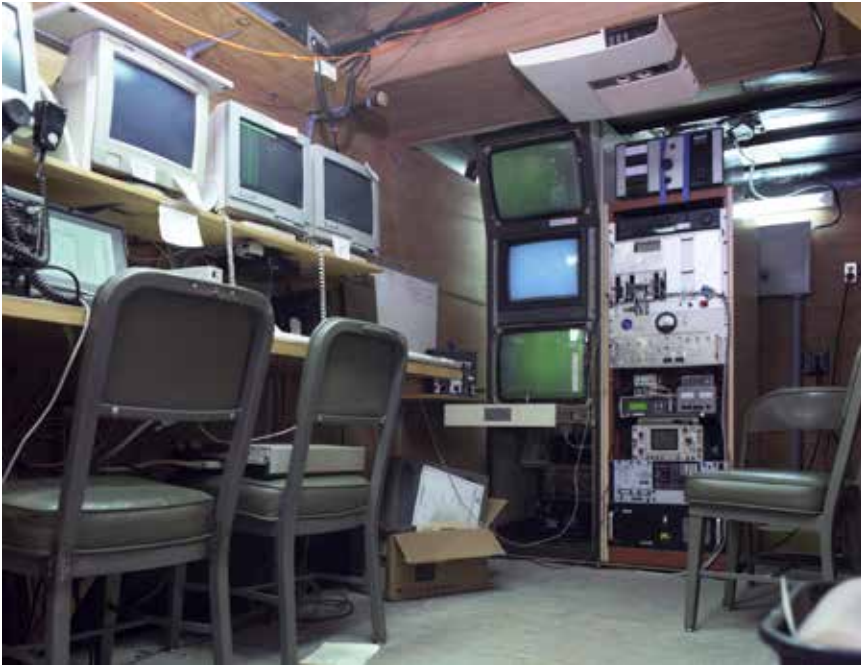
The Perseus GCS included positions for a pilot and several systems monitors. NASA

Several human factors contributed to the mishap. These were related to deficiencies in the design of the GCS as well as GCS team training.

First, displays in the GCS provided poor situational awareness. This precluded adequate mission monitoring and led to the test team's inability to detect the gyro failure. The control panel featured a very limited set of caution and warning annunciators and no autopilot-mode annunciation. Caution and warning indicators were primarily focused on catastrophic engine failures. None were used to indicate sensor failures. Although telemetry data were available to both the test director and flight-test engineer, the data were presented in a tabular format only, on one of 10 selectable pages. System limits were not indicated by these displays. Operating autopilot modes had to be determined by examination of the autopilot switches. At the time of the mishap, the test director was unable to see these switches due to the GCS layout and was unaware that the airspeed-hold autopilot had been switched back on.<sup>11</sup>

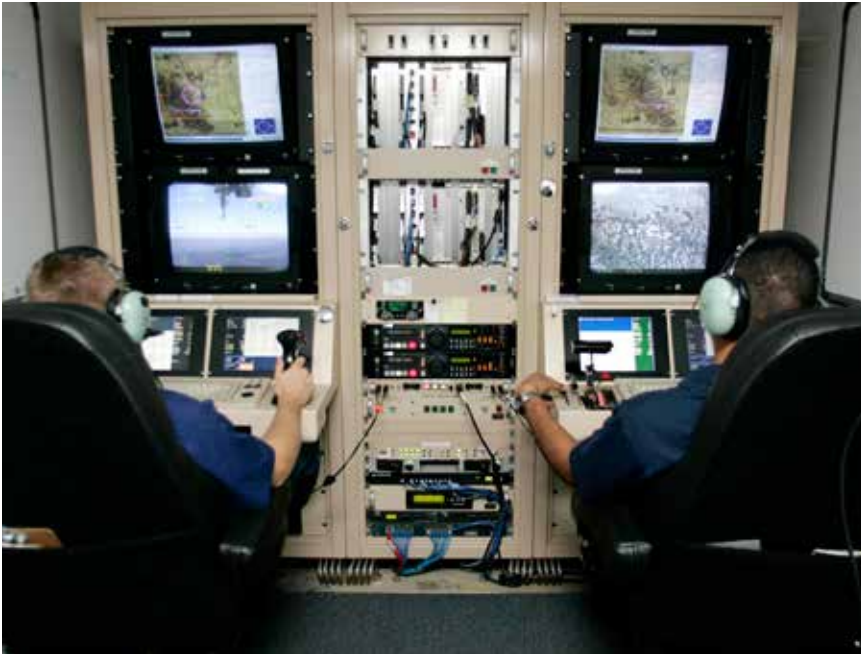
CBP agents operated the MQ-9 from a standard GCS, with identical consoles for pilot and sensor operator. CBP

According to the checklist, before switching control from one station to another, the primary pilot is supposed to match control positions on both consoles. In this case, the pilot failed to do this, he later told investigators, because he was “in a hurry.”<sup>5</sup> As a result, the situation lever, which had been used to lock the camera iris, was now in the fuel shutoff position. In aviation, this is known as a “switchology” error. The term refers to techniques used to ensure the proper settings of switches on control panels.
