# A Screening Method Using Pulsed-Power Combined with Infrared Imaging to Detect Pattern Defects in Bulk Metal Foil or Thin Film Resistors

Jay Brusse<sup>(1)</sup>, Lyudmyla Panashchenko<sup>(2)</sup>

To be published in the conference proceedings of the Space Passive Component Days (SPCD) international Symposium, Noordwijk, The Netherlands, October 9-12, 2018.

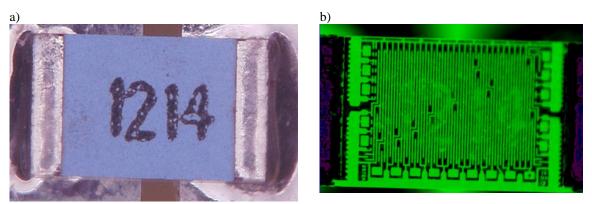
To assess this potential the authors examined several surface mount foil resistors and thin film resistors from more than one source with all of the protective coatings still intact. To our surprise, even with no power applied to the resistor and with the protective polymer and epoxy coatings still present, the FLIR SC8300 camera was able to produce a detailed image of the resistor pattern beneath the coatings almost as if the coatings were not present (see Fig. 7). The SC660 camera could not identify pattern features with the coatings present. Such detail was possible with the SC8300 due to the highly transmissive attributes of these specific protective coatings in the spectral range ( $\sim$ 1.5  $\mu$ m to  $\sim$ 5  $\mu$ m) used by this infrared detector. Notice in Fig. 7b, however, that the black marking ink used to label the resistor with lot date code information is more opaque in this infrared spectral range. Nevertheless, even with this hindrance, the ability to see through the coatings is highly advantageous for this screening technique.

Fig 7. a) Optical Microscopy Image of a Foil Resistor and b) FLIR SC8300 Infrared Image of Resistor in a) without Removing Protective Coating and Without Power Applied

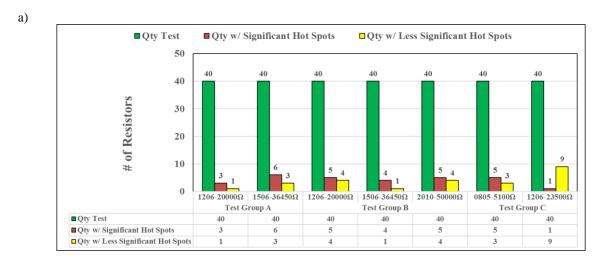
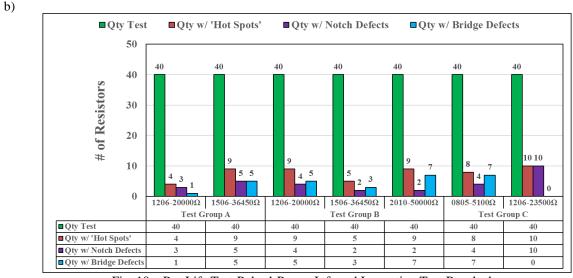
A total of 280 resistors identified in Table 3 were screened prior to life test using the aforementioned pulsed-power infrared inspection technique in Fig. 4. A serialization scheme was used to maintain traceability. The results of this screening inspection are presented in Figs. 10a and 10b. Hot spot severity was qualitatively assigned as either 'significant' or 'less significant' based on how readily discernable they were by human operator review of the infrared images. Fig. 10a shows that within each 40 piece sample from the 7 lots tested there was at least 1 resistor and up to 6 resistors with a 'significant' hot spot. A total of 29 out 280 resistors were judged to have 'significant' hot spots with an additional 25 resistors having 'less significant' hot spots. Neither the type of foil used (i.e., Type A = with particles vs. Types B & C = "particle-free") nor the level of STOL screening (i.e., Types A & B = 1 STOL vs. Type C = 2 STOL exposures) appears to have produced a significant difference among the 7 lots tested in terms of number of resistors with hot spots remaining in the 40 piece samples.

Fig. 10 – Pre-Life Test Pulsed-Power Infrared Inspection Test Results by

- a) Severity of Hot Spots and
- b) Type of Hot Spots (Notches vs. Bridges)

Fig. 10b presents the same pre-life test pulsed-power infrared inspection results in terms of the total number of resistors with hot spots (total = 'significant' plus 'less significant') and then identifies them by the type of constriction defect (notch vs. bridge). Several resistors had more than one hot spot within the resistor pattern including some resistors having both notch and bridge type defects. For this reason the total number of resistors with hot spots does not always equal the sum of resistors with notches plus resistors with bridges.
