Analysis of the failure of a PPS polymer cycling support: Microscopy and Finite Element studies

J. Marsh, R.P. Turner*, M. Wang and M.J. Jenkins

School of Metallurgy & Materials, University of Birmingham, Edgbaston, Birmingham, United Kingdom B15 2TT

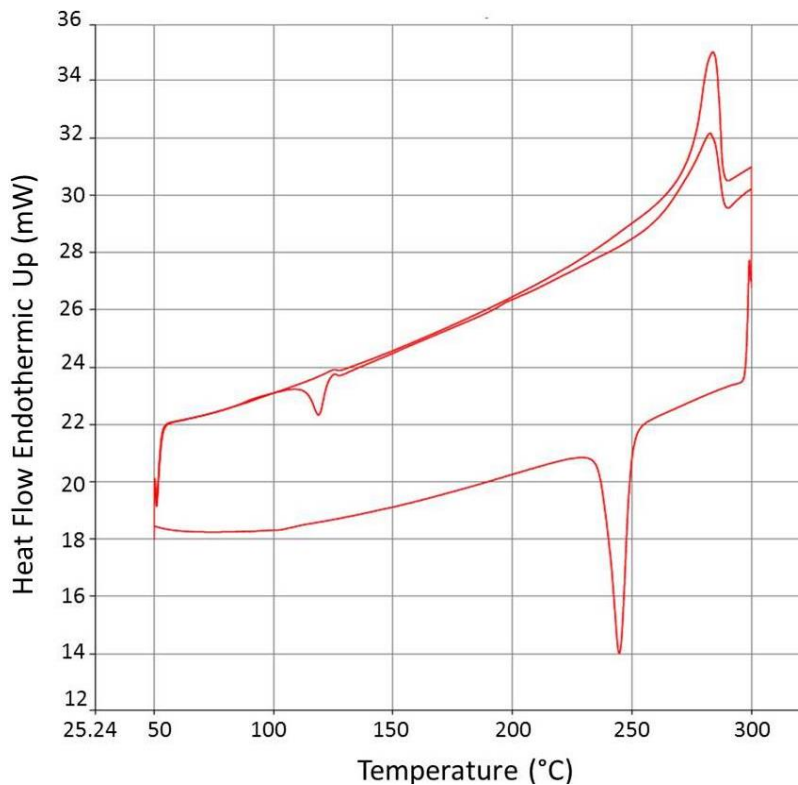
Figure 3: DSC trace of PPS GF30

A Perkin Elmer DSC7 was interfaced with a personal computer to measure thermal properties of the composite. The differential scanning calorimeter (DSC) was calibrated using known masses of indium (99.999% pure) and tin (99.999% pure). The composite sample of PPS GF30 (30% glass fibre) was tested using a DSC to determine its thermal properties. A 17 mg sample of PPS was subjected to a heat-cool-heat scan between 50 and 300°C at 10°C/min. Crystallisation and melting temperatures were recorded as 282.9 and 244.8°C respectively. Injection moulding components are cooled rapidly to increase production. This rapid cooling prevents the completion of non-isothermal crystallisation. An exothermic peak at 118.9 °C shows this incomplete crystallisation during manufacture (see **Figure 3**). The mechanical properties for the reinforced PPS material were obtained from the literature [15], and can be seen in **Table 1**.
