## Case Study and Back Analysis of a Residential Building Damaged by Expansive Soils

# **Case Study and Back Analysis of a Residential Building Damaged by Expansive Soils**

J. Li, D. A. Cameron and G. Ren

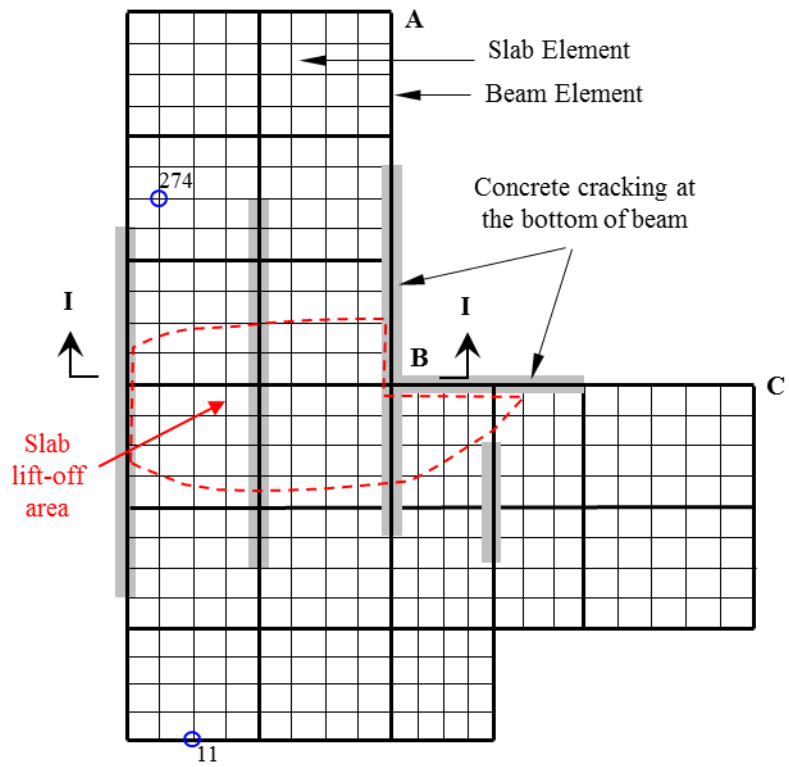
**Figure 14 Finite Element Mesh and Locations of Concrete Beam Cracking**

The finite element mesh for this case study is shown in [Figure 14](#). It consisted of 608 plate elements, 196 beam elements and 348 gap elements. A line load of 6.5 kN/m was imposed along all the edges to simulate the masonry veneer walls and roof loads of the constructed building, while an internal distributed load of 2.2 kPa was applied to model loading from internal plasterboard partitions, the floor and live loads.

The back-analysis provided an estimate of the level of stress in the distressed slab footing. It was predicted that the footing was over-stressed at the re-entrant corner, B (see Figure 13). The calculated maximum torque and bending moment in the external beams in this region were 80 kNm and 399 kNm, respectively. The maximum shear force was 142 kN. The maximum compressive stress in the concrete was found to be 13 MPa, which was acceptable. The results of the back analysis indicated that the maximum tensile stress of 2.7 MPa in the concrete beams had been exceeded and that the steel bars at the bottom of the beam along section I-I should have yielded (see Figure 13). So this section of the slab had failed in a structural sense. The back analysis predicted concrete cracking in both edge and internal

beams at the locations indicated on [Figure 13](#), close to the location of the observed superstructure cracks (refer [Figures 2-5](#)).
