NATIONAL AERONAUTICS AND SPACE ADMINISTRATION

TECHNICAL REPORT
R-54

FACTORS THAT AFFECT OPERATIONAL RELIABILITY OF TURBOJET ENGINES

By LEWIS CENTER STAFF

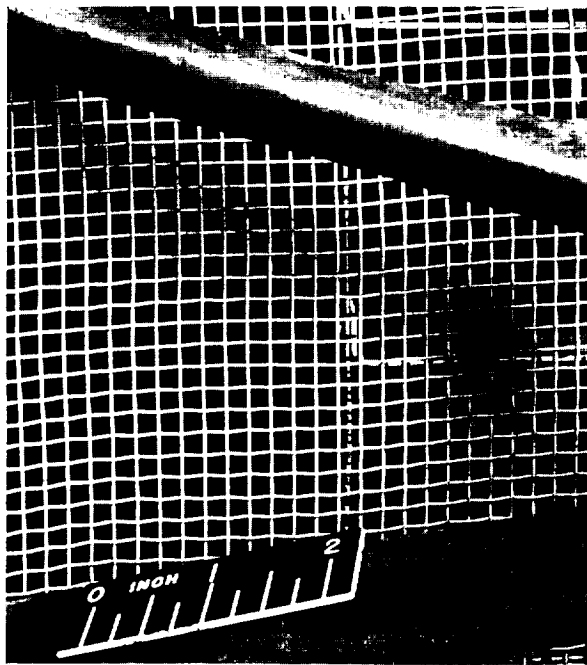
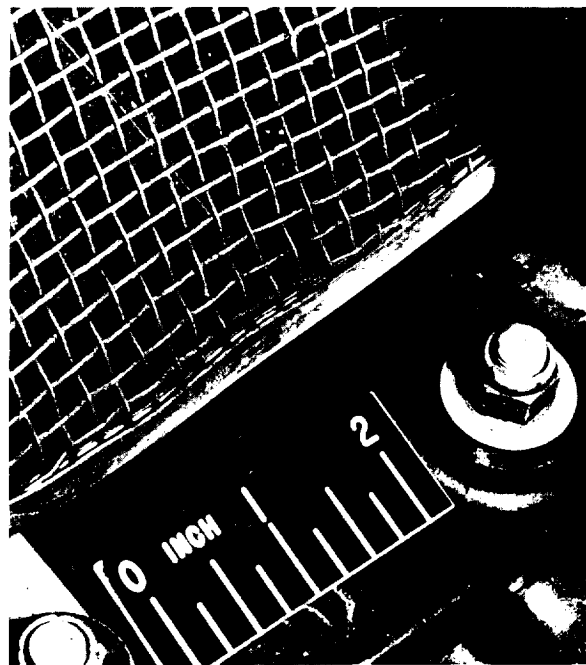
The two screen types were inspected after service on engines in NACA research projects. The fine mesh screens were in excellent mechanical condition after extensive usage; the coarse mesh screens were deteriorated. Broken wires, enlarged mesh dimensions, and large edge clearance between screen and engine frame resulted in openings as large as 0.50 inch in the coarse mesh screen (fig. 3 (b)) through which objects might pass. Thirty-six percent of the engines with the fine mesh screen were damaged, while

(a) Openings 0.132 inch square.

(b) Openings 0.216 inch square.

FIGURE 3. Fixed air-inlet screens on centrifugal engines.

84 percent of the engines with the coarse mesh were damaged, which indicated the need for small screen openings and the importance of construction details that ensure reliability in screen design.

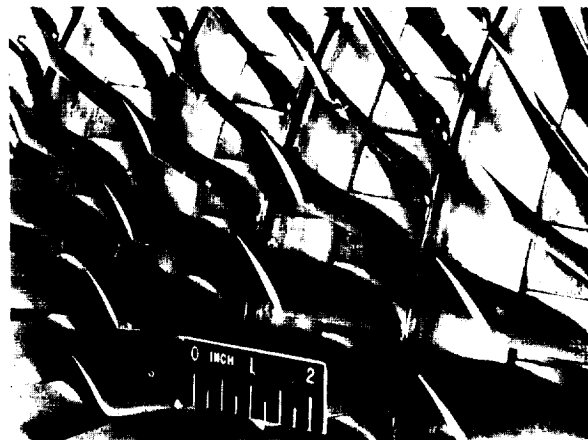
Foreign-object damage.—The axial-flow-compressor rotor blades are the first moving objects encountered by foreign matter entering a jet engine. Because every other row of blades in a compressor is stationary and immediately obstructs any motion imparted to foreign particles by the intervening rotor blades, damage is caused to a large percentage of the total number of blades in a multistage compressor. Also, the cantilever-type attachment and the thin leading and trailing edges of the airfoils make the axial-flow units extremely susceptible to foreign-object damage (fig. 5).

FIGURE 5.—Damage resulting from foreign object entering inlet.

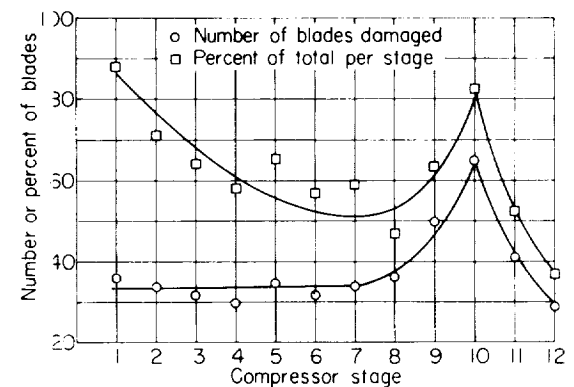
Foreign-object damage is a serious problem because of the large numbers of blades involved and the expense of disassembly, blade replacement, and compressor rebalancing. The number of rotor blades per stage varies from 17 to over 130 (fig. 7), the total per compressor averaging about 800 rotor blades. Occasionally, as many as 75 percent require replacement. Figure 8 shows the typical result of a foreign object passing through a compressor. The number of blades hit in the first eight stages was relatively constant.

Because the number of blades per stage increases toward the rear of the compressor, the first stage had the highest percentage of damage. The peaks in the curves indicate that the foreign object lingered slightly in the tenth stage. The values do not include stator blades, which are not nearly as critical because of the absence of centrifugal loads.

FIGURE 8.—Number of blades damaged by foreign object in typical axial-flow compressor.

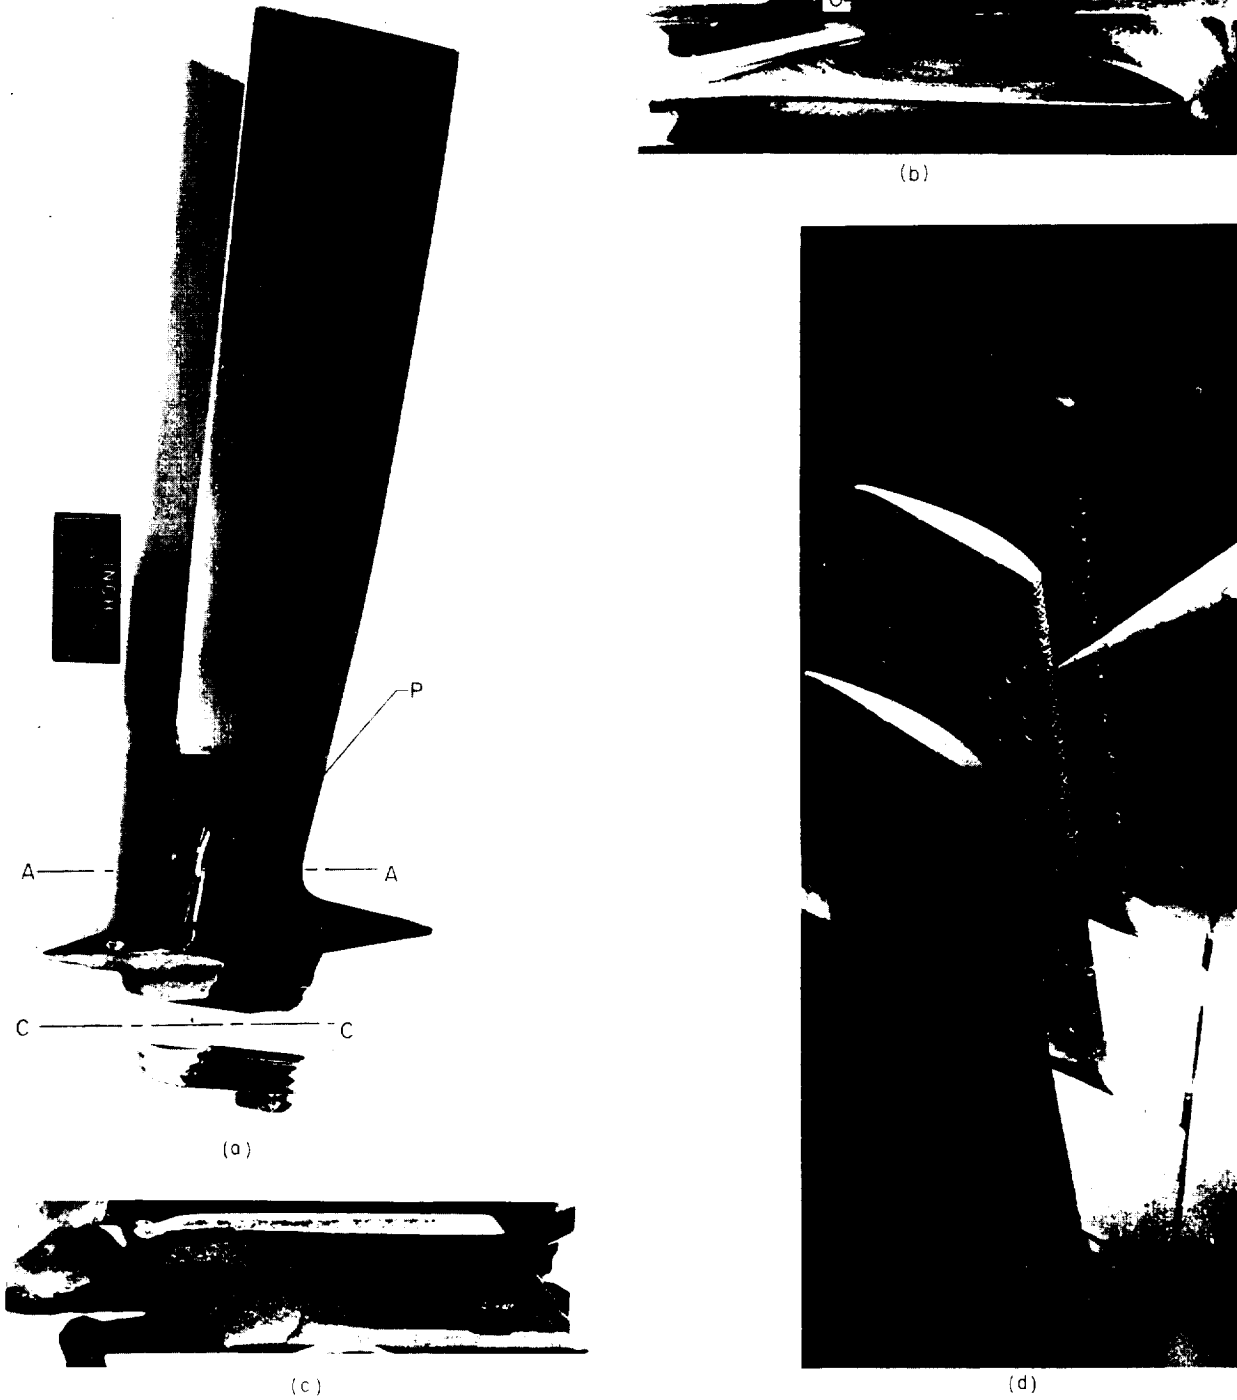
Vibration fatigue.—Fatigue usually occurs in the rotor blades, but is occasionally experienced in the stator blades or rotor disks at the blade recesses because of vibratory loads from the blades. The blade vibrations are generally induced by pulsation in the airflow. In most cases of blade failure, the fractures occur in the airfoil section near the base and show progressive damage typical of pure fatigue (fig. 9(b)). The origin of

(a) Failed blade.

(c) Cross section CC from (a).

(d) Foreign object damage.

FIGURE 9. Initiation points of fatigue in typical compressor blade.

the failure is usually on the convex surface at the maximum camber point (point O), where the bending stress is maximum during vibration. Fatigue failures may also originate in the trailing edge of the airfoil (point P). In other cases, the failure is in the fastening (fig. 9(c)). Frequently fatigue failures originate at random locations on the airfoil where stresses are not ordinarily high but are magnified by stress concentrations arising from toolmarks or nicks made by foreign objects (fig. 9(d)). Six types of fastenings that have been used for compressors are shown in figure 10. In the fir-tree types (figs. 10(a) and (c)), high stress concentrations occur in the fillet between serrations, particularly if the radii are small. The bending stresses due to vibration are superimposed on the steady centrifugal and gas-bending stresses. All stresses are magnified by the stress concentration caused by the abrupt changes in cross section.

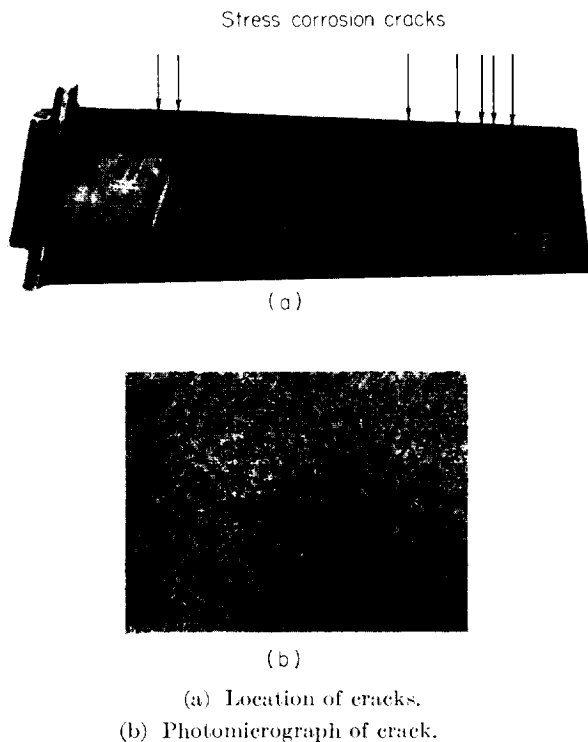
Stress-corrosion cracking.—A difficulty called stress-corrosion cracking has recently been encountered with the 12-percent-chromium iron alloy currently being used for nearly all compressor blades (refs. 5 to 7). Although the actual mechanism for this process has not been completely established, the cracks (fig. 12) are known to appear under the following circumstances.

FIGURE 12.—Typical blade cracked by stress corrosion.
534962—60—5

As a result of the strengthening heat treatment and quenching at 1750° F, residual stresses due to fabrication technique are frozen into the material according to the theory outlined in references 5 and 6. The residual stresses tend to assist moisture in the air and particularly in salty atmospheres in penetrating and reacting with the grain boundary material (fig. 12(b)). Another theory suggests that the problem is simply one of hydrogen embrittlement and is independent of residual or operating stresses (ref. 7). In either case, because of extreme thinness, the trailing edges of the blades are most vulnerable to cracking.

The stress-corrosion cracks themselves are not very serious, but in the presence of vibration, the crack is propagated until ultimately the blade fails from fatigue.

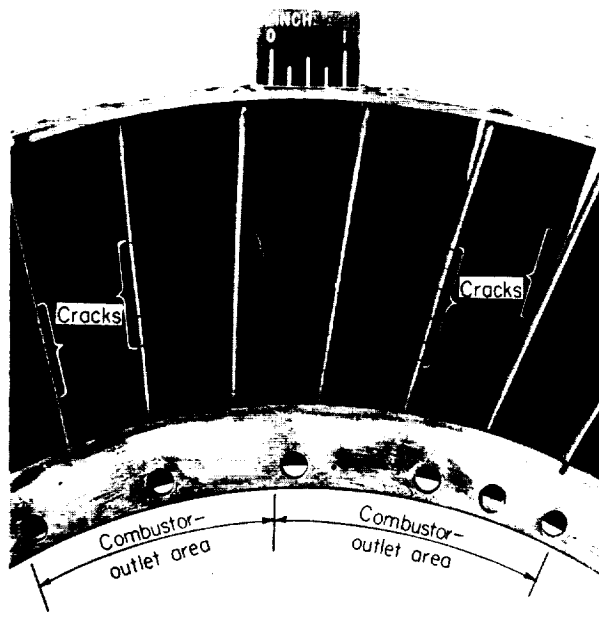
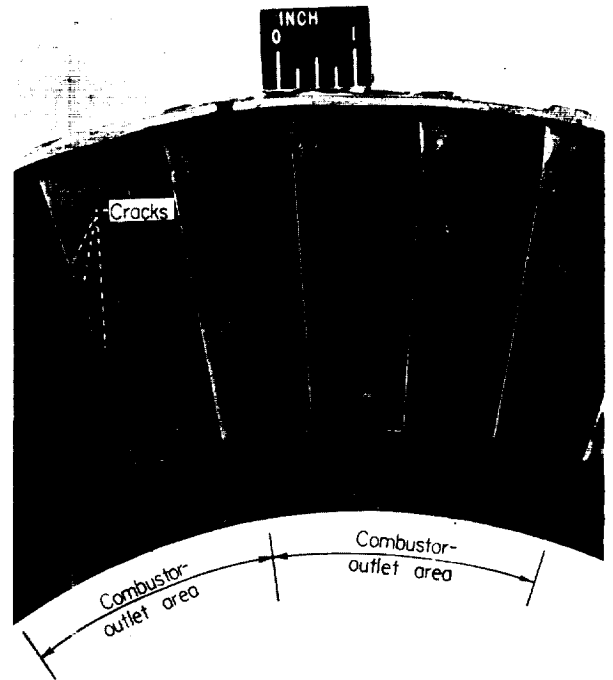
FIGURE 3.—Nozzle diaphragm showing cracks on edges of vanes (ref. 9).

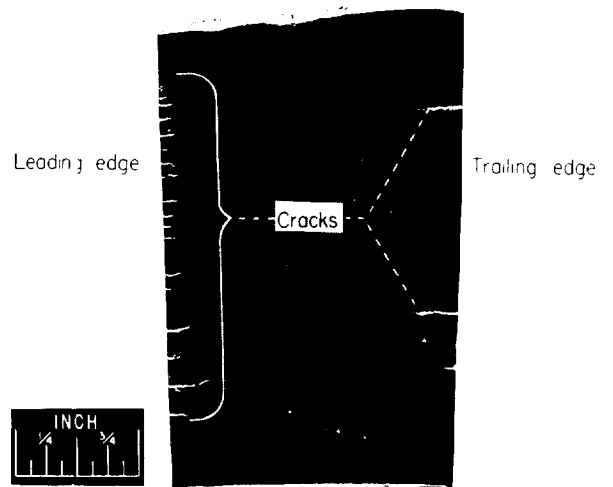
FIGURE 4.—Typical cracks in nozzle-diaphragm vane after 319 cycles (ref. 9).

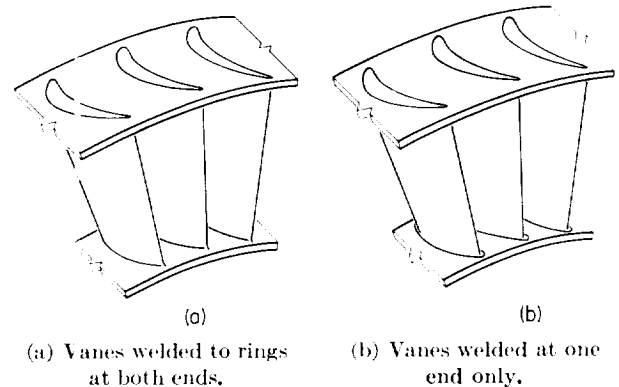
In the early nozzle diaphragms, the vanes were welded at both ends onto thick rings, as shown in figure 13(a). Since the outer ring does not heat as much as the rest of the unit, it constrains the expansion of the vanes during heating. This constraint causes compressive strains

FIGURE 13.—Sections of nozzle diaphragm (ref. 5).

in the vanes when hot, and, if these strains are plastic, residual tensile stresses are introduced when the vanes are cooled. Successive repetition produces thermal-fatigue cracks.

A later design that eliminates the end constraint of the nozzle vanes is shown in figure 13(b). In this design, the vanes are retained by welding to the outer ring and are floated in slots cut into the inner ring. The vanes can expand and contract freely along their length, with the inner ring serving only to position them. Other alternatives to allow free floating are possible.

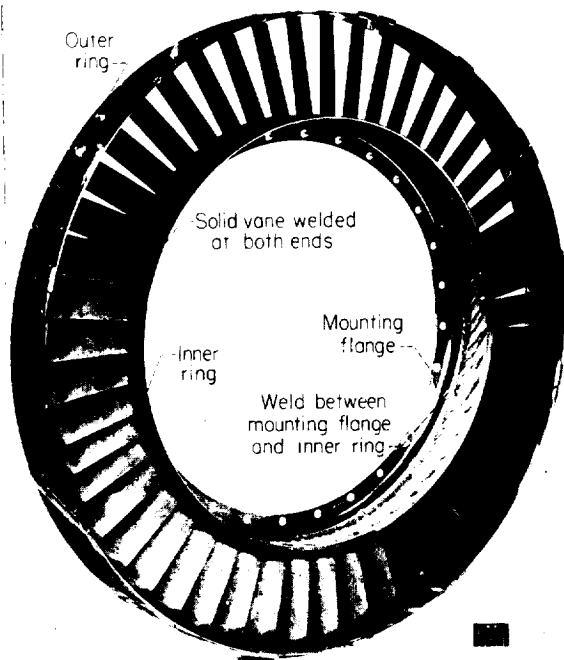
The advantages of the floating design are seen by comparing operating records for different engines. Figure 14(a) shows the design in an early engine. Note that the vanes are welded at both ends to the inner and outer rings and that the mounting flange is welded to the inner ring. Figure 14(b) shows the free-floating design of a later engine. The vanes are alternately welded to either the inner or outer rings, except for a few vanes that are welded at both ends. A bellows between the inner ring and the mounting flange reduces constraints further. The records

(a) From early engine.

show that vane cracking was more frequent in the early design than in the later free-floating design. Part of this difference may have been due to differences in operating conditions and to the use of cooled hollow vanes in the later engine instead of the solid vanes used in the first engine. Cracks in the inner ring running aft from the vane slots were more frequent with the floating design, however. These cracks often extended into the mounting flange. The records did not show whether these cracks were located

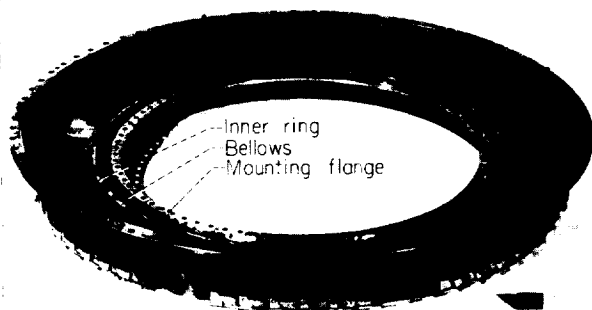
(b) From later engine.

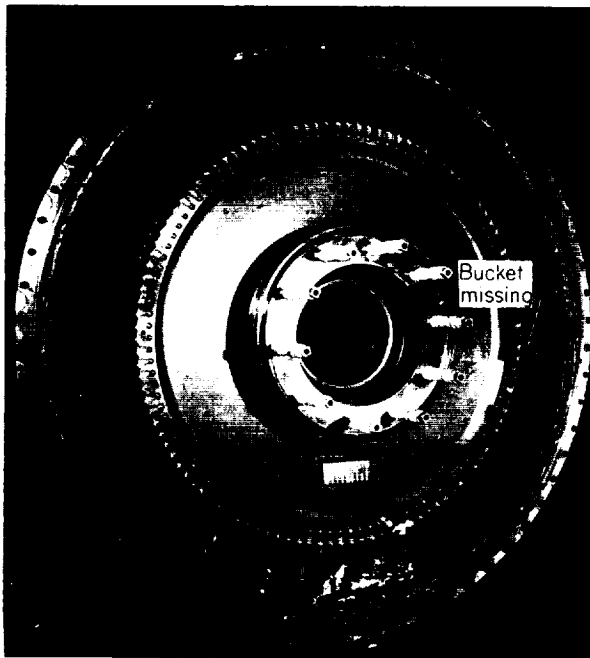
Damage resulting from failure of turbine buckets will likely be much more severe in multistage turbines than it has been for single-stage turbines. In multistage turbines, a fragment from a first-stage bucket failure must pass through subsequent stages where it can cause appreciable damage. A failed three-stage shrouded turbine is shown in figure 2. Failure of a second-stage

(a) Second stage of turbine; all bucket shrouds gone.

FIGURE 2.—Damage to three-stage turbine resulting from failure of second-stage bucket.

bucket broke the tips and shrouds of all the second- and third-stage buckets. The probability is very high that an engine will no longer produce thrust if a bucket fails in any stage except the last; therefore, the reliability must be much

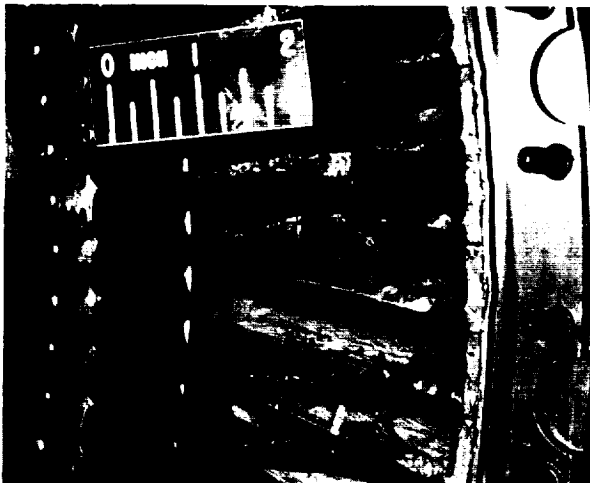
(b) Closeup of fractured second-stage bucket.

FIGURE 2. Continued. Damage to three-stage turbine resulting from failure of second-stage bucket.

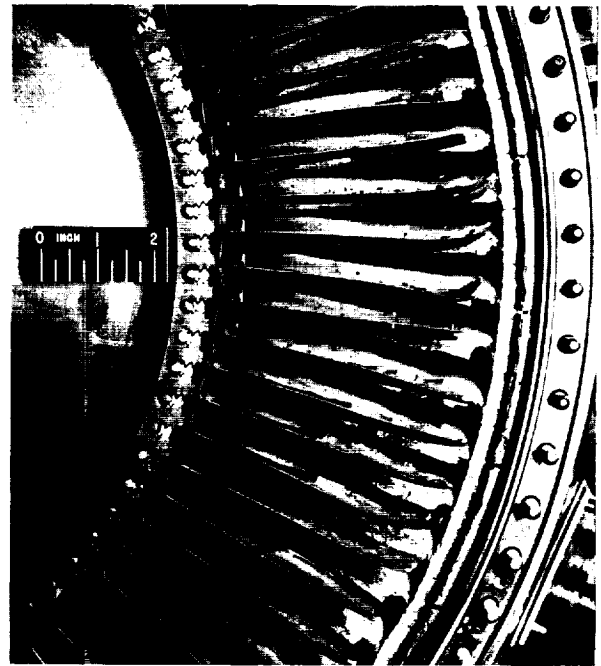
(c) Third stage of turbine; all bucket shrouds gone.

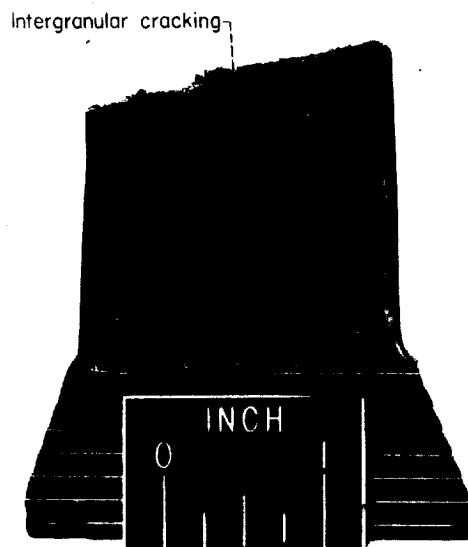
FIGURE 6.—Typical stress-rupture fracture.

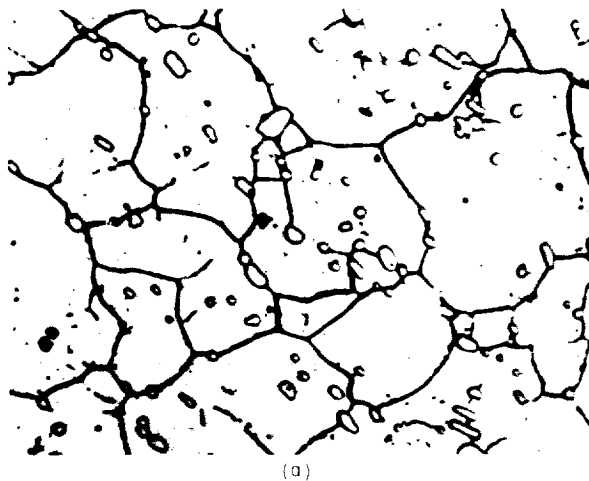
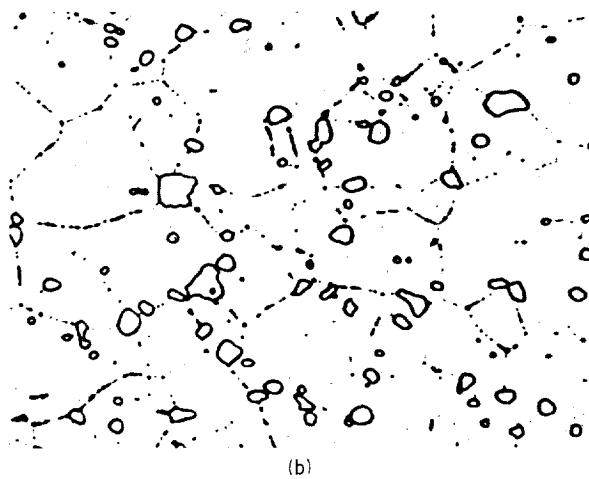
Overtemperature can be so severe as to melt or burn the buckets, or to cause warping, cracking, obvious stretch, or fracture. For some alloys, the occurrence of overtemperature causes changes in the microstructure. This is shown for overtemperated S-816 in figure 25(b), which shows that grain boundary precipitates have been partially redissolved, compared with an undamaged structure in figure 25(a). For some alloys, hardness is changed markedly by re-resolution, and such a change may indicate damage.

(a) Standard heat treatment: 1 hour at 2,150° F, water-quenching; 16 hours at 1,400° F, air-cooling.
(b) Severely overtemperated (15 min at 2,000° F) following standard heat treatment.

FIGURE 25.- Effect of overtemperature on microstructure of S-816. X1000.

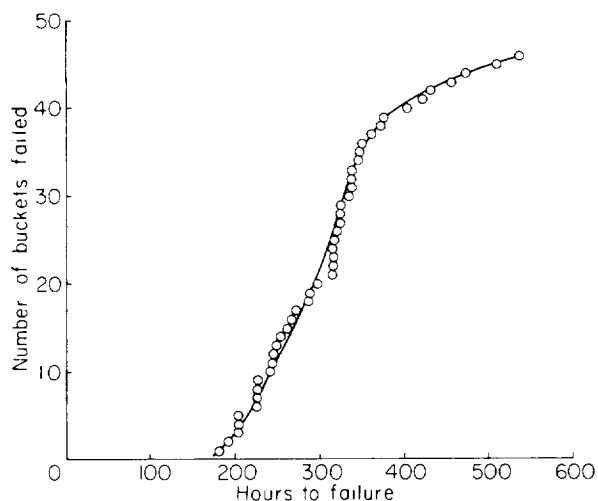
Turbine buckets of a single wheel will differ considerably in time to failure. This is demonstrated in figure 26. A total of 46 turbine buckets of the same material for a given engine, chosen at random from Air Force stock, were installed in a turbine wheel. The engine with this wheel was operated continuously at full engine power until a bucket failure occurred. Operation was continued, with each failed bucket being replaced, until all original buckets had failed. Figure 26 is a plot of number of original buckets failed against time at full engine power. The first failure occurred after 180 hours and the last after 540 hours, a spread ratio of 3:1.

The data of figure 26 also indicate that the failure distribution of these turbine buckets is of the "wear-out" type discussed in chapter II. Thus, after the first bucket had failed, additional failures followed shortly with the rate of failure increasing with time. For buckets of this kind, after the first bucket failure has occurred, additional bucket failures can be expected at very

FIGURE 26.—Typical distribution of turbine-bucket failures. Forty-six buckets in one wheel. (Data from ref. 18.)

short time intervals and the wheel should be equipped with all new buckets.

wheel when the first fails because, as indicated by figure 26, when the first of a sample of buckets fails by stress-rupture, failures of the remainder will follow shortly. It is not desirable to allow even one bucket to fracture by stress-rupture, however, because this results in a high risk of flight accident, particularly since a piece of the bucket of the order of one-half the airfoil has been released. Although this procedure has been used in single-stage turbines, it is not permissible for multistage turbines because of the greatly increased likelihood of a serious accident.

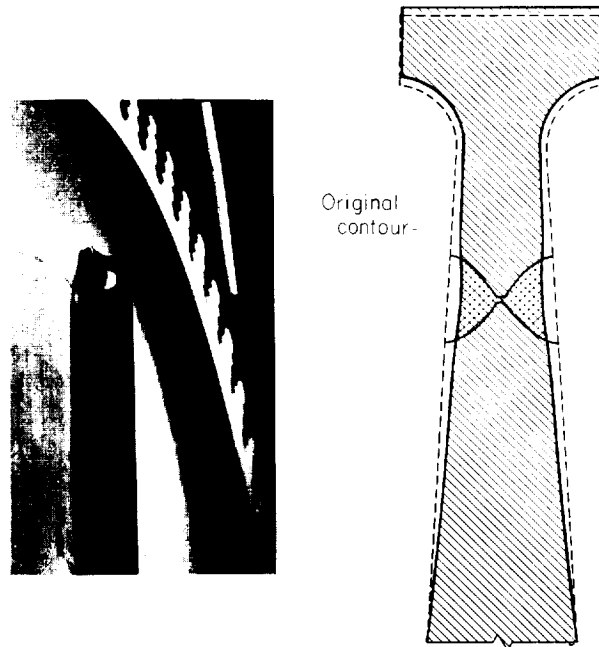
If substantial overtemperature operation is encountered, the web may be subjected to creep that may lead to severe necking with an accompanying increase in the over-all diameter of the disk. This condition is shown in figure 9. A composite disk is shown, although the difficulty could also occur with disks fabricated from a single alloy. The dashed line shows the original contours of the disk and the solid line the contour after necking has taken place. In this case, considerable deformation took place in the weld area. A photograph of a necked disk is also shown in figure 9. The face of the disk was originally a straight-line contour; the light shining through

FIGURE 9.—Growth of welded turbine disk.

between the straight edge and the disk indicates that necking has taken place.

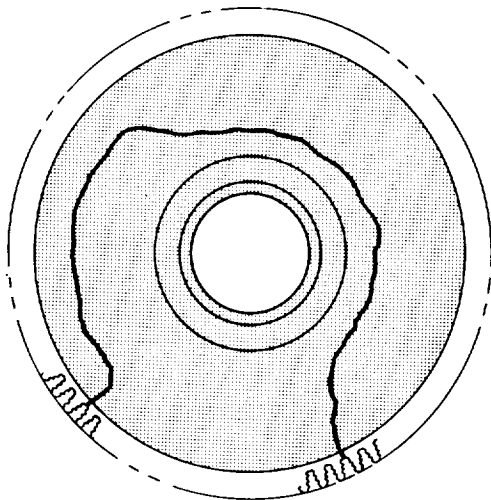
If allowed to proceed, the deformation or necking mechanism can lead to a burst such as that shown in figure 10. The photograph shows a disk fabricated of one material that had been operated in an engine having warped cooling-air baffles. This type of failure can be as catastrophic as a center burst.

FIGURE 10.—Turbine-disk burst as result of excessive growth of web.

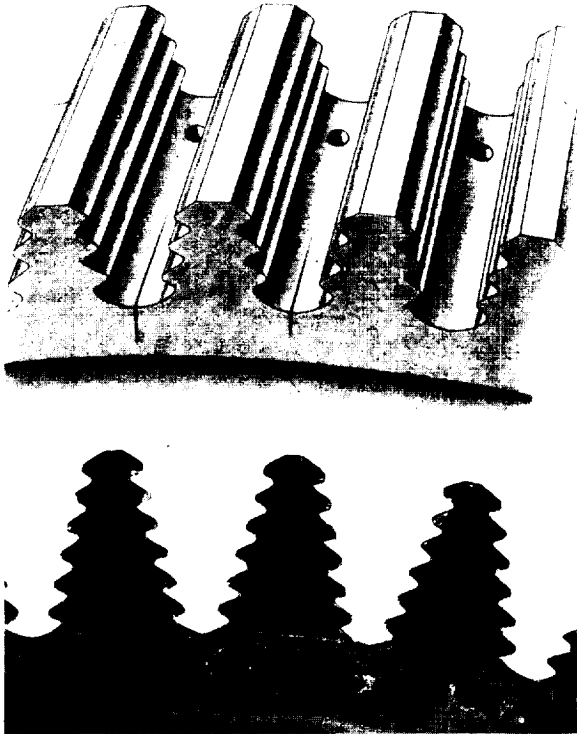
Thermal-fatigue cracks.—As stated previously, the combined effects of centrifugal loading and thermal gradients induce high compressive stresses in the rim area of the turbine disk at rated-speed operation. During starting, the thermal gradients in the disk are even more severe; as a consequence, the stresses are further increased to the point where they frequently exceed the yield strength of the alloy. This induces an immediate compressive plastic flow. In some cases further

FIGURE 12. Thermal-fatigue cracks.

plastic flow can take place (at a much reduced rate) by a creep mechanism. This creep can also occur when the stresses induced by the temperature gradient are insufficient to cause immediate plastic flow. In either case, on engine shutdown the plastic flow that occurred at high temperature will induce a residual tensile stress; this stress may also exceed the yield strength of the material and cause plastic flow in tension. Repetition of this cycle in successive starts and stops eventually consumes the capacity of the alloy to deform and the rim cracks. This mechanism of failure, termed thermal fatigue, is described in

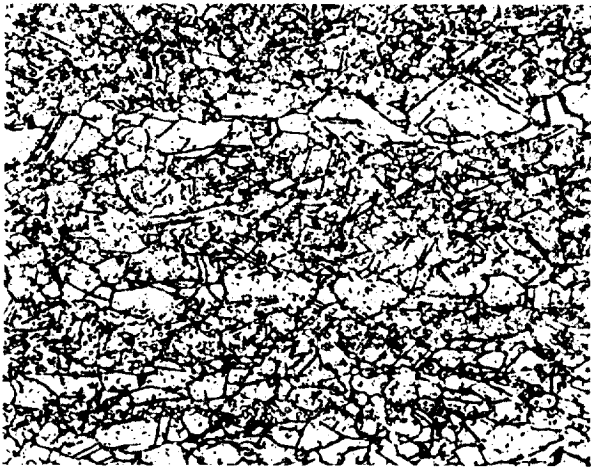
An example of a structural change that reduces life is given for 16-25-6 alloy in figure 16. The heavy precipitate shown was produced by overheating test bars in the laboratory; similar structures have been reported present in turbine disks having serration tensile failures. This change greatly embrittles the alloy.

FIGURE 16. Structure of 16-25-6 alloy after aging. Etchant, aqueous solution of 90 percent hydrochloric acid plus 10 percent nitric acid; X500.

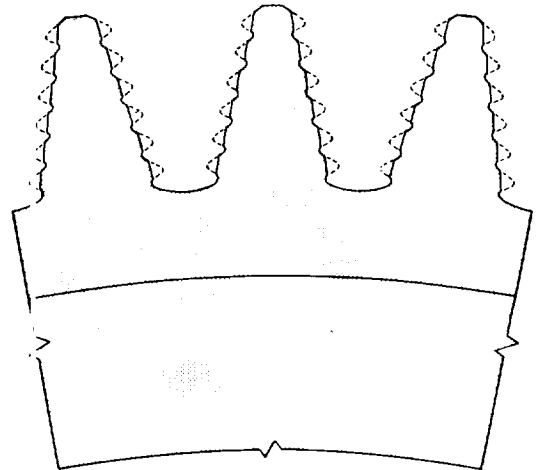
FIGURE 20.—Serration shear failure.

1500 hours in shear. This disk could be expected to fail by tensile stress-rupture. If the temperature were raised to 1350° F, both the tension life and the shear life would be decreased; but shear life now controls, and a failure in shear could be expected in about 16 hours.

Figure 20 shows a spin-pit disk that has suffered a shear failure.

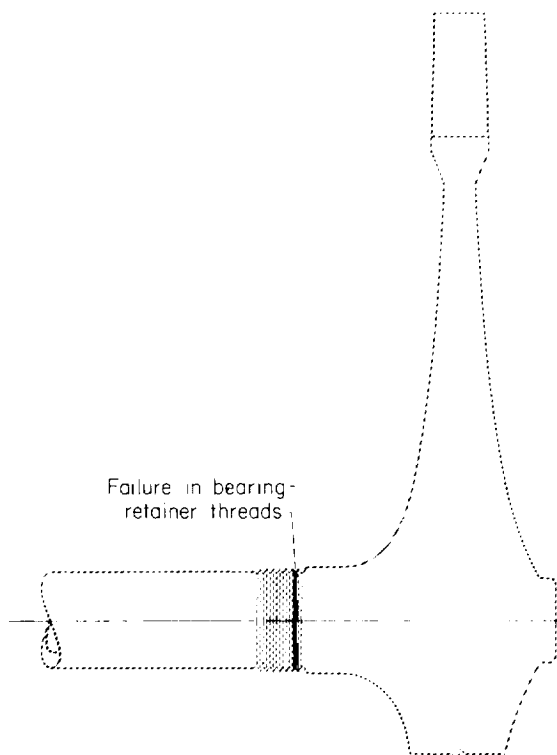
A typical turbine-shaft failure is represented schematically in figure 21. Failure generally occurs at stress-concentration points such as those at the bearing-retainer threads. Since this region of the disk operates at relatively low stress, the failures are attributed to unusual operating con-

FIGURE 21. Turbine shaft failure.

ditions. Several possible causes are (1) torsional vibration of the shaft, (2) overheating of the shaft caused by faulty bearing operation, (3) failure of the cooling-air supply to the bearing, (4) sudden unbalance loads imposed by bucket failures, and (5) gyroscopic loads.

There are no data to indicate whether the failure goes through a detectable incipient stage, but the current practice of inspecting the shaft during overhaul by magnetic means or penetrant oil is undoubtedly sound. Shaft failure, while rare, is extremely destructive.

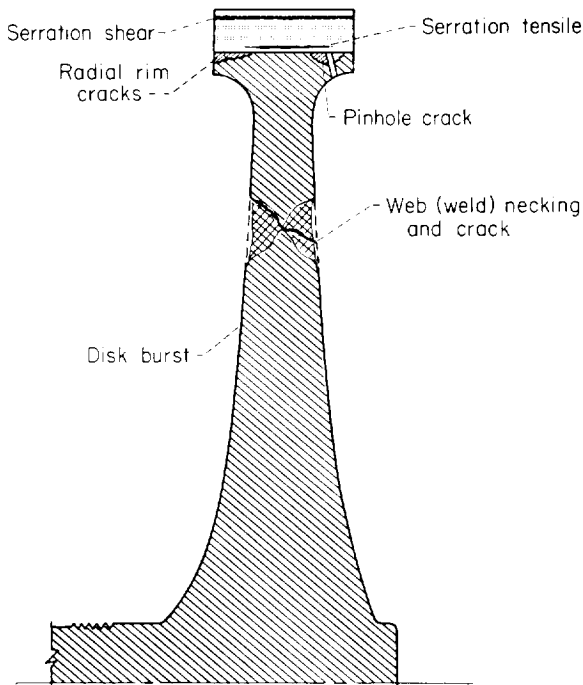
Failure of a turbine disk can cause immediate destruction of an engine. Turbine disks are inspected in manufacture for internal and surface flaws and are usually given overspeed spin tests to check their short-time strength. Difficulties with turbine disks in service can develop through design defects, overheating, thermal cycling, and creep. The principal disk failure mechanisms are summarized in figure 22 and table I.

Overheating can be caused by failure of the disk-cooling system, improper installation of the system, or excessive combustion temperatures. Overheating in combination with the stresses in the disk caused by centrifugal force can cause excessive growth of the disk rim. Because rapid and catastrophic failure of disks can occur by severe overtemperature, a device for warning of overtemperature of the disk is desirable. Possible devices that might be developed are radiation thermocouples that scan the disk rim, elec-

FIGURE 22. -Locations of disk failures.

trical contact devices that warn of excessive disk growth, or a device to detect a reduction in cooling airflow.

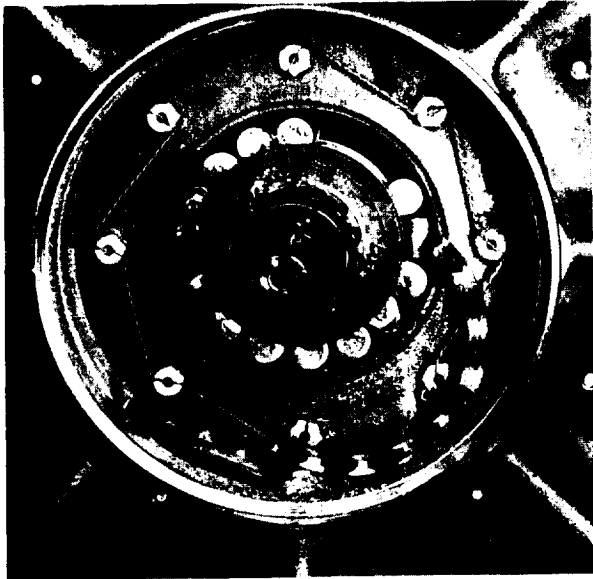
FIGURE 5.—Bearing failure resulting from oil interruption. Engine with jet lubrication of bearings. Photograph shows cage has failed completely. Failure occurred 17 minutes after oil interruption (from ref. 1, appendix B). Other photographs of this engine in figures 6 and 7.

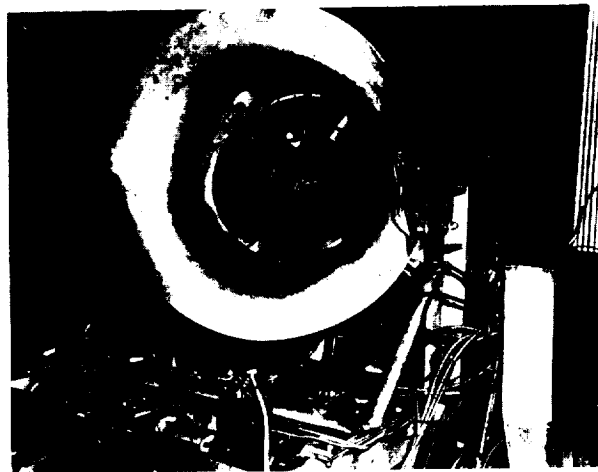
FIGURE 7.—Engine torn from test mount as result of engine stoppage by bearing failure in oil-interruption tests (from ref. 1, appendix B).

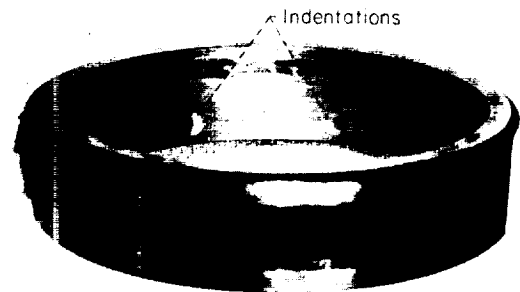
“False brinelling” is a special case of fretting (fretting corrosion, friction oxidation). Fretting is the surface failure that occurs when closely fitting metal surfaces (such as a rolling element and race) experience slight relative motion over long periods of time. False brinelling of engine bearings usually occurs when the engine is subjected to vibration during shipping or when

FIGURE 13.—False brinelling of outer race of double-row self-aligning ball bearing caused by vibration without bearing rotation (from ref. 15).

standing on a vibrating platform. Such damage can usually be prevented by eliminating or appreciably decreasing the vibration at the bearings. This type of damage can take place under loads far below the static-load capacity of the surfaces. False brinelling in a double-row, self-aligning ball bearing is shown in figure 13.

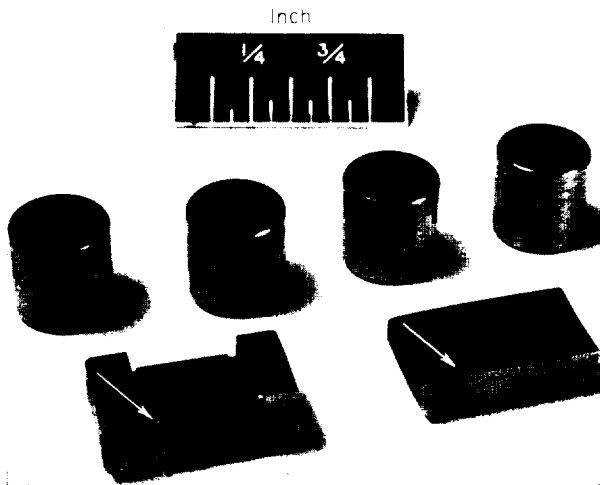
Misalinement may cause several types of bearing failure. Parts of a roller bearing that failed because of misalinement are shown in figure 14; this bearing shows evidence that misalinement

FIGURE 14.—Cylindrical roller bearing that failed because of misaligned load.

altered the load from a fairly uniform distribution across the length of the rollers to a very heavy load near one end of the rollers. This caused premature surface failure of both races in the plane of the magnified load. Both races are flaked in this region.

The time between incipient failure and total failure, from misalignment causes, is probably long enough to permit total failures of this type to be forestalled by scheduled inspections. Vibration measurements may possibly be used to detect failures of this type.

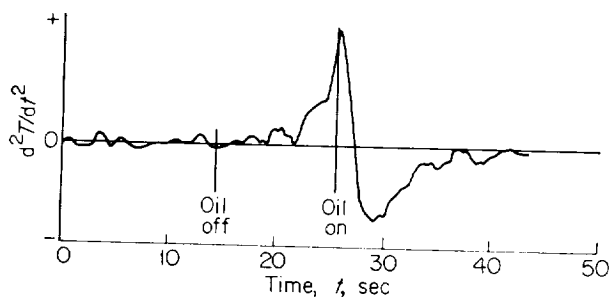
FIGURE 19.—Temperature acceleration pattern during incipient failure (data from ref. 19).
