LATERAL LOAD TESTS ON EARTHQUAKE DAMAGED HOUSES IN CHRISTCHURCH

ABSTRACT: *Thousands of houses in Christchurch were damaged in the Christchurch earthquakes of 2010 and 2011. Uni-directional lateral load tests were undertaken on two houses in the residential red zone in Christchurch in June 2012. The aim of the tests was to measure the lateral load stiffness of typical moderately damaged houses to identify the change in stiffness due to the seismic load history. The wall bracing systems of the houses are assumed to satisfy the regulations in force at the time, which are outlined. Several relevant tests from the literature are briefly reviewed.*

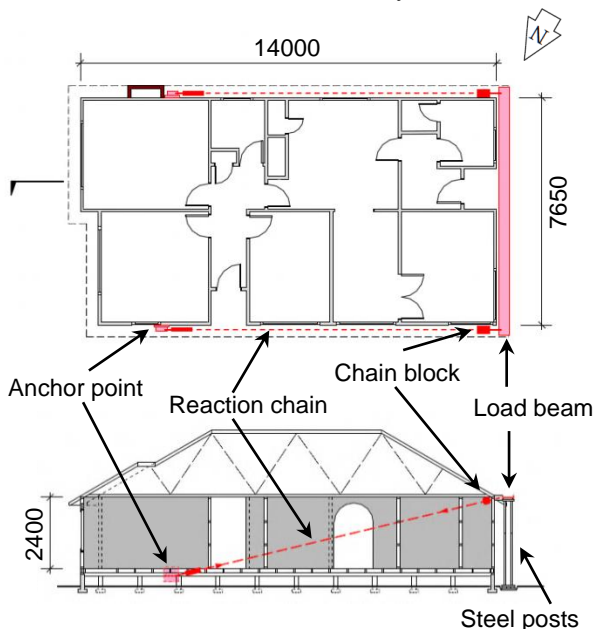
Figure 1: Floor plan and section of Bexley Rd. with test rig in place. All dimensions in mm. By L. Holt.

No house plans were available on the Christchurch City building files. On-site measurements were done and plans were created. The test rig, shown for the Bexley Rd. house in Figure 1, comprised of a 360UB57 (I-section) load beam that was borrowed and placed against one end of the house at ceiling height with its strong axis parallel to the wall. Adjustable steel Acrow-Prop posts supported the load beam at both ends and mid span. The posts were designed to support the vertical component of the applied load. 7.5 ton capacity chain blocks were attached to both ends of the load beam using a 15mm thick attachment plate that slid over the flange closest to the house, as shown in Figure 2. The chain was anchored to a point at the opposite end of the house with an inline load cell to record the tension in the system.

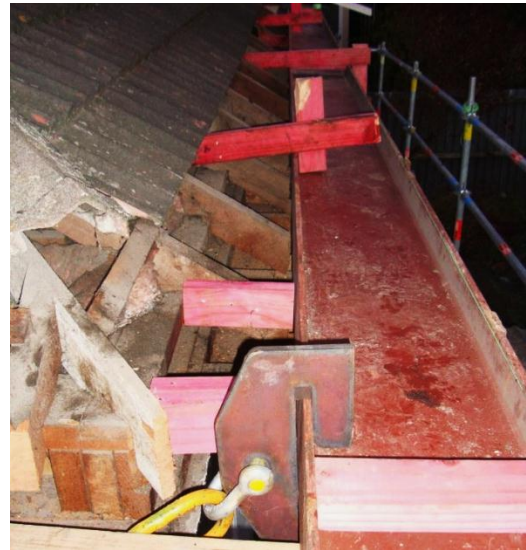
The test house at Bexley Rd. had a hipped roof structure therefore tiles had to be removed and the load beam was propped off the top plate using 400 mm long timber blocks. Props of 90x45mm timber were located at points coinciding with bracing lines and by using props the roof's timber frame could remain in place during testing without conflicting with the load beam, see Figures 2

Figure 2: Load beam with slide plate with 90x45mm props to transfer load to the top plate, Bexley Rd. Note a string line along the outside edge used to monitor beam bending. Photo: L. Holt

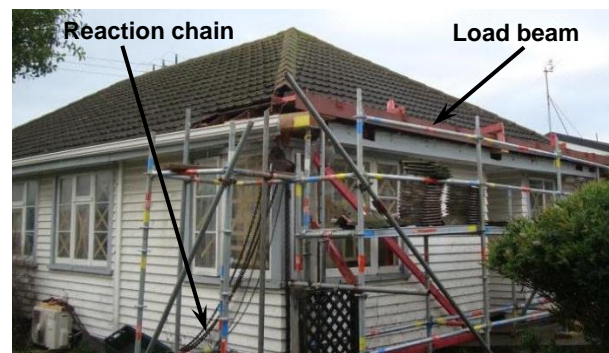
Figure 3: Load beam in place on west wall, reaction chain slack prior to loading, Bexley Rd. Photo: L. Holt

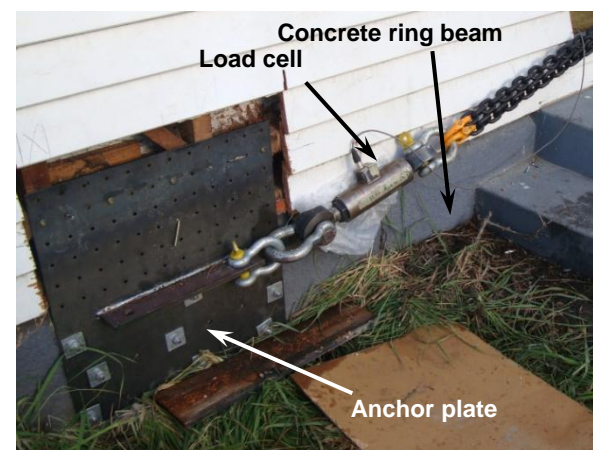
and 3. The load beam was placed along the west wall. Due to a step in the east wall the anchor beam from the other test house could not be used. Instead anchor plates, see Figure 4, were fixed at the base of the north and south walls using large timber screws into the bottom plate and studs and dyna-bolted into the concrete ring beam foundation.

Figure 4: Anchor plate at Bexley Rd screwed to wall and subfloor and dyna-bolted to foundation. Photo: L. Holt

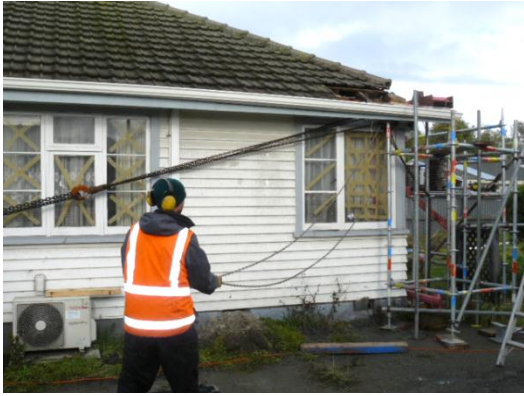
Two people operated the loading chain blocks simultaneously from both sides with real time load monitoring, as shown in Figure 5. Scaffold safety towers were built beneath the ends of the load beam in case of an earthquake or failure of the posts. A near pinned connection was made at the ground support of the steel posts so the entire horizontal component of the test load was applied to the house.

Figure 5: Applying load to the house via the chain block, Bexley Rd. Photo H. Morris

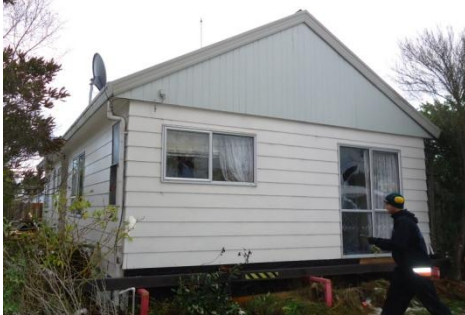
Figure 6: Wairoa St. House, base anchor beam visible

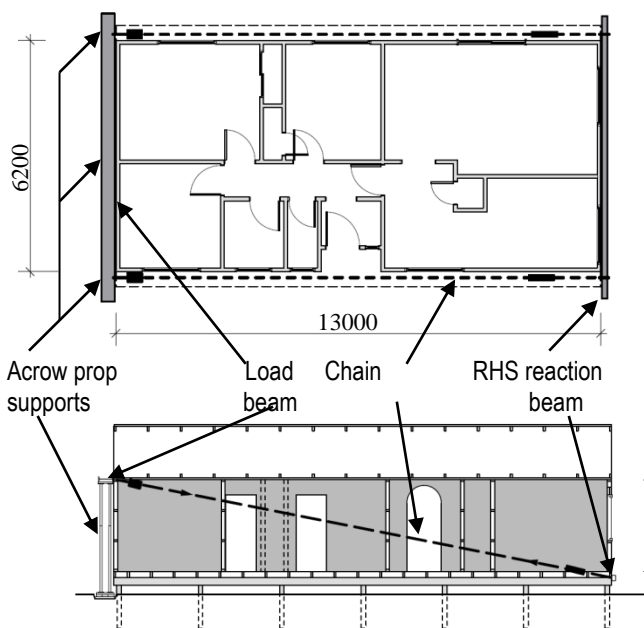
Figure 7: Floor plan and section view of Wairoa St. house showing load system By L Holt

The test house at Wairoa St. had a gable end roof (Figure 6). The load system is illustrated in Figure 7. The load beam was able to sit directly against the top plate of the timber frame at the west end, see Figure 8a. Limited exterior cladding was removed to accommodate the load beam. The anchor point shown in Figure 8b consisted of a 150x100x6mm rectangular hollow section (RHS) beam at floor level along the east end of the house. The RHS was placed with its strong axis parallel to the ground to prevent lateral deflections and ‘rolling’ from occurring. Hold downs were screwed to the wall studs to prevent the RHS from sliding up the wall. Chains connected to the load cells were looped over the ends of the RHS.

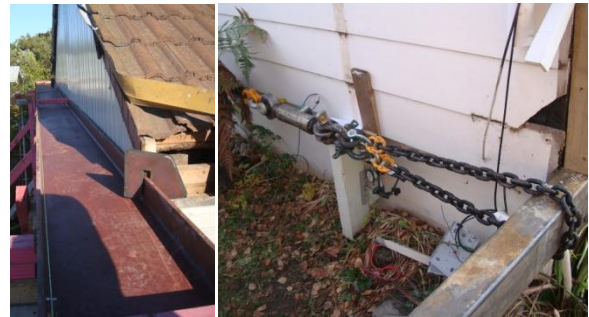
Figure 8 The 360 UB 57 Load beam positioned at ceiling against the gable end(a left). Load cell and reaction chain looped around RHS at floor level (b right). Wairoa St.

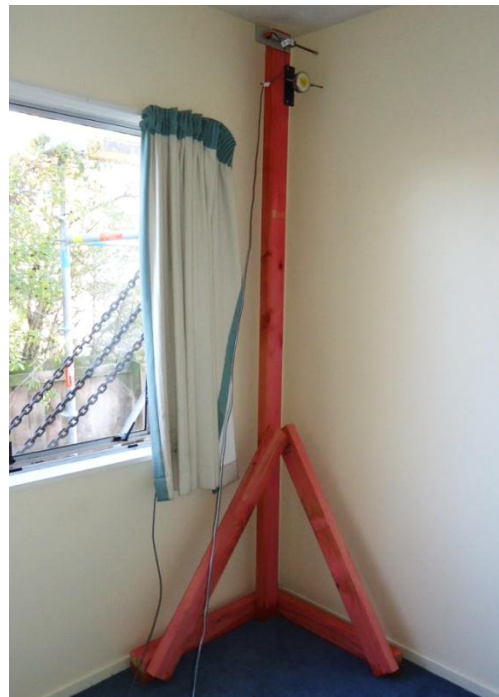
Figure 9: Potentiometer and manual dial gauge supported by timber props nailed to floor, Wairoa St Photo: D. Yeoh

Eight potentiometers were used at each site to measure horizontal deflections. Seven were located at ceiling height anchored to the floor inside, see Figure 9, or to the ground outside. A single potentiometer was used to measure slip between the floor and the foundation.

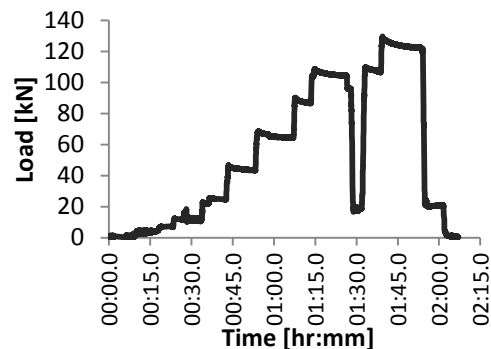
Loading was applied to both sides evenly, see Figure 5, pausing every 20kN (10kN each side) for approximately 15 minutes to read manual gauges. At 100kN the load was reduced back to 20kN gauges read and then loaded to 120kN within five minutes. This was done to give some cyclic response and also keep tension in the catenary load system. Finally, the max load applied was

130kN which was the capacity of the test rig. The load was then removed in approximately two minutes. The total test period was two hours. The entire loading sequence for Bexley Rd. is shown below in Figure 11 which is similar to the 2 hour sequence for Wairoa St.

Figure 11: Load vs Time during testing at Bexley Rd.

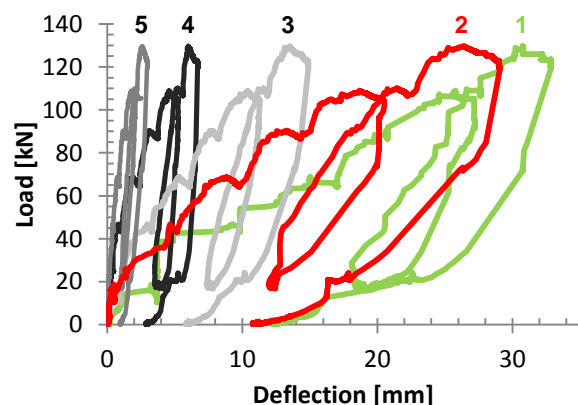
Figure 12: Load vs deflection plot showing five of the six locations measured during the test at Bexley Rd.

Significant variation in deflection was observed depending on location within the house. Numbers above the plots in Figures 12 (and 14) refer to the locations of the potentiometers shown in Figure 13 (and 15).

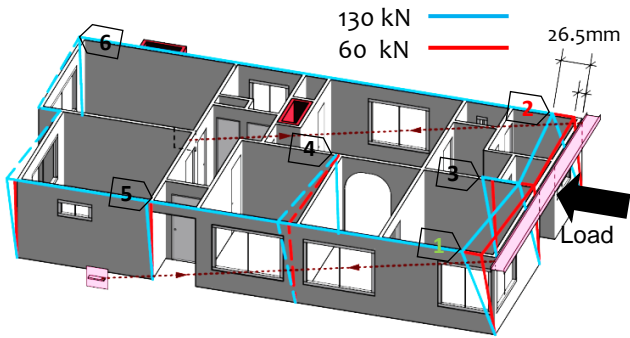
Figure 13: Isometric of Bexley Rd. The blue line shows the (exaggerated 30:1) deflected shape of the house under maximum test load (130kN). The relative deflections at measured points are circled and all intermediate points are estimated.

The 360UB load beam available was lower stiffness than ideal and was measured to bend approximately 5mm away from the building at Wairoa St and 10mm away from the building at Bexley Rd. A simplified bending analysis indicates a load distribution in Bexley Rd of around 50% to the central wall area and 25% to each of the side walls.

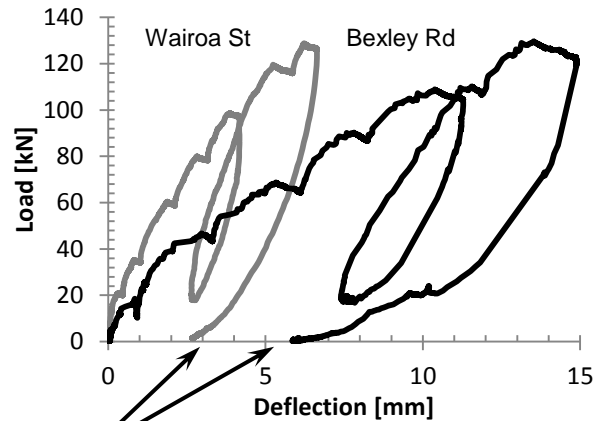
Figure 16: Load vs average deflection for both test houses showing similar pattern of stiffness.

Average deflection under maximum load and residual deformation were 6.5mm and 2.7mm at Wairoa St and 14.7mm and 6.0mm at Bexley Rd as shown in Figure 16.

As shown in Figure 16 earlier there was residual deformation once the test load had been removed. However it should be noted that deflection data was only recorded for five minutes after the test load returned to zero. While it is likely that there will be permanent/plastic deformation due to the test load the magnitude may be less than that shown in the results due on-going creep recovery over a greater period of time.

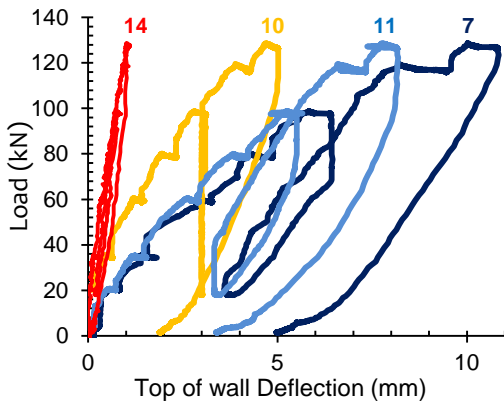
Figure 14: Deflections at Wairoa St related to the location of potentiometers

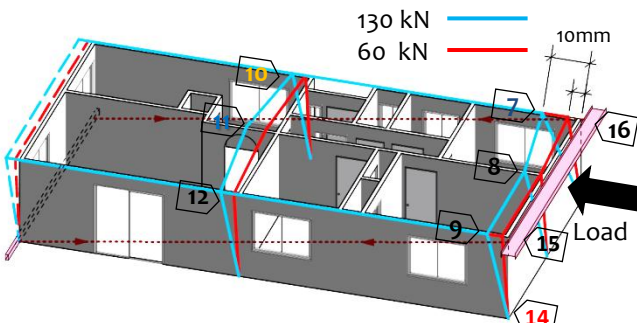
Figure 15: Deflections at Wairoa St (exaggerated 100:1) and location on potentiometers

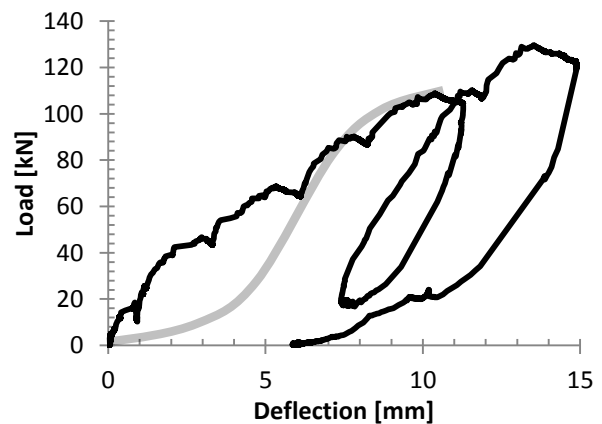
Because of the numerous reports of flexibility due to the existing damage it was predicted that load deflection plots would show less stiffness under low loads, an increased but uniform stiffness under medium loads and then a reduction in stiffness under maximum load as the bracing elements began to fail. This expectation is conceptually shown by the grey line in Figure 22. This was not observed during testing. All load deformation plots showed a moderately high initial stiffness and an approximately linear relationship.

Figure 22: Stiffness profile comparison. Light grey line represents predicted changes in stiffness compared to the black line representing average deflections at Bexley Rd.

Loads of less than 10kN are not considered to be precise

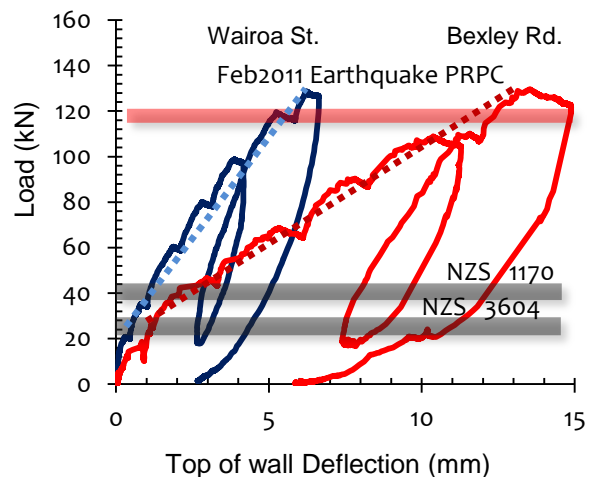
The stiffness of both buildings was estimated from the backbone trend lines shown in Figure 23 and was found to be 18kN/mm for Wairoa St. and 9kN/mm for Bexley Rd. Thurston [7] states, during the testing of an undamaged LTF house, a static load of 30kN produced an approximate deflection of 2mm. This suggests a stiffness of around 15kN/mm which is similar to that of the test houses.

Figure 23: Load vs average deflection plots for both test houses showing approximate linear stiffness and equivalent load levels from the NZ Standards and the Pages Road Spectra.

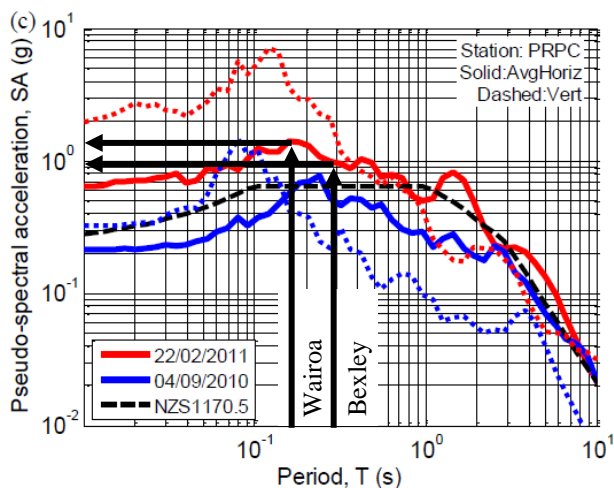
Using the structural properties of the houses defined in table 1, earthquake design loads were found using New Zealand Standards 3604:2011 [11] and 1170.5:2004 [12]. The amended value of the seismic hazard factor, Z, for Christchurch of 0.3 was used in the calculations and actual earthquake loads were found using a pseudo spectral acceleration plot. Observed ground motions at the Pages Road Pumping Station strong motion station (PRPC) were used to derive the pseudo-spectral acceleration plot in figure 24 [13]. The PRPC station was

initially assumed to be nearby on similar soils but was 680m from the Bexley Rd house and 1070m from Wairoa St house. Using the spectral acceleration plot and the period of each house, shown in table 1, an acceleration coefficient related to the actual base shear of the February quake can be determined. The coefficient multiplied by the estimated mass lumped at ceiling height calculates the actual load applied to the houses during the February quake. These different loads are compared with the test load in table 2. The periods calculated in section 5.3. were used to determine the acceleration experienced by each house during the February earthquake as presented in table 2.

The PPRC record is severe and it is likely that a detailed evaluation of actual site response would be different. It does however indicate a near maximum load scenario.

Figure 24: Pseudo acceleration response spectra from Pages Road Pumping Station (PRPC) B Bradley [10]
