Troubleshooting Challenges on the James Webb Space Telescope (JWST)

July 23, 2019

John McCloskey

NASA/GSFC Chief EMC Engineer

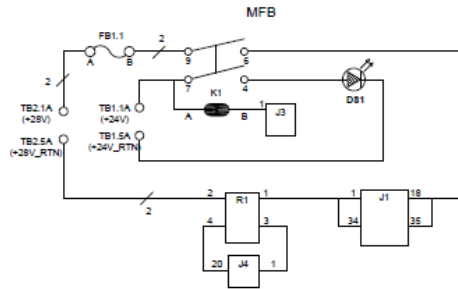
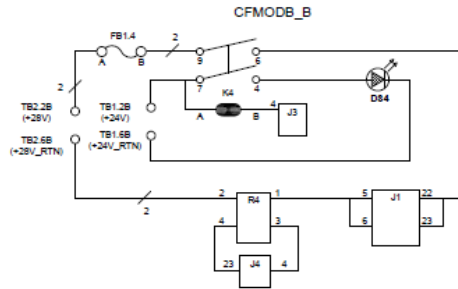
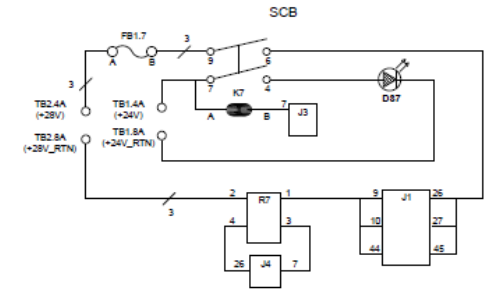
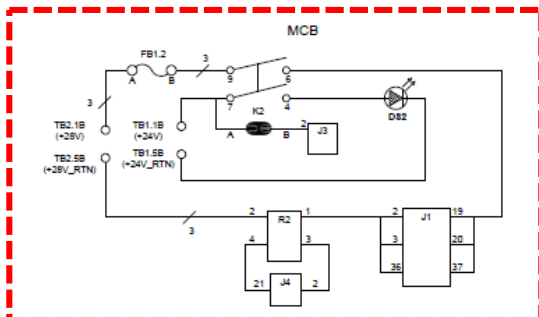
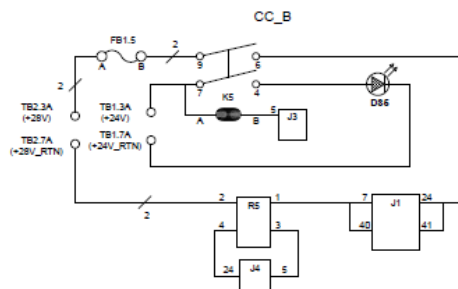
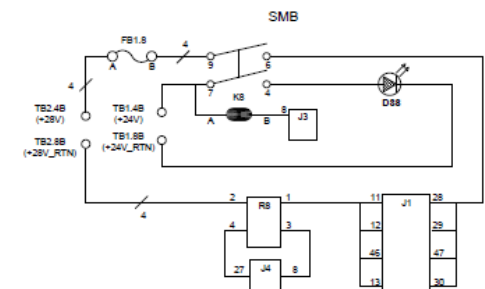
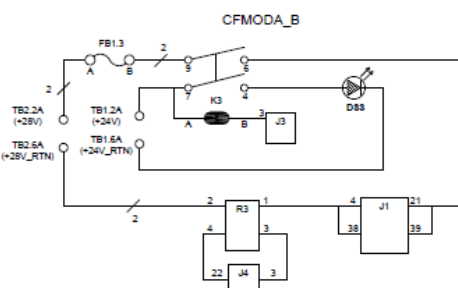
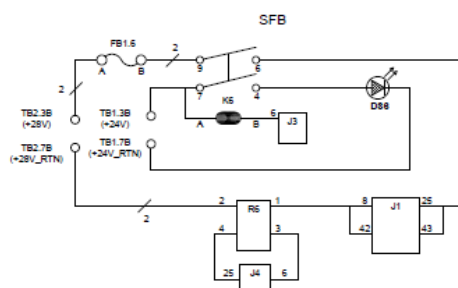
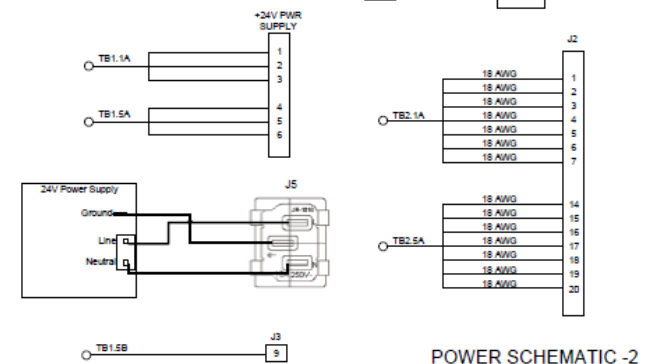
SI Redundant Power Drawer Block Diagram

MIRI ICE B feed
(identical to all others)

No transient suppression elements on relay contacts or coils

Limited transient suppression (~3 meters of cable from relays)

- **Mechanical relays**
 - Inherently noisy (contact bouncing, etc.)
 - No transient suppression elements (transorbs, etc.)
- **Long cables and large current loops**
 - Increased risk of coupling
- **Measurements show significant noise generated by relay switching transients, but...**
 - These relays were not operating when 1553 events occurred (relays close to turn on box and stay closed)
 - Transient energy couples EVERYWHERE; no credible explanation for why only one side of one box would be affected
 - Ringing in switching transients has resonant frequency of ~1 MHz
 - MIRI ICE B has robust input filter with lots of attenuation at 1 MHz
 - **RELAY SWITCHING TRANSIENTS UNLIKELY ROOT CAUSE**

- **All relays and sockets replaced in SCSim2A**
 - All power feeds now “clean”; show no trace of erratic behavior
 - Relays provided to GSFC parts branch for evaluation; could not reproduce erratic behavior 🤨

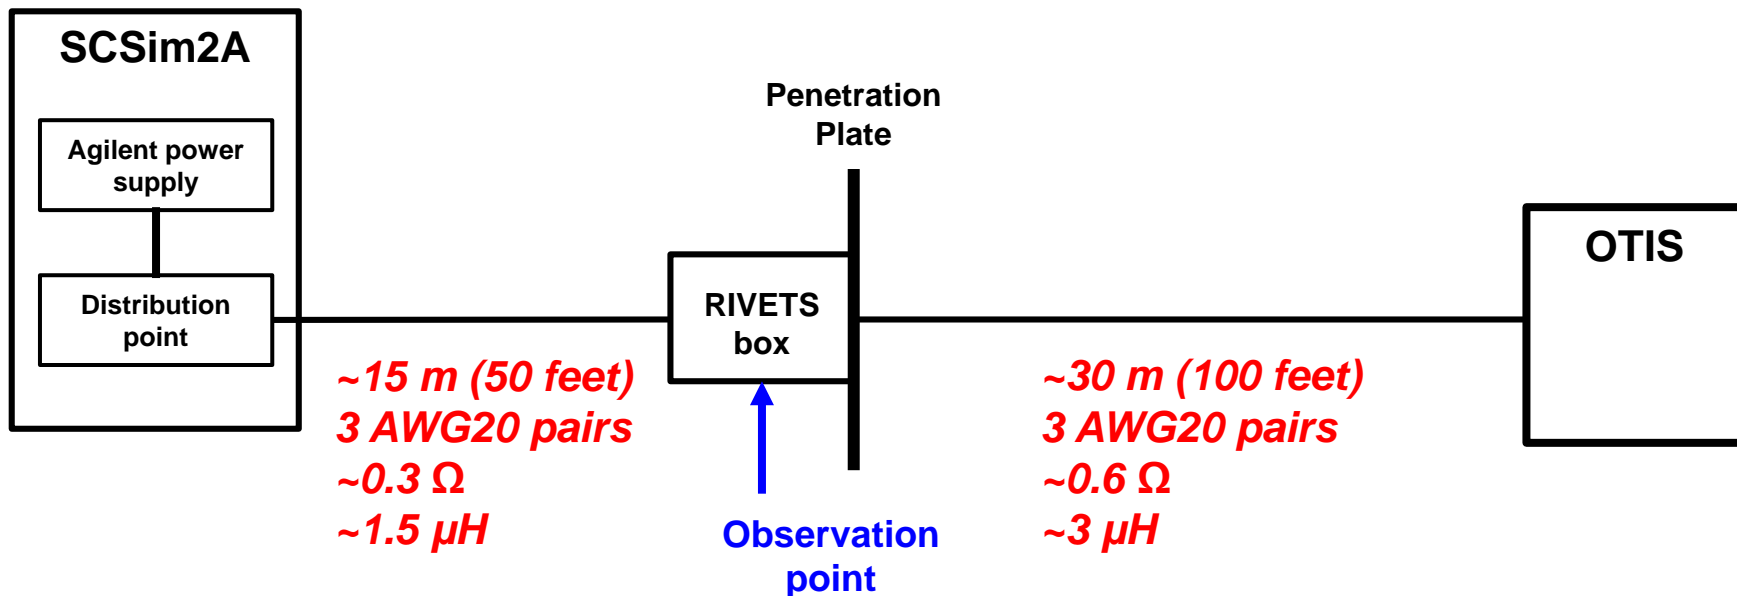
- Using “RIVETS” box (Remote Interface Verification Electrical Test System) at penetration plate, observed voltage and current on power feed to MIRI ICE-B

- **During 1553 transactions:**
 - $\Delta I \approx 120 \text{ mA}$, $\Delta V \approx 200 - 300 \text{ mV}$
- **Effective $Z \approx 1.7 - 2.5 \Omega$**

- **HARNESS RESISTANCE DOES NOT FULLY ACCOUNT FOR OBSERVED VOLTAGE DROPS**

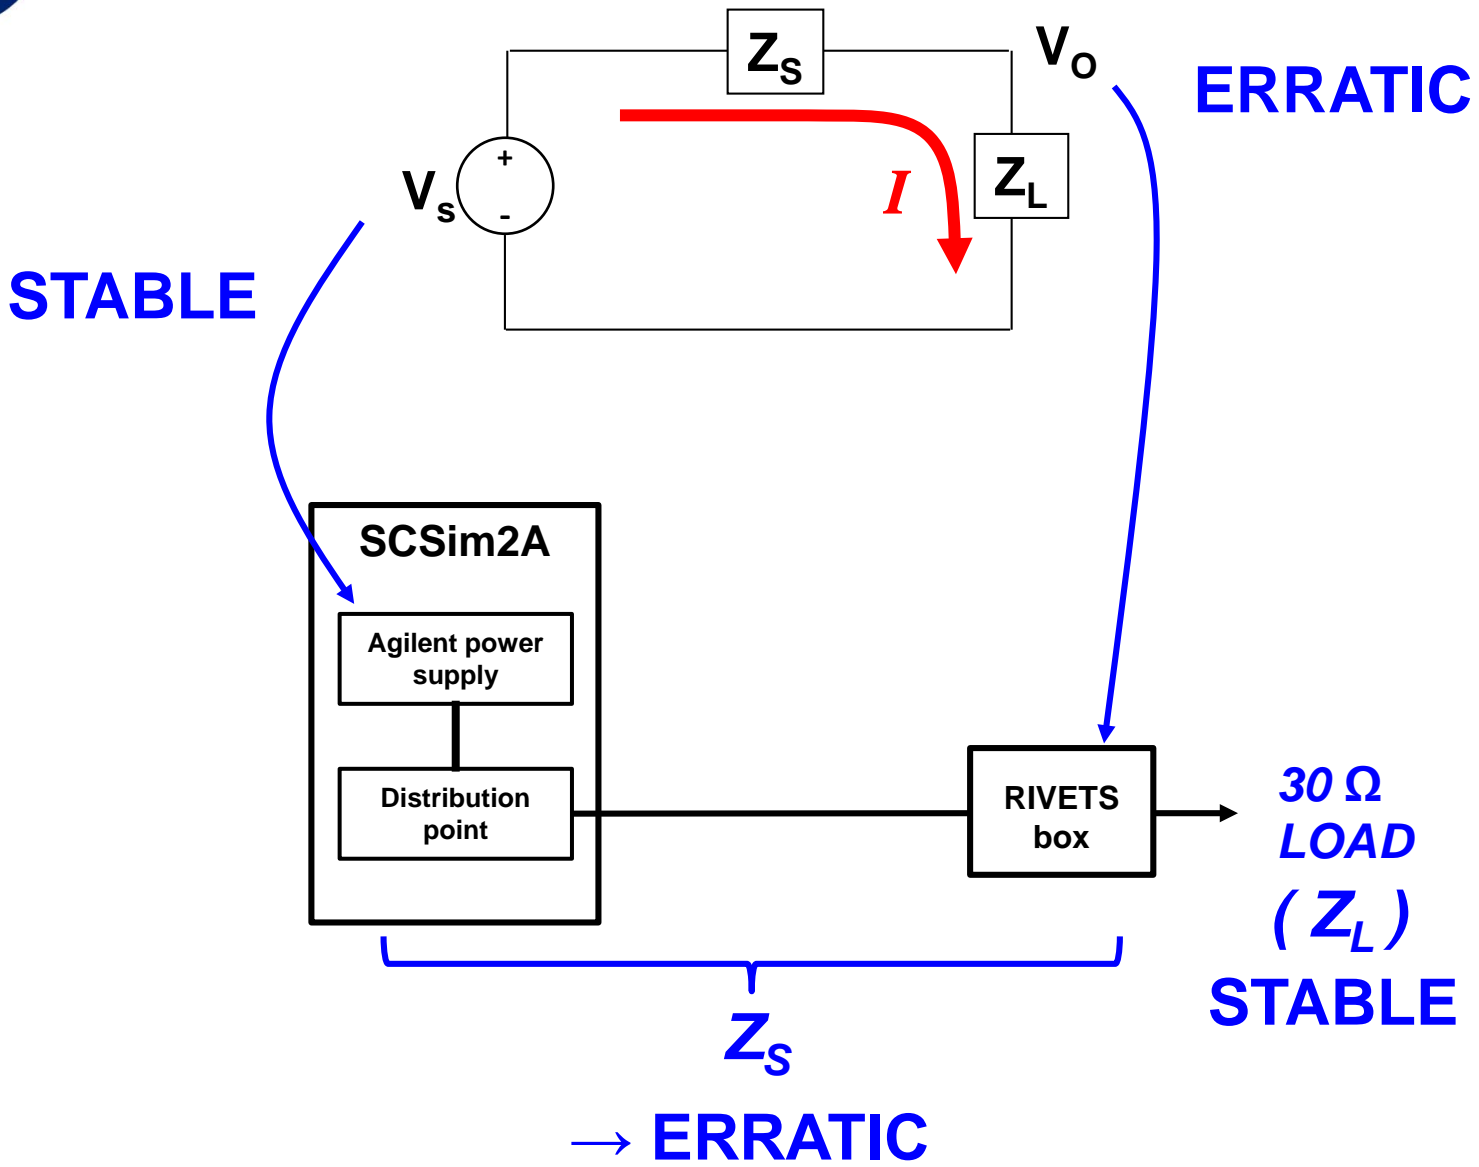
Power Feed Voltage Drop

- Per GSFC Parts Branch (Code 562), erratic behavior is consistent with previously observed behavior of corroded relay contacts (SCSim has been in near continuous use for > 5 years)
- May contribute to instability in power interface
- May correlate to previously observed events

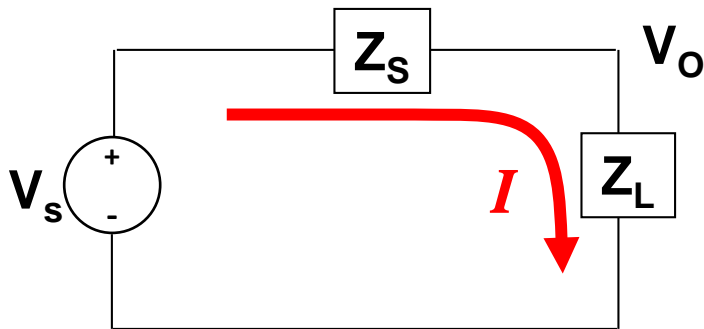
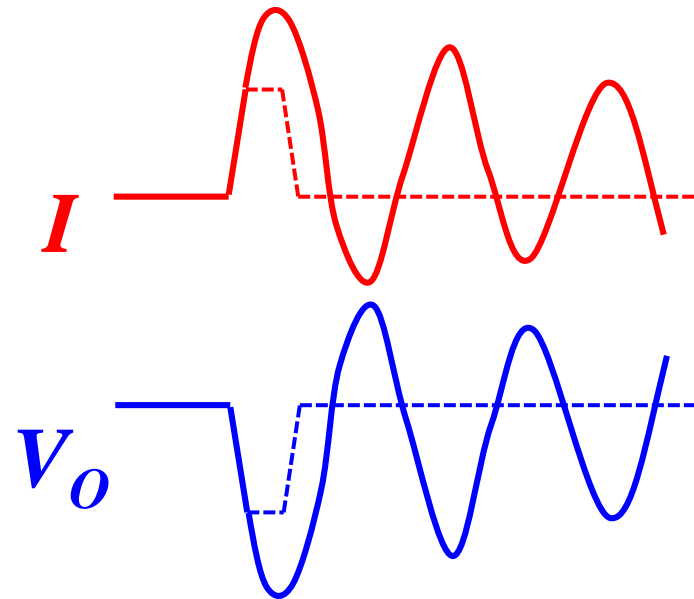
- $\theta_S - \theta_L \approx 180^\circ$
 - Source looks like resistance, load looks like negative resistance
 - Simplified model for power converter
 - For constant power load, current increases when voltage drops and vice versa
 - When magnitudes are (nearly) equal, current from any transient increases uncontrollably
 - larger than expected ΔV_O , oscillations, etc.

- **Though not proven, instability is leading theory for root cause**
 - Middlebrook magnitude criteria violated from ~500 Hz to ~50 kHz for increasing values of relay contact series resistance
