HIGHLIGHTS OF TESTS OF STEEL  
BEAM-TO-COLUMN BOLTED CONNECTIONS  
(C6, C7, C8, C9)

October 1974

Fritz Engineering Laboratory Report No. 333.29

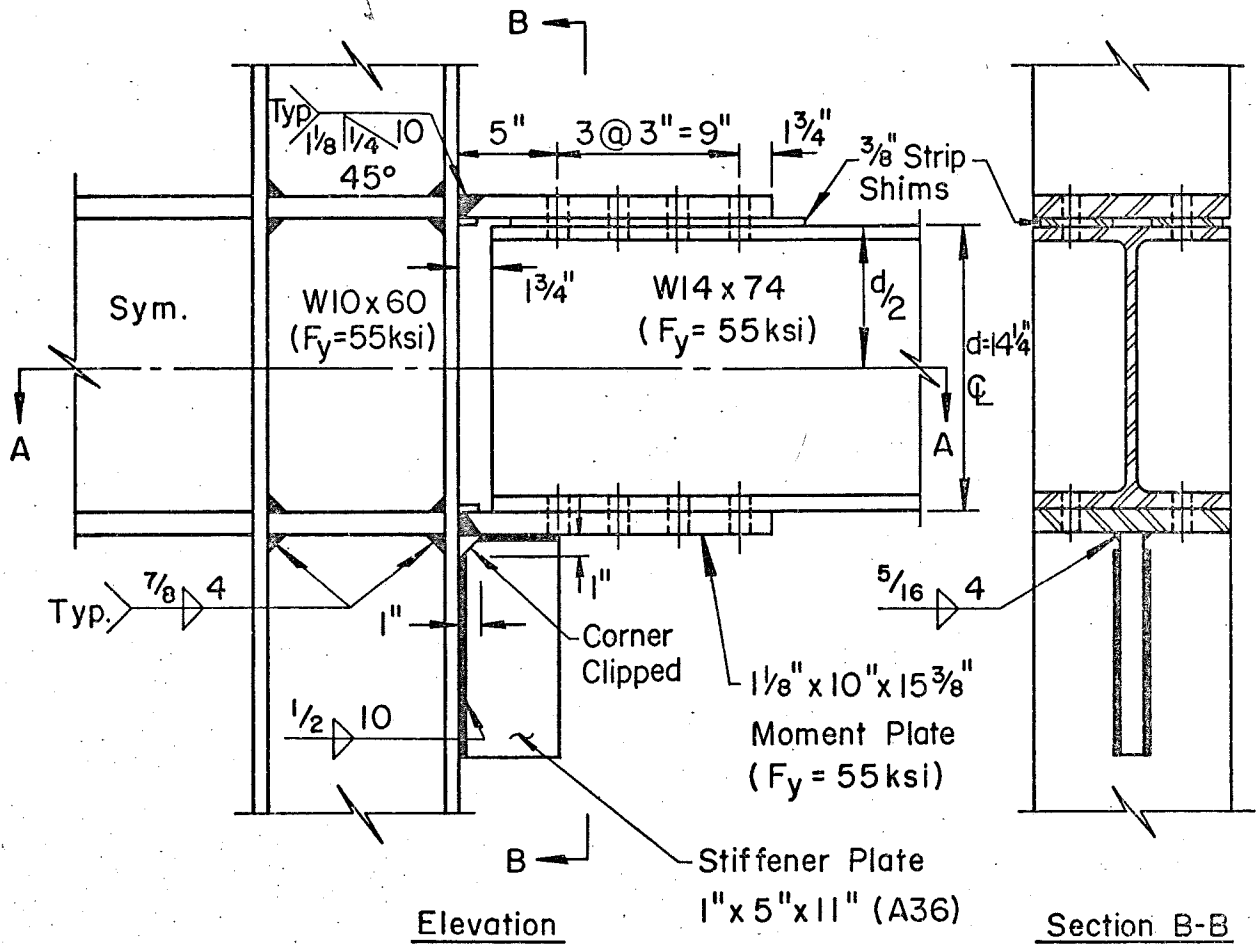
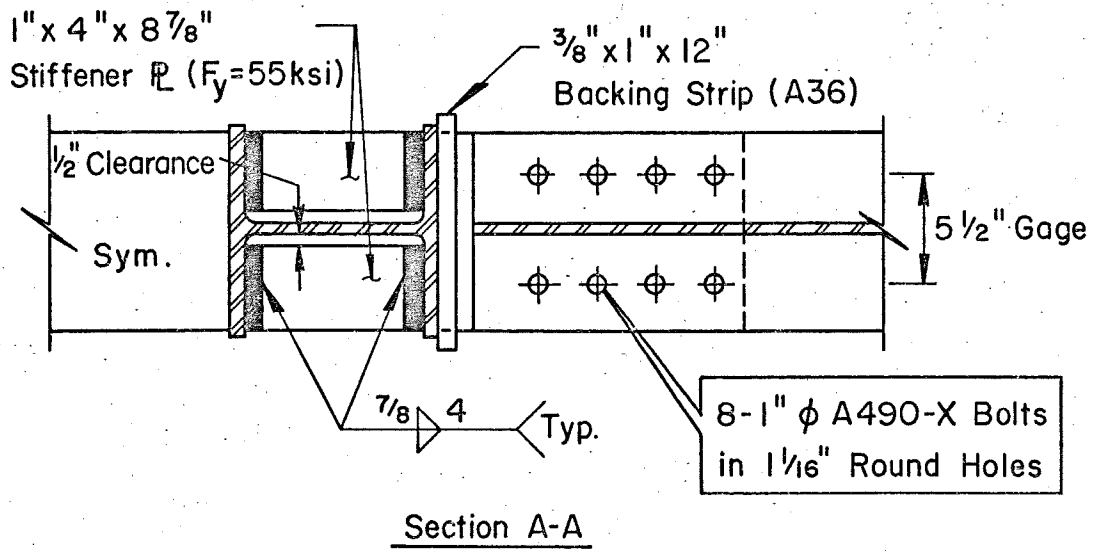
Fig. 1 Connection C6

Connections C6 and C7 are shown respectively in Fig. 1 and Fig. 2. Both connections were designed using A572 Grade 55 steel with a W10x60 column section and a W14x74 beam section.

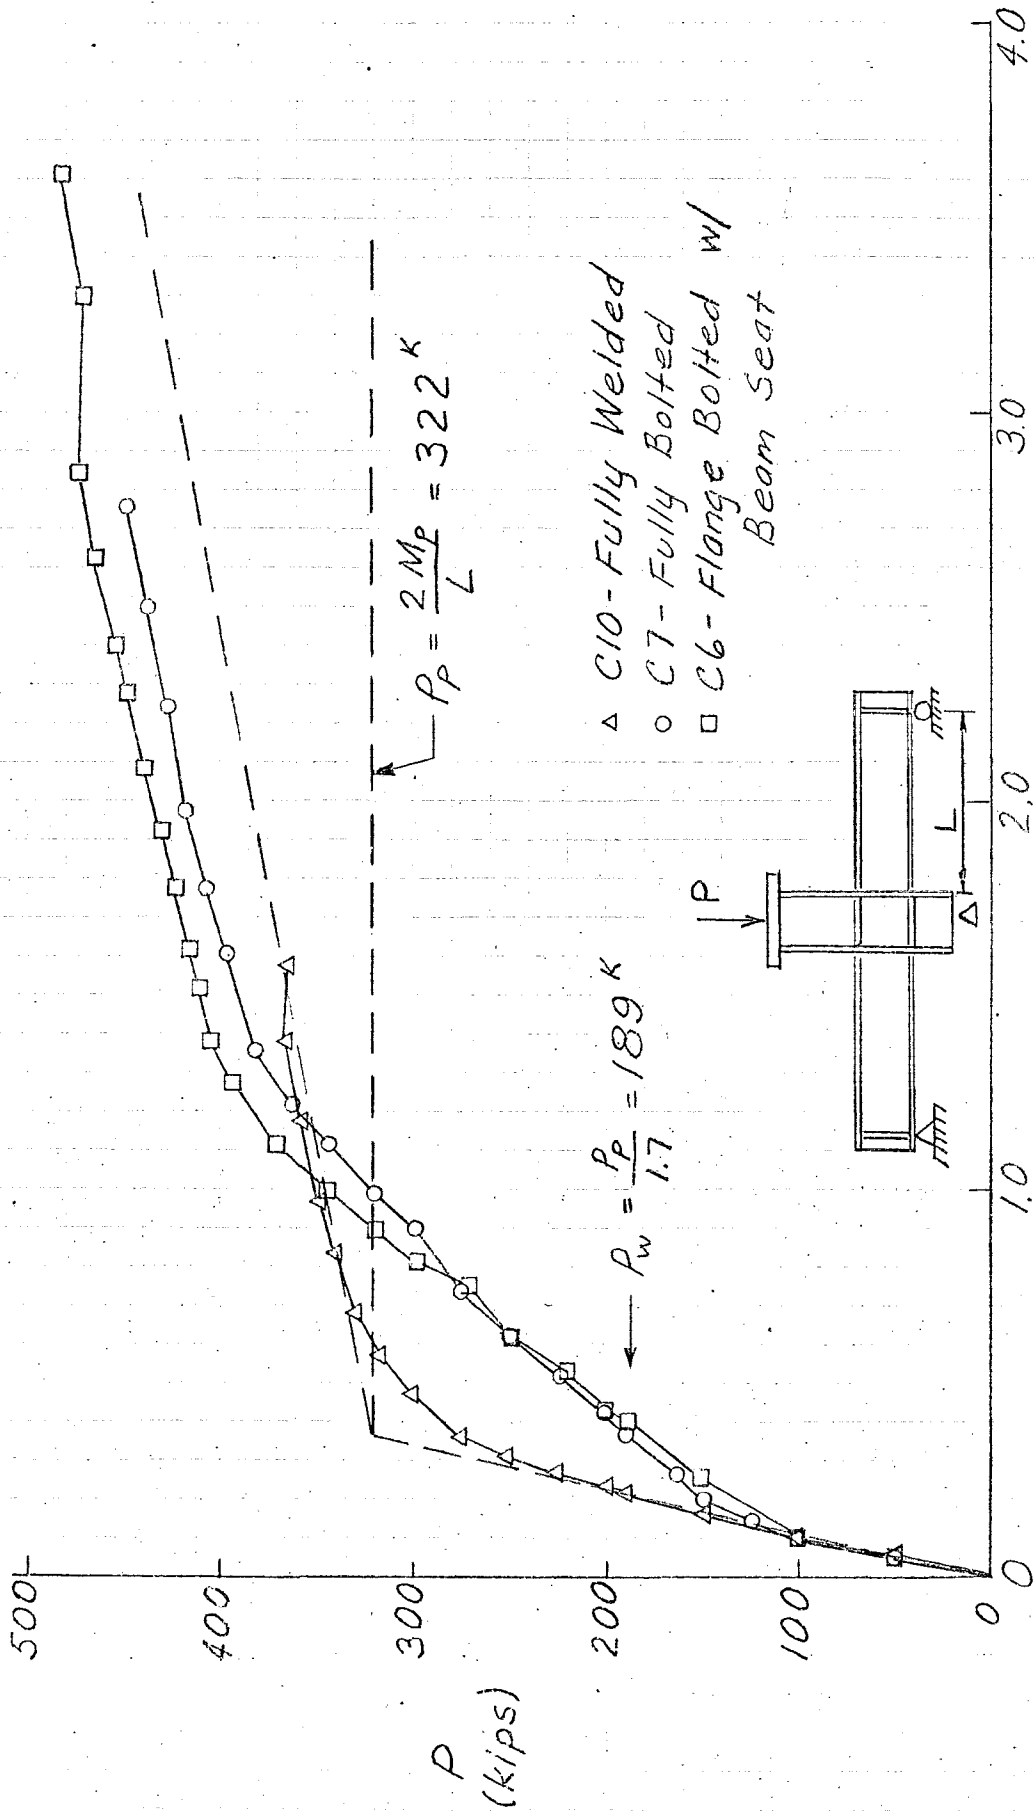
Fig. 3 Load vs Deflection of C6 and C7

The load versus deflection curves for C6 and C7 are given in Fig. 3. Also shown on the figure is a plot of C10 which is the control (fully welded) specimen using the same beam and column sections as C6 and C7. On this plot, as well as the plot of C8 and C9, the effects of slip are averaged by not plotting any of the horizontal slip plateaus. Note that the load-deflection plots for both C6 and C7 have three distinct phases (slopes).

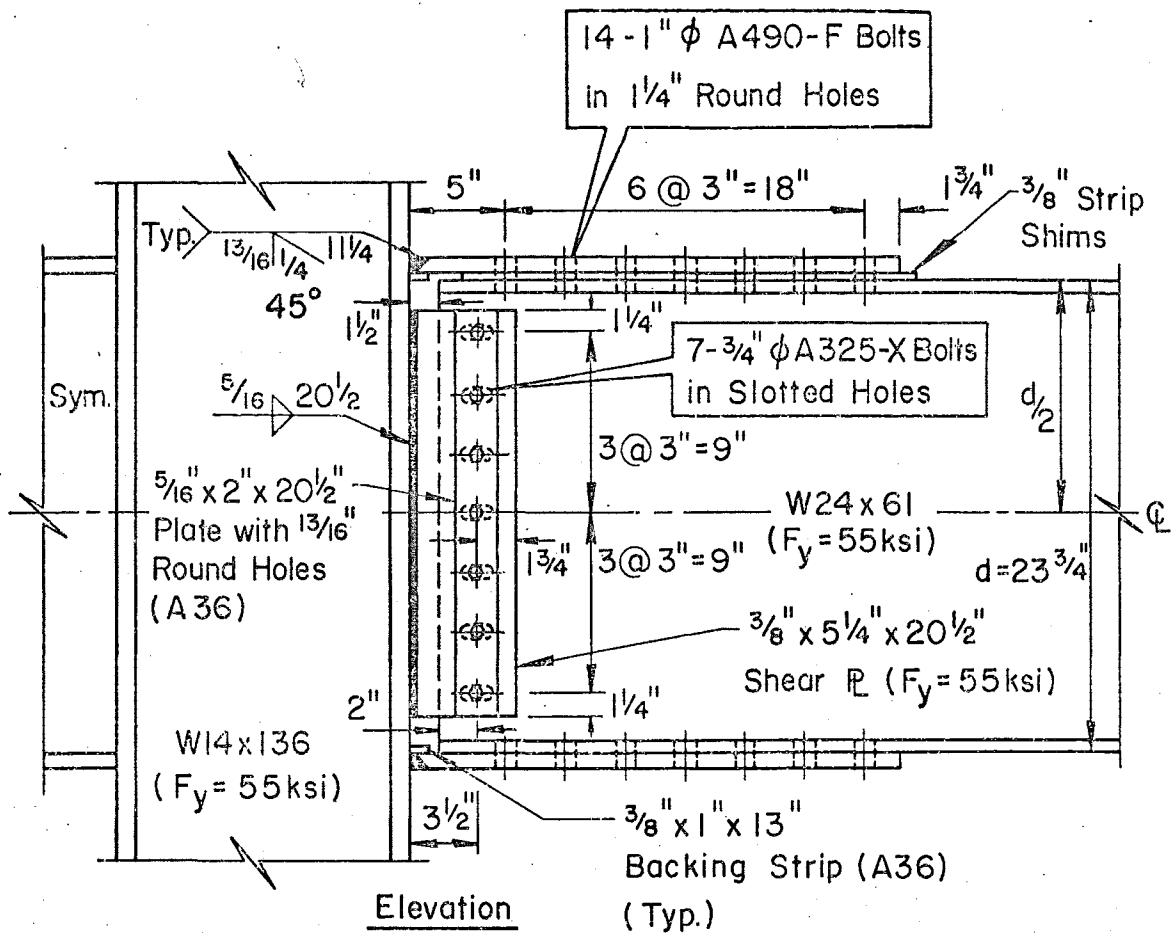
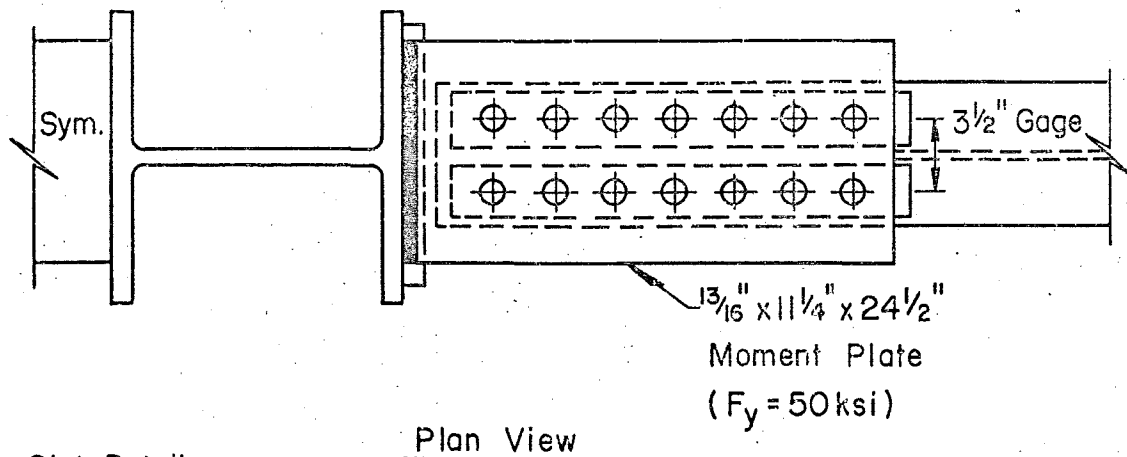
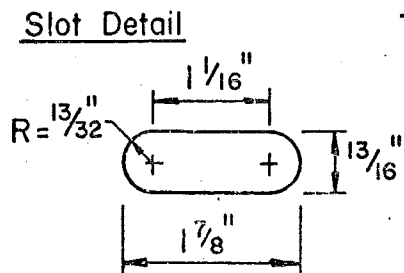
Fig. 13 Connection C8

Connections C8 and C9 are shown respectively in Fig. 13 and Fig. 14. Both connections were designed using ASTM A572 Grade 55 steel with a W14x136 column section and a W24x61 beam section.

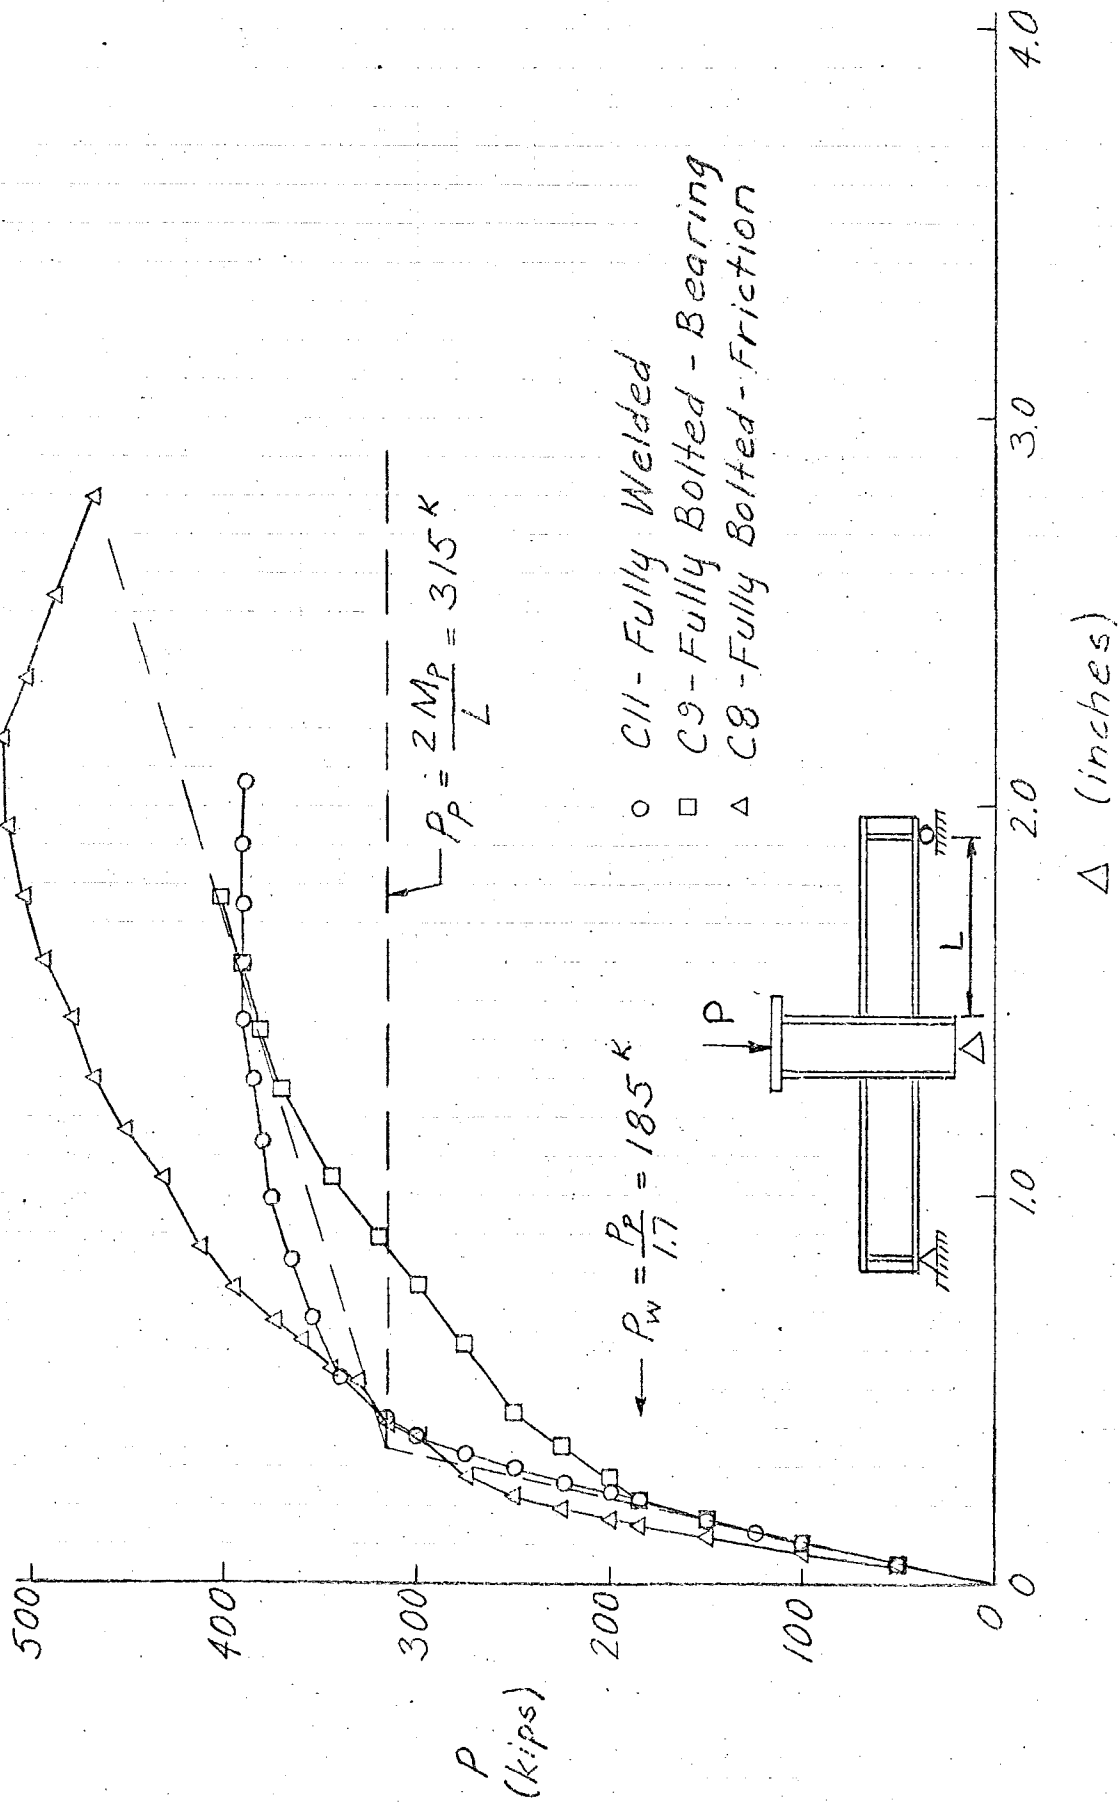
Fig. 15 Load vs. Deflection of C8 and C9

The load versus deflection curves for C8 and C9 are given in Fig. 15. Also shown on the figure is a plot of C11 which is the control (fully welded) specimen using the same beam and column sizes as C8 and C9.
