A STUDY OF THE DEFECTS AND ELECTROSLAG WELDS IN THE I-79 BRIDGE AT MEADVILLE

September 1982

Report No. 455-1(82)

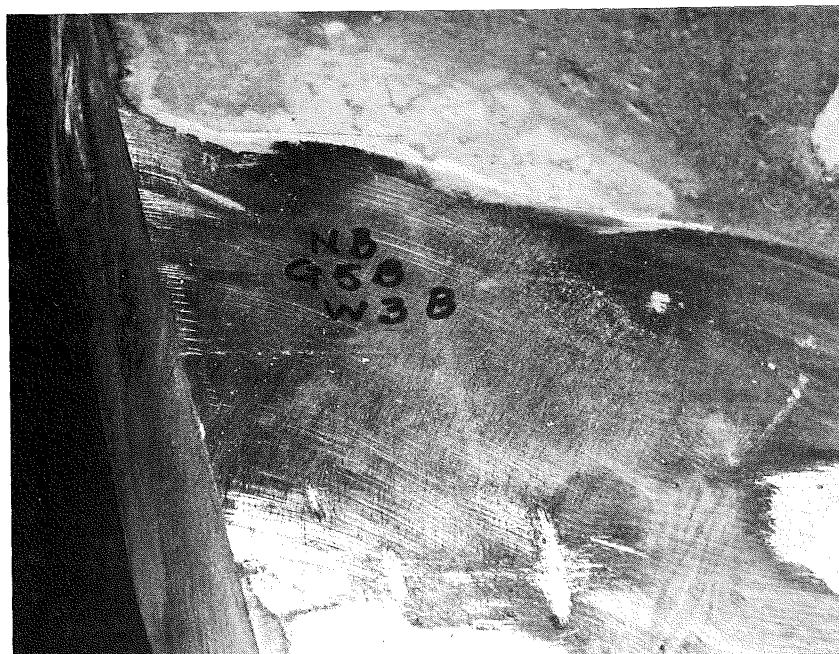
Fig. 3b. Lack of fusion extending across northbound girder G5 W3B about 2 inches.
